## Survey of green building water systems reveals elevated water age and water quality concerns†

William J. Rhoads,\* Amy Pruden and Marc A. Edwards

Widespread adoption of innovative water conservation strategies has potential unintended consequences for aesthetics and public health. A cross-section of green buildings were surveyed and compared to typical conventional buildings in terms of water retention time (*i.e.*, water age), water chemistry, and levels of opportunistic pathogen genetic markers. Water age was estimated to be 2–6.7 months in an off-grid office, an average of 8 days in a Leadership in Environmental Engineering Design certified healthcare suite, and was increased to 2.7 days from 1 day due to installation of a solar “pre-heat” water tank in a net-zero energy house. Chlorine and chloramine residuals were often completely absent in the green building systems, decaying up to 144 times faster in premise plumbing with high water age when compared to distribution system water. Concentration of 16S rRNA and opportunistic pathogen genus level genetic markers were 1–4 orders of magnitude higher in green *versus* conventional buildings. This study raises concerns with re

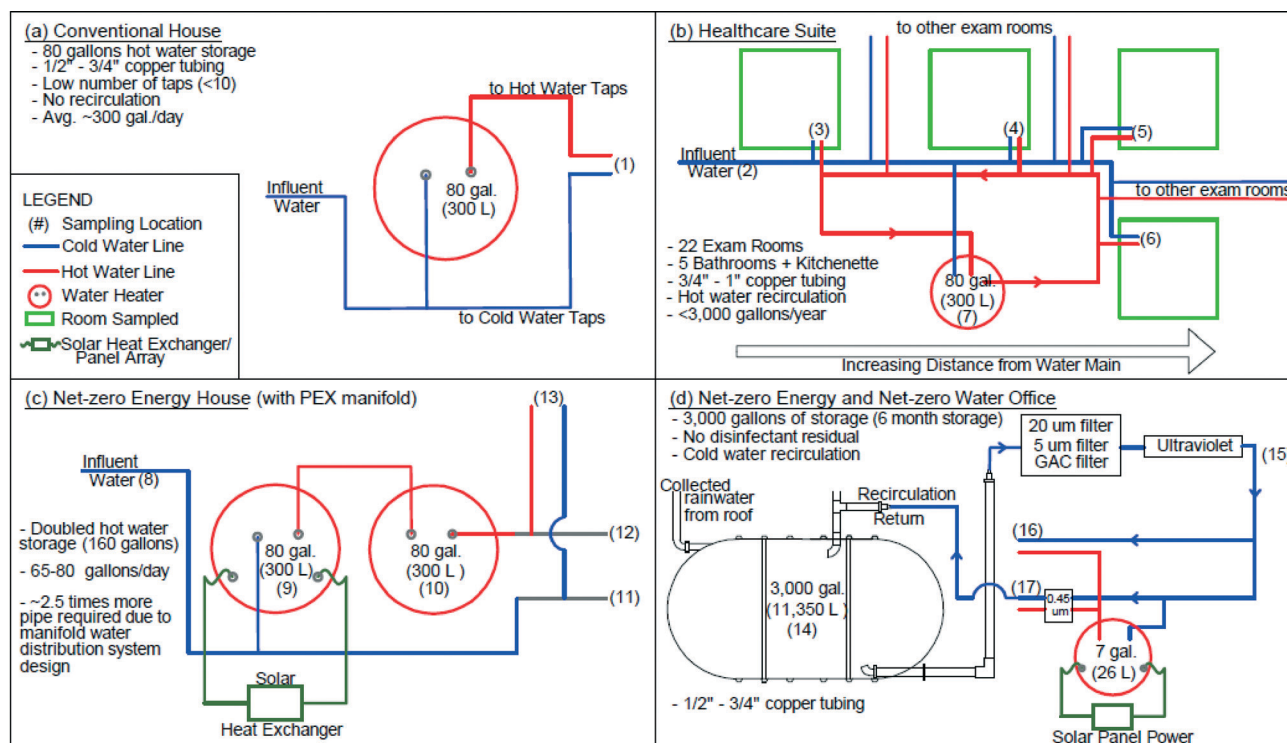
Note: Numbers 1-17 in parentheses indicate sampling locations referred to in Table 2.

Fig. 1 Plumbing schematics and sampling locations for each field site.

Four buildings with a cross-section of energy and water conservation strategies were surveyed and sampled to explore effects of green plumbing systems on water quality (Table 1). The buildings included a conventional house with no conservation features (Fig. 1a), a healthcare suite (Fig. 1b), a net-zero energy house (Fig. 1c), and a net-zero energy and net-zero water office building (Fig. 1d).

This study provided detailed documentation of the potable water systems in three innovative green buildings (Fig. 1). After reviewing the characteristics of each water system and closely examining trends in disinfectant residuals within the buildings, we provide an overview of microbial sampling from each building.

minutes of flushing was necessary to establish a chloramine residual similar to that present in the main distribution system (Fig. 2a). Taps at these locations are typically used for 15–30 seconds at a time; therefore, it is unlikely that a chloramine residual is ever present in portions of this plumbing system. Approximately 30 minutes of flushing was required at the net-zero energy house to establish a residual in the cold water system during the first site visit. In contrast, the conventional home had a residual of 0.71 mg L<sup>-1</sup> chlorine as Cl<sub>2</sub> in stagnant cold water. The water heaters at the net-zero house had <0.15 mg L<sup>-1</sup> chlorine as Cl<sub>2</sub> during a 20 minute flush due to the added storage volume and water age associated with the solar heater (Fig. 1c).
