Ongoing legacy contamination from a military radar station in Iceland: a case study

Cite this: *Environ. Sci.: Adv.*, 2024, 3, 972

Contamination in and around military radar stations in the Arctic has been an ongoing concern since first identified in the 1980s. This study reports on the environmental impact from a DEW line US military station that was operated on Heiðarfjall mountain in northeast Iceland from 1957 to 1970. This review is conducted as a part of work of the POPs Expert Group of the Arctic Monitoring and Assessment Program (AMAP) for an assessment report on local sources vs. long-range transport of Persistent Organic Pollutants (POPs) in the Arctic. The main resource for this summary is an evaluation of results from several reports on Heiðarfjall Langanes, one from an Icelandic Environmental Authority in 1993 and another from the Canadian Environmental Science Group (ESG) at the Royal Military College of Canada, which was commissioned in 2017 by the owners of the land that was used for the station. The results are compared to findings in scientific papers and reports for contamination at other military radar stations in Canada and Alaska. This review shows considera

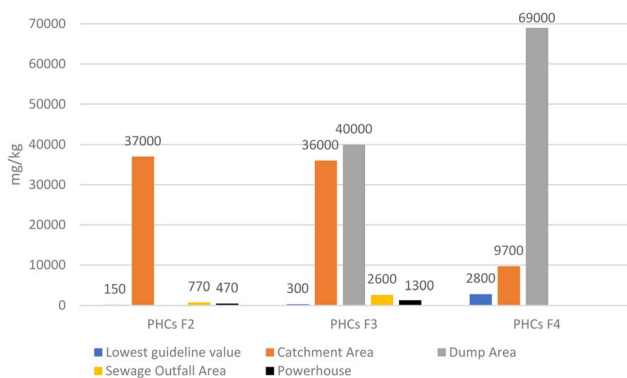
Fig. 6 PHCs (mg kg⁻¹) detected above the lowest guideline value for F2, F3 and F4 (150, 300, and 2800, respectively) at four areas. The highest value in each area of the four is shown in the figure.

PHCs, used as fuels and lubricants, consist of a large number of hydrocarbon compounds, some of which can cause severe health issues. The ESG observed considerable remains of oil barrels, some of which were stained black, and some black tar like chunks around the Dump area and around the Powerhouse area. Oil barrels were also observed by the MHR in 1993, as mentioned previously.⁴³ PHCs are arranged into four categories (F1, F2, F3, F4) depending on the number of carbons, and their volatility decreases and persistence increases in the environment with a rising number of carbons. PHCs in F1 were not detected over the lowest guideline values whereas this was the case with the other three, to varying degrees. PHCs were tested at six areas and detected over the lowest standard at four areas: the Dump, Sewage outfall, Powerhouse and Catchment areas (Table 2 and Fig. 6). The highest concentration of PHCs ranged from 40 000 mg kg⁻¹ to 69 000 mg kg⁻¹ at the Dump area and was 9700 to 37 000 mg kg⁻¹ at the Catchment area. A similar case was at the DEW line site at Utqiagvik in Alaska where areas around the powerhouse site showed significant petroleum-derived contamination as mentioned earlier.⁵

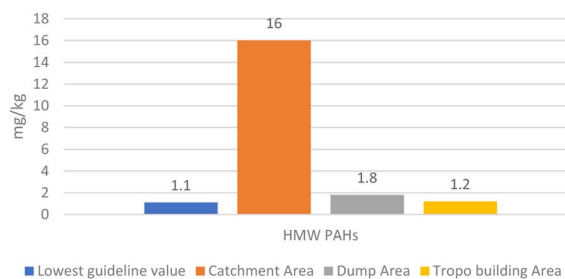
Fig. 7 HMW PAHs (mg kg⁻¹) tested in five areas with the content exceeding the lowest guideline value (1.1 mg kg⁻¹) in three areas. The highest values detected in the three areas are shown.

PAHs are released during incomplete combustion of petroleum products or from petroleum spill. They are persistent in the environment and several have multiple adverse health effects.²⁷ PAHs were summarized in two categories, low molecular weight PAHs (LMW PAHs) and high molecular weight PAHs (HMW PAHs), with the latter being more toxic and carcinogenic.⁵¹ Fifteen PAHs were tested (5 LMW and 10 HMW) in nine samples from five areas (Dump, Tropo, Sewage outfall, Powerhouse and Catchment), see Table 1, and found to exceed the lowest guideline value at three areas: Catchment, Dump and Tropo areas. The highest values in both categories (LMW and HMW) were found at the Catchment area (Table 2). See Fig. 7 for results for HMW PAHs.
