Cite this: *Environ. Sci.: Water Res. Technol.*, 2021, 7, 274

This study was conducted to determine if the thermal degradation of various plastic drinking water pipes (*i.e.*, PEX, HDPE, PP, PVC, and CPVC) may be a source of drinking water contamination. Widespread volatile organic compound (VOC) contamination was found in water distribution systems following three wildfires in California. A potential source of this contamination was thought to be due to the degradation of plastic components in drinking water distribution systems. Eleven plastic drinking water pipes, across eight brands, were exposed to elevated temperatures (200 °C to 400 °C), and subsequently submerged in water or in *n*-hexane to observe the extent of VOC leaching. Results indicated that thermally damaged drinking water pipes can be sources of VOC leaching, with ten of the eleven materials leaching benzene, a carcinogen, into water. As exposure temperature increased, an increase in VOC leaching was observed in the polyethylene materials. Conversely, in the vinyl materials the significant mass loss associated with high exposure temperature was inversely proportional to the amount of BTEX leaching that was observ

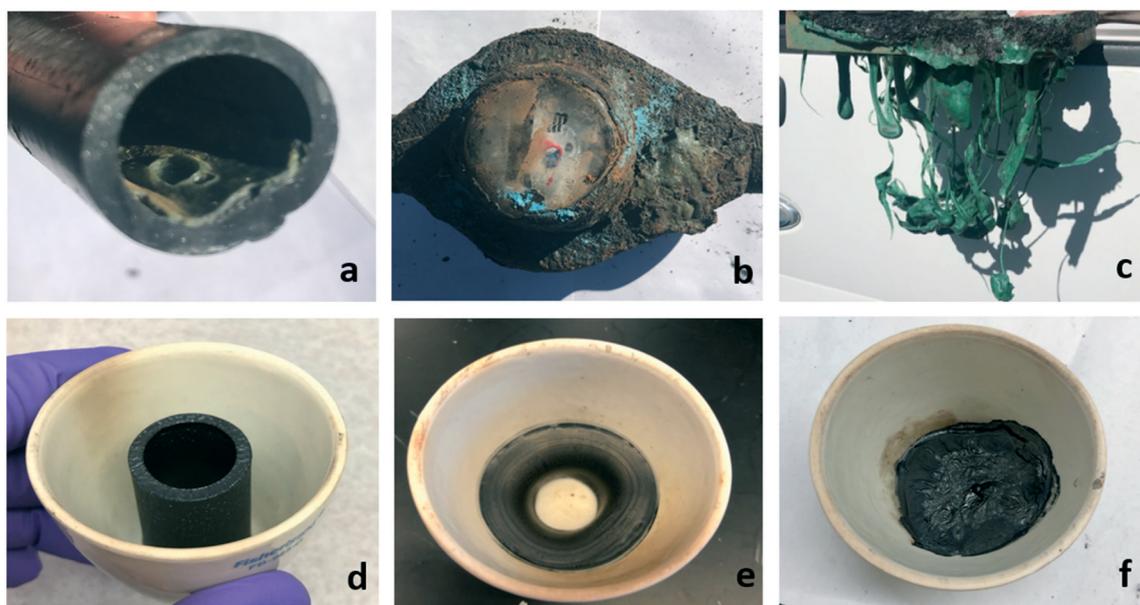
**Fig. 1** Images of fire-damaged water system components including (a) a HDPE plastic pipe, (b) a water meter, and (c) a water meter cover following the Camp Fire. Thermally degraded pipe samples in laboratory experiments include the (d) PEX-c pipe degraded at 300 °C, (e) HDPE pipe degraded at 300 °C, and (f) HDPE pipe degraded at 400 °C.

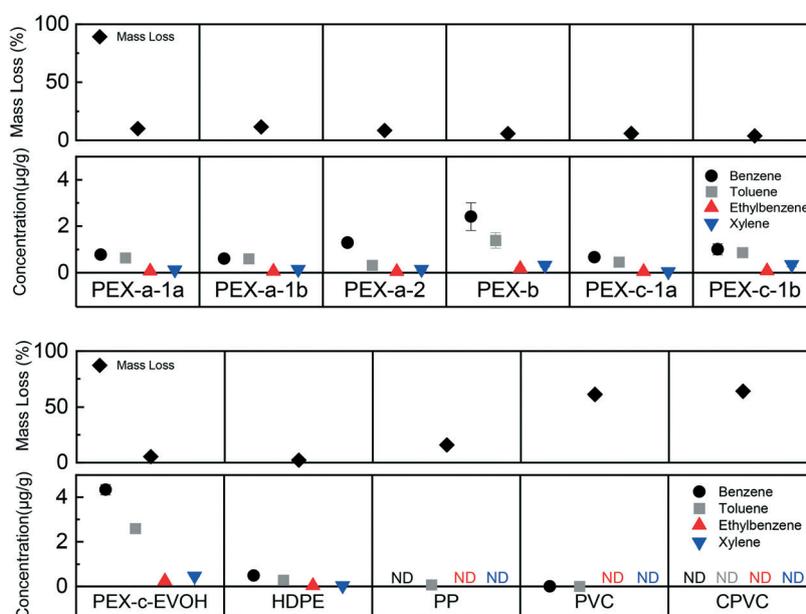
Fig. 2 Average amount of benzene, toluene, ethylbenzene, and xylene leaching observed after burning each material at 400 °C and extracting in water for 7 days. The error bars reflect the standard deviation of the measurements ( $n = 3$ ). If no error bars are visible, this indicates the error bars are smaller than the symbol size. ND indicates the compound was not detected above the MDL.

Results showed that plastic pipe thermal exposure can generate BTEX, which can then leach from cooled plastics into water. BTEX was not found from new and non-thermally degraded plastics in water, while 10 of 11 thermally degraded plastic pipes leached at least one BTEX component (Fig. 2). The chemical leaching differences between products is likely attributed to differences between plastic characteristics and experimental conditions. PE materials lost less mass due to isothermal heating (5 wt% to 10 wt%) compared to the PVC and CPVC samples (61 wt% and 64 wt%, respectively) (Fig. 2). A detectable, but significantly lower amount of benzene and toluene was observed for the PVC pipe, and no BTEX was found for the CPVC pipe (Fig. 2). Additionally, there was a general trend of compound concentration leaching across the plastics where benzene > toluene > ethylbenzene ≈ xylene (Fig. 2). This trend could be attributed to several factors including compound production, water solubility, air volatilization, polymer solubility parameters, and/or partitioning into the aqueous phase. Octanol-water coefficients and solubility values mirror the trend of concentrations observed (Table S4†), indicating that benzene would most readily partition into the aqueous phase.

The discovery that BTEX was generated by thermally degraded plastic pipes is supported by prior literature focused on air testing. Benzene and toluene tend to be formed during the first stage of decomposition for vinyl material thermal degradation.<sup>49</sup> Alkylated aromatics, such as ethylbenzene and xylene can be formed during a second degradation step due to chain scission and aromatization.<sup>49</sup> VOC release from HDPE into air during pyrolysis (lack of oxygen) or combustion (presence of oxygen) occurs due a similar scission and aromatization mechanism, and previous studies have observed all four BTEX compounds.<sup>50,51</sup> The results of this study suggest that BTEX may have been formed in the intact, but thermally degraded, plastics and subsequently leached into the water. The inverse relationship between BTEX in the aqueous phase and mass loss (Fig. 2) indicates that as structural integrity becomes compromised, as was the case for the vinyl materials (Fig. S2–S5†), the volatile compounds tend to partition into air. To the best of the authors' knowledge, there have been no prior PEX thermal degradation studies that have found BTEX compounds in the air. Primary degradation products of PEX have been reported to include linear hydrocarbons and cyclical siloxane compounds, although PEX pipe is created by crosslinking HDPE and medium density polyethylene resins.<sup>52</sup>

Little to no BTEX was found for the PP pipe, which has a similar structure to HDPE. The onset degradation temperature of the PP pipe (416 °C) was lower than that of the HDPE and PEX materials (Table 1), and unsurprisingly, the PP had more mass loss (~15 wt%) (Fig. 2) at the same temperature. In previous PP studies, benzene has been found in the air after pyrolysis between 300 °C to 600 °C.<sup>53,54</sup> No prior studies were found that examined BTEX release into water from thermally damaged PP materials.

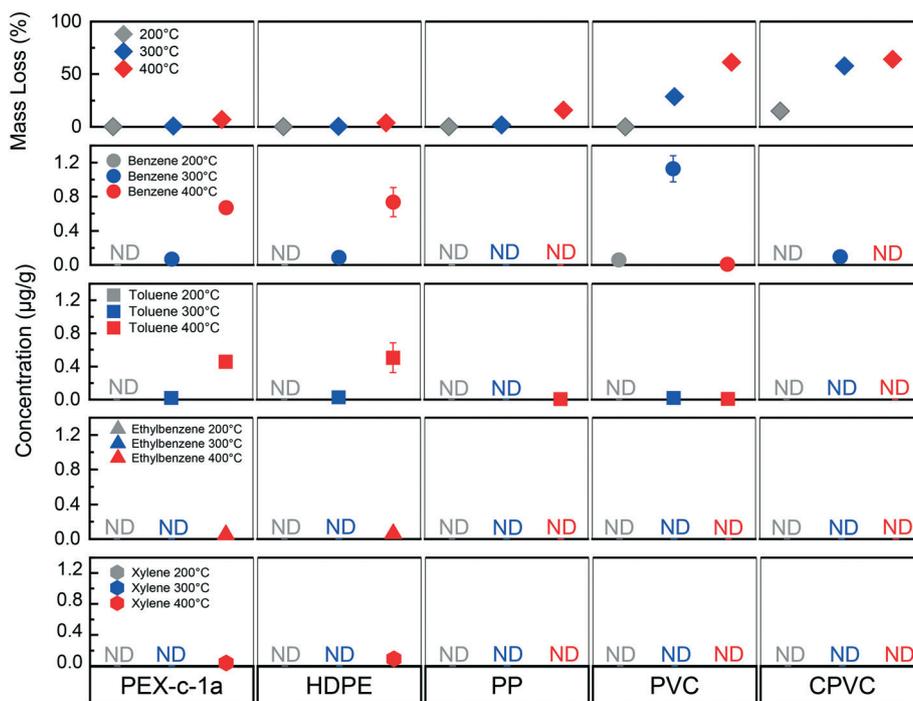
Fig. 3 Mean BTEX concentration after extracting each burned material at 200 °C, 300 °C, and 400 °C in water. The error bars reflect the standard deviation of the measurements ( $n = 3$ ). If no error bars are visible, it indicates they were smaller than the symbol size. ND indicates the compound was not detected.

Different concentrations of BTEX were found in water after changing the isothermal heating temperature, such that two patterns emerged (Fig. 3). For the HDPE and PEX pipes, the amount of BTEX that leached into the water increased as the plastic degradation temperature increased from 200 °C to 400 °C (Fig. 3). Conversely, the greatest benzene concentration was found for the PVC pipe when exposed to 300 °C, with relatively less concentrations at 200 °C and 400 °C (Fig. 3). The CPVC pipe showed a similar pattern for benzene as the PVC pipe, however, at much lower concentrations (Fig. 3). This spike phenomenon for vinyl materials can potentially be explained by the lower amount of mass loss, where not all benzene produced during degradation volatilized out of the solid. The 300 °C exposure temperature was greater than the onset degradation temperature (Table 1) where dehydrochlorination would occur. However, the PVC pipe mass loss was only 23 wt% as opposed to 61 wt% at the 400 °C condition resulting in a more structurally intact plastic after degradation (Fig. S2†).

Despite structural similarities for the vinyl pipes, benzene was only detected in water exposed to the CPVC pipe at a fraction of the amount it was found in water exposed to the PVC material (Fig. 3). This difference may be explained by the additional chlorine atoms present on the CPVC polymer chains resulting in a greater number of chlorine substituted aromatic products when CPVC was thermally degraded.<sup>34</sup> A previous CPVC pyrolysis study found significantly more

Compared to vinyl pipes, greater BTEX concentrations were found as the degradation temperature increased for the HDPE and PEX materials (Fig. 3). The onset degradation temperature for both of these materials exceeds 430 °C (Table 1) which can explain why little to no BTEX leaching was observed at 200 °C and 300 °C. The increase in leaching between 300 °C and 400 °C can be attributed to the plastic pipes beginning to degrade and generating BTEX and other compounds. Elevated temperatures lead to the polymer chain undergoing chain scission resulting in the formation of alkenes.<sup>32</sup> As the pipe is exposed to greater temperatures, the amount of polymer chain scission that occurs also increases. The increase in scission results in more alkene fragments that may subsequently undergo aromatization. A similar pattern was observed in a study of HDPE combustion by others, in which the benzene concentration in the air increased as the combustion temperatures increased from 500 °C to 800 °C.<sup>51</sup> However, the increase in potential BTEX formation does not necessarily indicate that this trend of increased leaching as a function of temperature will
