## Ongoing legacy contamination from a military radar station in Iceland: a case study

Contamination in and around military radar stations in the Arctic has been an ongoing concern since first identified in the 1980s. This study reports on the environmental impact from a DEW line US military station that was operated on Heiðarfjall mountain in northeast Iceland from 1957 to 1970. This review is conducted as a part of work of the POPs Expert Group of the Arctic Monitoring and Assessment Program (AMAP) for an assessment report on local sources vs. long-range transport of Persistent Organic Pollutants (POPs) in the Arctic. The main resource for this summary is an evaluation of results from several reports on Heiðarfjall Langanes, one from an Icelandic Environmental Authority in 1993 and another from the Canadian Environmental Science Group (ESG) at the Royal Military College of Canada, which was commissioned in 2017 by the owners of the land that was used for the station. The results are compared to findings in scientific papers and reports for contamination at other military radar stations in Canada and Alaska. This review shows considerable contamination on Heiðarfjall over 50 year

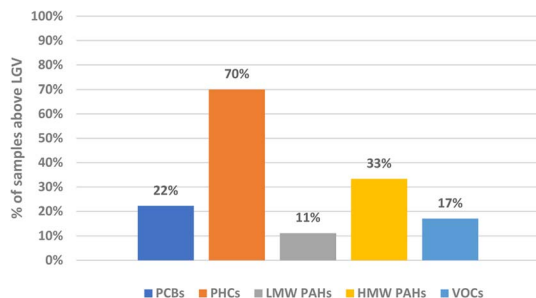
Fig. 5 Non-compliance of POPs with the LGV (lowest guideline value) in samples.<sup>10</sup>

POPs are non-compliant to the lowest guideline value, as shown in Fig. 5, from 11% for low molecular weight PAHs to

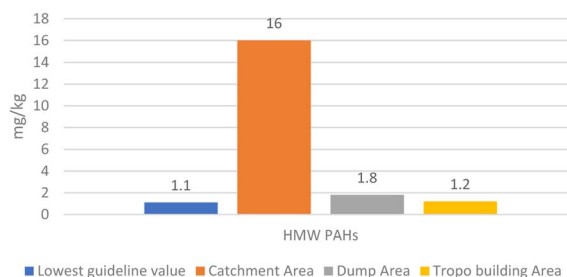
Fig. 7 HMW PAHs (mg kg<sup>-1</sup>) tested in five areas with the content exceeding the lowest guideline value (1.1 mg kg<sup>-1</sup>) in three areas. The highest values detected in the three areas are shown.

PAHs are released during incomplete combustion of petroleum products or from petroleum spill. They are persistent in the environment and several have multiple adverse health effects.<sup>27</sup> PAHs were summarized in two categories, low molecular weight PAHs (LMW PAHs) and high molecular weight PAHs (HMW PAHs), with the latter being more toxic and carcinogenic.<sup>51</sup> Fifteen PAHs were tested (5 LMW and 10 HMW) in nine samples from five areas (Dump, Tropo, Sewage outfall, Powerhouse and Catchment), see Table 1, and found to exceed the lowest guideline value at three areas: Catchment, Dump and Tropo areas. The highest values in both categories (LMW and HMW) were found at the Catchment area (Table 2). See Fig. 7 for results for HMW PAHs.

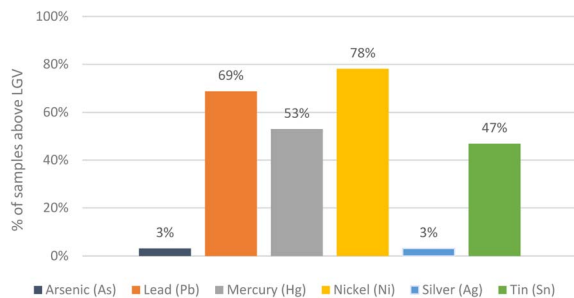
Fig. 8 Non-compliance with the lowest guideline value in samples of 6 primary trace elements, measured in 32 samples from the 10 areas chosen by the ESG for investigation at the H-2 area.<sup>10</sup>

aluminium, antimony, cobalt, copper, iron, manganese, vanadium, and zinc were frequently above the guideline values. None of the six primary inorganic elements were above the guideline values at the Eiði farm area. However, ten other inorganic elements (not shown here) exceeded the lowest guidelines at the Eiði farm area, especially vanadium and antimony which were 50 and 20-fold higher than the lowest guideline values. Others were aluminium, chromium, cobalt, copper, iron, manganese, sulphur, and zinc, ranging from 2 to 7-fold higher (Fig. 8).
