## Ongoing legacy contamination from a military radar station in Iceland: a case study

Cite this: *Environ. Sci.: Adv.*, 2024, 3, 972

Contamination in and around military radar stations in the Arctic has been an ongoing concern since first identified in the 1980s. This study reports on the environmental impact from a DEW line US military station that was operated on Heiðarfjall mountain in northeast Iceland from 1957 to 1970. This review is conducted as a part of work of the POPs Expert Group of the Arctic Monitoring and Assessment Program (AMAP) for an assessment report on local sources vs. long-range transport of Persistent Organic Pollutants (POPs) in the Arctic. The main resource for this summary is an evaluation of results from several reports on Heiðarfjall Langanes, one from an Icelandic Environmental Authority in 1993 and another from the Canadian Environmental Science Group (ESG) at the Royal Military College of Canada, which was commissioned in 2017 by the owners of the land that was used for the station. The results are compared to findings in scientific papers and reports for contamination at other military radar stations in Canada and Alaska. This review shows consid

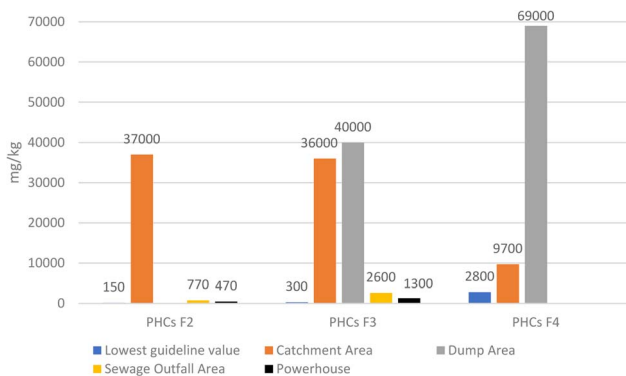
Fig. 6 PHCs (mg kg<sup>-1</sup>) detected above the lowest guideline value for F2, F3 and F4 (150, 300, and 2800, respectively) at four areas. The highest value in each area of the four is shown in the figure.

PHCs, used as fuels and lubricants, consist of a large number of hydrocarbon compounds, some of which can cause severe health issues. The ESG observed considerable remains of oil barrels, some of which were stained black, and some black tar like chunks around the Dump area and around the Powerhouse area. Oil barrels were also observed by the MHR in 1993, as mentioned previously.<sup>43</sup> PHCs are arranged into four categories (F1, F2, F3, F4) depending on the number of carbons, and their volatility decreases and persistence increases in the environment with a rising number of carbons. PHCs in F1 were not detected over the lowest guideline values whereas this was the case with the other three, to varying degrees. PHCs were tested at six areas and detected over the lowest standard at four areas: the Dump, Sewage outfall, Powerhouse and Catchment areas (Table 2 and Fig. 6). The highest concentration of PHCs ranged from 40 000 mg kg<sup>-1</sup> to 69 000 mg kg<sup>-1</sup> at the Dump area and was 9700 to 37 000 mg kg<sup>-1</sup> at the Catchment area. A similar case was at the DEW line site at Utqiagvik in Alaska where areas around the powerhouse site showed significant petroleum-derived contamination as mentioned earlier.<sup>5</sup>
