Energy & Environmental Science

washing facilitates the direct regeneration of spent cathodes from retired EV Li-ion batteries† Yi Guo,‡^a Yang Li,‡^{bcd} Kai Qiu,^d Yan Li,^e Weijing Yuan,^b Chenxi Li,^b Xinyu Rui,^a

Removal of residual contaminants by minute-level

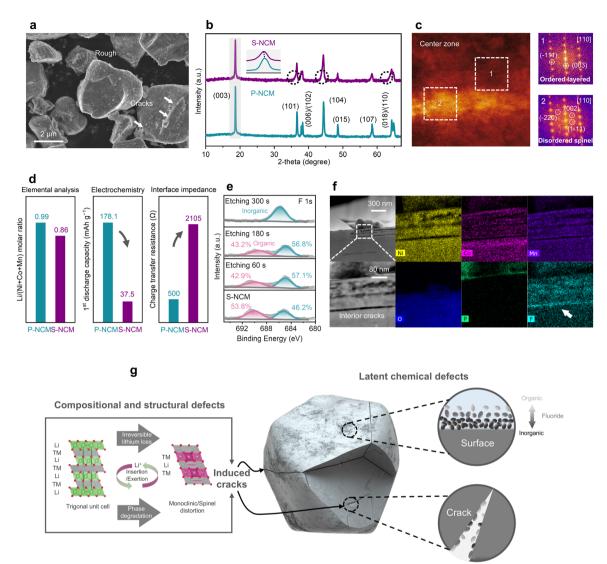
Fig. 1 Neglected chemical residuals on the 250k-miles-serviced cathode. (a) SEM image and (b) XRD pattern of the degraded S-NCM. The black dotted circle accentuates the subtle peaks that do not belong to the layered structure; (c) high-resolution HAADF-STEM images on the central area of the S-NCM particle and the FFT patterns of the selected dark and bright regions; (d) comprehensive comparison of lithium loss in degraded powders measured by ICP-OES, electrochemical capacity, and charge-transfer resistance analyses in the half-cell using S-NCM and P-NCM powders as cathode active materials; (e) F 1s XPS patterns of S-NCM powders for different sputtering times using an ion-beam. Based on the calculated integral area, the proportional values of the organics and inorganics in fluoride are presented in the patterns; (f) HAADF-STEM images based on focused ion beam cutting and an enlarged view displaying the interior microcracks. Corresponding EDS mapping analysis indicates the presence of F elements along these microcracks pointed out by a white arrow. (g) Deficiencies of S-NCM addressed before direct regeneration, including the compositional and structural aspects (e.g., irreversible lithium-ionic loss, phase degradation, internal and external cracks) and latent chemical defects (e.g., surface and crack-edge impurities enriching the F element).

As shown in the Materials and methods and Fig. S1 (ESI†), a series of pretreatments, such as sorting, dismantling, crushing, and shredding, were employed to collect the spent NCM cathode (denoted as S-NCM) with minor metal and polyvinylidene fluoride (PVDF) binder (Table S3 and Fig. S2, ESI†). First, a comprehensive comparison between S-NCM and pristine NCM cathodes (P-NCM) was conducted to identify the failure mechanism of the S-NCM materials. As shown in scanning electron microscope (SEM) images (Fig. 1a and Fig. S3, ESI†), the end-oflife battery S-NCM cathode showed intensive rough surface residuals with minor cracks after 250 000-mile service, with the planar gliding degradation and cracks in the single-crystal cathode consistent with previous reports. 26,27 The X-ray diffraction (XRD) analysis, shown in Fig. 1b, demonstrated that the S-NCM still preserved an ordered layered $R\bar{3}m$ structure with a minor degraded phase near the (101), (104), and (018) peaks, possibly corresponding to the subtle monoclinic phase transition due to lithium loss. 28 According to the high angle annular dark field scanning transmission electron microscopy (HAADF-STEM) analysis and fast Fourier transform (FFT) pattern (Fig. 1c and Fig. S4, ESI†), the degraded S-NCM cathode showed a spinel phase in zone 2 and exhibited significant spatial heterogeneity. Besides the structural degradation, the inductively coupled plasma optical emission spectrometry (ICP-OES) result (Fig. 1d and Table S4, ESI†) indicated that, even after the longterm cycling, the end-of-life S-NCM cathode showed only 13.1% loss of Li inventory compared to the pristine P-NCM. Contradictorily, the specific capacity of S-NCM significantly declined to 37.5 mA h g^{-1} compared to 178.1 mA h g^{-1} for the P-NCM, as shown in Fig. 1d. Especially in the follow-up cycle, see Fig. S5 (ESI†), the S-NCM cathode exhibited a capacity of less than 10 mA h g^{-1} after 100 cycles. Note that, there was only 13.1% Li deficiencies, which could not sufficiently account for the 78.9% capacity fading of S-NCM. Therefore, to further reveal the origin of the poor electrochemical performance, electrochemical impedance spectroscopy (EIS) characterization was conducted, as shown in Fig. 1d and Fig. S6 (ESI†), the charge-transfer resistance ($R_{\rm ct}$) for S-NCM steeply climbed to 2105 Ω and was

To understand the surface state of the spent cathode, energy-dispersive spectroscopy (EDS) element mapping and X-ray photoelectron spectroscopy (XPS) were conducted. As shown in Fig. S7-S9, and Tables S5, S6 (ESI†), the S-NCM cathode surface residuals consisted of C, O, F, and P elements, and displayed a surface-rich gradient distribution, as revealed

by XPS with etching. The F 1s XPS peaks with etching for S-NCM are shown in Fig. 1e, where two F 1s peaks could be observed before sputtering, with the major peak centered at 685.5 eV, which was attributed to inorganic fluorides and the minor F 1s peak centered at 690.4 eV, which could be assigned to organic fluorides, with the ratio of 53.8% for organic flourides.²⁹ However, the organic-related F peak declined significantly after sputtering, and completely disappeared after 300 s Ar+ sputtering. The surface-rich distribution of organic fluoride was consistent with the cathode electrolyte interphase (CEI) composition previously reported.^{29,30}

To further reveal the microscopic distribution of those F-rich residuals, SEM combined with time-of-flight secondary ion mass spectrometry (SEM-ToF-SIMS) characterization was conducted for the cycled cathode. The results are shown in Fig. S10 and Videos S1, S2 (ESI†). Based on the spatial distribution of F secondary ion fragments, it was confirmed that fluoride impurities were primarily deposited on the particle surface. Moreover, during the long-time battery service, it could be observed from the HAADF-STEM image and corresponding element mapping (see Fig. 1f) that, in the S-NCM cathode, the fluorides could spread into the interior of the cathode along the intragranular cracks. Coincidentally, from the selected FFT figure shown in Fig. S4 (ESI†), the existence of an amorphous ring was observed along the intragranular cracking, which may be related to the fluorides also observed in the bulk. To sum up, the collected S-NCM exhibited limited structural and compositional degradation, while preserving the fluoride-containing impurities aggregated on the surface and along the intragranular cracks, as illustrated in Fig. 1g.

Furthermore, it was previously widely accepted that the source of F-rich impurities in the spent cathode was due to decomposition of the PVDF binder during the heat delamination process at around 350 °C; 11,23-25,31 however, during the thermal decomposition of PVDF, most the fluoride-containing products were gas species (i.e., HF) and fragments (-CF- and -CH-CF-), 32-34 which are subject to ejection instead of propagating along the cathode intragranular cracks. To confirm the source of those observed residual impurities, four kinds of cathodes with varying cycling conditions were collected and examined, namely cathode laminates with/without electrolyte filling, and laminates from 125k and 250k miles-serviced batteries, as listed in Table S7 (ESI†). The SEM images and electrochemical performance are shown in Fig. S11 and S12 (ESI†). Compared with the pristine one (sample A), the other spent cathodes from battery formation and cycling exhibited a rough surface and limited discharge capacity. Notably, the laminate from formation only but with no cycling (sample B), which it was believed would retain the full lithium inventory and show negligible structural degradation since it had not undergone charge/discharge cycling, showed a poor discharge capacity, which was the same as the other long-cycled ones. Moreover, the heat exfoliation used to pyrolyze the adhesive binders deteriorated the original CEI layer on the spent cathodes and generated more harmful byproducts (e.g., Li₂CO₃, Li₃PO₄, LiF). This, combined with electrolyte decomposition during electrochemical cycling, exacerbates chemical degradation, resulting in a significant capacity decline. Therefore, the above comparison revealed that the cathode residual impurities should originate from the electrolyte components (such as LiPF₆, DMC, ethylene carbonate (EC)) decomposition during battery formation, cycling, and common heat exfoliation, leading to severe capacity loss in spent cathodes (Fig. 1d).

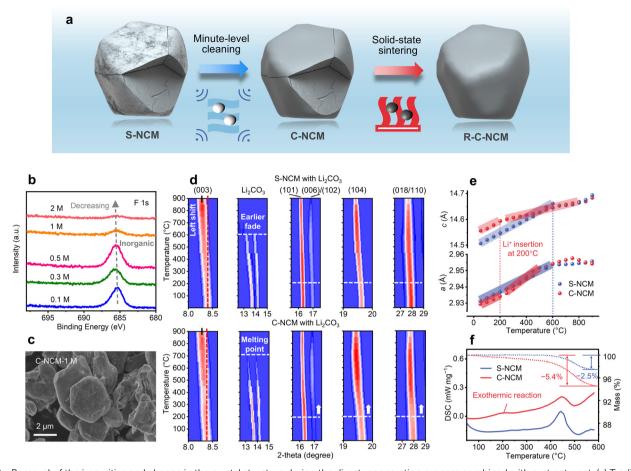
Fig. 2 Removal of the impurities and change in the crystal structure during the direct regeneration process combined with pretreatment. (a) Traditional direct regeneration path using solid-state sintering and the minute-level pretreatment introduced in an advanced path targeted to the critical obstacles within degraded cathode materials; (b) F 1s XPS fine patterns of C-NCM undergoing ultrasonic stirring in solutions with different concentrations; (c) SEM image of C-NCM obtained by soaking S-NCM in 1 M HNO₃ solution; (d) partial in situ XRD patterns of S-NCM and C-NCM mixed with a Li resource, keeping a constant heating rate (20 °C min⁻¹) and holding the temperature for diffraction at 50 °C intervals; (e) evolution of the unit cell parameters a and c for S-NCM (blue symbols) and C-NCM (red symbols) mixed with Li slate through Rietveld refinement. The earlier Li⁺ insertion at 200 °C changed the variation tendency of the unit parameters for the sample after cleaning. (f) Heat generation measured by DSC from mixtures.

morphology of the cathode remained unchanged, which may be related to the Li⁺/H⁺ exchange mechanism with the stabilizing lattice structure. 40,41 Moreover, as shown in Fig. 2b and Fig. S22 (ESI†), based on the charge/discharge efficiency, we further optimized the solution concentration as 1 M in the following investigations.

C-NCM cathode was consumed gradually until it disappeared at its melting point around 730 °C, while the Li₂CO₃ in the S-NCM cathode completely vanished at around only 600 °C, and this earlier consumption of the lithium source may be attributed to the reaction between Li₂CO₃ and the residual impurities (such as LiF, LiOH, and Li₃PO₄) by co-melting, vaporizing, and replenishing in S-NCM.42 Equivalently, the high angle reflection peak intensity spanning from (006) to (110), representing the layered structure, significantly increased starting from around 200 °C for the C-NCM cathode after the purifying treatment compared to there being no obvious enhancement for S-NCM, indicting the better repair of the layered structure during heating. To further unveil the underlying mechanism, Rietveld refinement of each XRD pattern was conducted, which can depict the continuous change of the unit cell parameters during regeneration. Generally, the unit cell parameter c decreases and a increases with the insertion of Li ions into a layered structure, similar to in the discharge process.²⁸ As shown in Fig. 2e, the lattice evolution of the S- and C-NCM

cathodes were compared. For C-NCM, the lattice c expansion slope became obviously flatter at 200 $^{\circ}$ C, denoting a lattice cshrinkage at this temperature induced by the Li-ion insertion and repairing. However, for the S-NCM without undergoing purifying treatment for the residuals, the lattice expanded still nearly linearly with no obvious lithium insertion until 600 °C. Concurrently, the lattice a expansion slope became steeper at 200 °C for C-NCM. Last but not least, Differential scanning calorimetry (DSC) characterization was also conducted during the regeneration process to confirm the lithium insertion pattern for the S- and C-NCM cathodes, which can trace the lithium replenishment associated with the exothermic reaction as reported by others. 43 As shown in Fig. 2f, the characteristic exothermic reaction at around 200 °C was only observed for C-NCM, confirmed the earlier lithium insertion after the purifying treatment. The earlier lithium insertion was also supported by the CO₂ gas release observed during Li₂CO₃ decomposition to supply the lithium source for the C-NCM cathode, as shown Fig. S23 (ESI†). Moreover, from the thermogravimetric results shown in Fig. 2f, the weight loss of C-NCM was 5.4%, which was significantly larger than that of S-NCM of 2.5%, indicating that more Li₂CO₃ was activated and decomposed to provide the lithium source for C-NCM. 43,44 To sum up, through multiple in situ and ex situ characterizations, we proved that, with a purifying pretreatment, the direct regeneration could be facilitated to start at a lower temperature of 200 °C from the spent cathode.

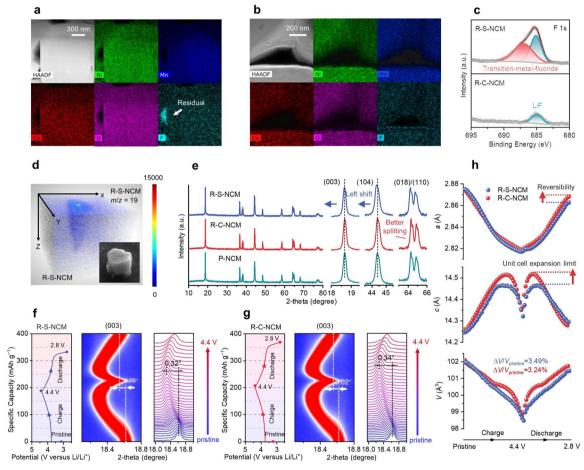
Fig. 3 Chemical and structural details of the regenerated cathode materials under the influence of impurities. (a) HAADF-STEM images and (b) corresponding EDS element mappings of R-S-NCM and R-C-NCM particles, focusing on the pores of the packing particles. (c) F 1s XPS high-resolution patterns of R-S-NCM and R-C-NCM powders. (d) Pseudo-three-dimensional distribution of F element and SEM image of the corresponding R-S-NCM particle. (e) Full patterns and characteristic peak comparison of the regenerated and pristine NCM cathodes with Cu Kα radiation at a scan rate of 8° min⁻¹. (f) 1st charge-discharge curves, corresponding XRD patterns of R-S-NCM, and (g) (003) peak position variation when the cell charge from pristine to 4.4 V and comparison with R-C-NCM. (h) Lattice parameters a, c, and the unit cell volume V of R-S-NCM and R-C-NCM in the 1st chargedischarge test according to the refinement.

Furthermore, the crystal structure of the regenerated cathode could also be affected by the residual impurities. As shown in Fig. 3e and Fig. S28 (ESI†), the XRD pattern indicated a layered structure with no impurities phase for both the R-S-NCM and R-C-NCM cathodes. However, the R-C-NCM cathode had a higher (003)/(104) intensity ratio and larger splitting degree for the (018)/(110) peaks compared to R-S-NCM, suggesting its more ideal layered structure similar to P-NCM cathodes. After regeneration accompanied by impurities, the diffraction peaks of R-S-NCM were shifted toward a low-angle direction, indicating the lattice expansion, as supported by the refined parameters (Table S11, ESI†) and in situ experiments (Fig. 2d). Furthermore, in situ XRD was performed during the 1st charge/ discharge process for both regenerated cathodes (see Fig. 3f and g). The R-C-NCM cathode showed a higher capacity with a smaller offset (0.02°) of the (003) peak position than the

57.5% for R-S-NCM, indicating the R-C-NCM cathode had better cycling stability, even compared to the pristine one. As for the rate performance, the R-C-NCM cathode demonstrated a better high-rate capability (Fig. 4c and Fig. S30, ESI†) at 3C (127.8 mA h g^{-1}) compared to R-S-NCM (69.8 mA h g^{-1}) and P-NCM (108.9 mA h g⁻¹), which was commonly observed on the regenerated NCM cathodes and may be attributed to appropriate F element doping. 12,47 The plateau at ~ 3.6 V in the voltage profiles (Fig. 4d and e and Fig. S30, ESI†) for R-S-NCM nearly disappears after 100 cycles, suggesting that R-S-NCM had a rising polarization after long-term cycling. Based on the cyclic voltammetry curves at different scan rates and calculations (Fig. S31 and Table S12, ESI†), the fitting line slope for R-S-NCM was found to be the lowest among all the samples. According to the equivalent circuit (Fig. 4f), the calculated impedance values ($R_{\rm ohm}$, $R_{\rm int}$, and $R_{\rm ct}$) of R-C-NCM (Fig. 4g and h) were 1.4, 51.1, and 307.1 Ω , respectively, and were smaller than that of R-S-NCM. These results indicate the deteriorated kinetics of Li⁺ transportation due to the residual impurities, especially on the surfaces of the regenerated cathodes. According to the chemical state of the electrode surface (Fig. S32, ESI†), R-C-NCM exposed less inorganic fluoride and more lattice oxide, leading to the suppressed interfacial resistance growing during the long-term cycling. Furthermore, the galvanostatic intermittent titration technique (GITT) test also revealed the kinetic characteristics of the solid phase. The current pulse profile and calculated Li-ion diffusion coefficient (D_{Li^+}) after activation are shown in Fig. 4i. The average D_{Li^+} values of R-C-NCM and R-S-NCM were calculated to be 5.78 \times 10^{-14} and 2.99×10^{-14} for the charge process (and 4.56×10^{-14} and 4.29×10^{-14} for the discharge process), suggesting that residual impurities penetrating the interior bulk after regeneration hamper Li⁺ hopping within the lattice of the NCM cathode, as supported by the observed F element (Fig. 3c and Fig. S27, ESI†).

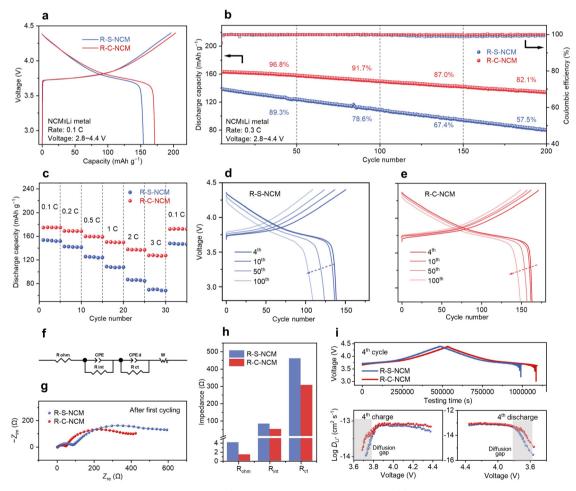
Fig. 4 Electrochemical deterioration for the regenerated NCM cathodes with impurity residue. (a) Initial galvanostatic charge-discharge curves of R-S-NCM and R-C-NCM at 0.1C (1C = 150 mA h g^{-1}) and (b) long cycling test and capacity retention in a half-cell. (c) Rate capabilities of R-S-NCM and R-C-NCM. Charge-discharge curves of (d) R-S-NCM, (e) R-C-NCM in the voltage range of 2.8-4.4 V (vs. Li/Li⁺) at different cycles. (f) Equivalent circuit applied in the EIS measurements. Nyquist plots of (g) R-S-NCM and R-C-NCM and (h) fitting results showing the Ohmic resistance (Rohm), interface resistance (R_{int}), and charge-transfer resistance (R_{Ct}). (i) GITT curves and the calculated Li⁺-diffusion rate of R-S-NCM and R-C-NCM for the 4th cycle number after activation in the same charge-discharge period. The shadow area indicates low Li⁺ diffusion in a certain voltage range.

As shown in Fig. 4a and Fig. S30 (ESI†), the initial discharge capacity increased from 154.1 mA h g⁻¹ for R-S-NCM to 171.4 mA h g^{-1} for R-C-NCM after the purifying treatment, although this was slightly lower than for P-NCM. In Fig. 4b and Fig. S31 (ESI†), the R-C-NCM cathode exhibit 91.7% and 82.1% capacity retention after 100 cycles and 200 cycles, respectively, compared with 91.6% and 78.3% for P-NCM, and 78.6% and

According to the above results (Fig. 1d, Fig. S6, S16 (ESI†), and Fig. 4h, i), the migration rate of lithium ions was significantly influenced by the residual impurities; therefore it was crucial to theoretically investigate their influence on capacity delivery in the reuse case and during direct regeneration. Considering the impurities were mostly concentrated at the surface before and after regeneration, and that F-rich residuals could be observed, as shown in Fig. S9 and S10 (ESI†) and Fig. 3c, we chose three representative inorganic components (LiF, Li2CO3, and LiOH) in the CEI layer⁴⁸ or residual alkali⁴⁹ to calculate the Li⁺ diffusion from a thermodynamic perspective, and their structures are shown in Fig. 5a. By maintaining a similar distance and concentration of mobile Li-ions, the diffusion energy barrier of lithium ions (ΔE_{Li^+}) during the cycling of spent cathodes within the different crystal structures (Fig. 5b) allowed valid comparisons. We found that the ΔE_{Li^+} of the LiF phase, as a common inorganic component from CEI, was about 2 and 3 times higher than that of the LiOH and Li₂CO₃ phases from

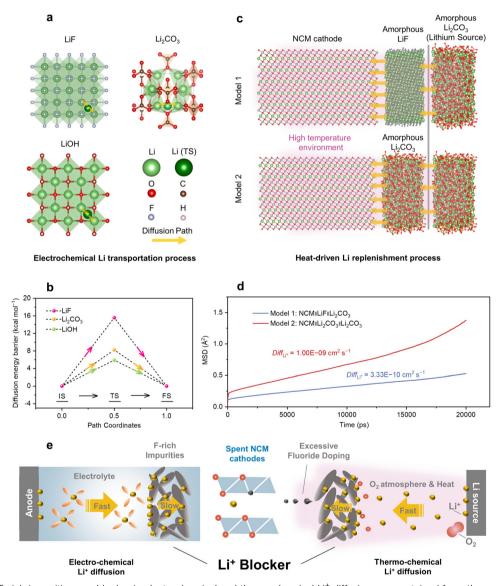
Fig. 5 Role of the F-rich impurities as a blocker in electrochemical and thermochemical Li⁺ diffusion as ascertained from thermodynamic and kinetic simulations. (a) Illustrations of the selected migration pathways with a similar distance for Li⁺ inside the crystal lattice of three common components. The initial state, transition state, and final state of Li⁺ transportation are denoted as IS, TS, and FS, respectively. (b) Calculated energy diffusion barrier for Li ions in selected phases. (c) Two models for stimulating the kinetics of Li transportation in direct regeneration. Model 1 consists of the NCM cathode substrate, the amorphous LiF layer, and Li_2CO_3 as a lithium source in direct regeneration, which is denoted as $\text{NCM} \| \text{Li}_F \| \text{Li}_2\text{CO}_3$. In Model 2 ($\text{NCM} \| \text{Li}_2\text{CO}_3 \| \text{Li}_$ short), the middle LiF layer is replaced by a common residual alkali (Li₂CO₃), which is used to simulate the regeneration of NCM cathodes after cleaning pretreatment. Each shape symbol is the same as for Fig. 5a. (d) MSD of the Li atoms in 20 ns and calculated Li⁺ diffusivity based on the above model. "E – $9^{\prime\prime}$ means 10^{-9} . (e) Mechanism diagram for preventing the NCM cathodes from reusing and directly regenerating under the influence of impurities.

Fig. 5b. Therefore, this result confirmed that the presence of fluoride-rich impurity residuals on the cathode surface significantly increased the diffusion resistance of Li ions when cycling, ultimately exacerbating the cell impedance and interfacial parasitic reactions (Fig. 1d). To comprehend the largerscale kinetic characteristics and understand the effect of impurity coatings during heating for regeneration of the spent cathodes, two molecular dynamics models were established for simulating Li⁺ transportation at 1000 K over 20 ns. Specifically, Model 1 was devised to include an impurity barrier consisting of a LiF layer (Fig. 5c and Fig. S33, ESI†). Through computing the mean square displacement (MSD) of Li atoms and fitting curves (Fig. 5d), we determined that the Li diffusivity (Diff_{Li}+) of Model 1 was 3.33×10^{-10} , which was an order of magnitude lower than that of Model 2 (1.00 \times 10⁻⁹). The differences in molecular dynamics models under practical conditions suggest that fluoride-rich impurity coatings increase the resistance to Li-ion diffusion into spent cathodes with Li deficiencies during thermo-driven regeneration, leading to inadequate compositional and structural recovery.

As illustrated in Fig. 5e, the impurity phase containing the F element served as an electro- and thermo-diffusion blocker of Li ions hindering the reuse and direct regeneration of the spent cathode. In the spent cathodes collected by physical pretreatment and collection from used lithium-ion batteries, the ubiquitous electrolyte was decomposed to form an ion barrier with slow ion diffusivity. However, these impurities have long been overlooked in most studies (Table S2, ESI†), mainly due to the use of lab-scale degraded cathodes and fine manual separation pretreatment. In previous studies, 12-16,42 the latent impact of the residual impurities on direct regeneration remains untouched because impurities are easily converted into other inconspicuous matter in extreme physical or chemical regeneration environments. Looking ahead, the direct regeneration of nextgeneration sensitive cathode materials, such as Li-rich Mnbased, Co-free, and ultra-high-Ni cathode materials, faces serious challenges from these latent impurities if they enter the recycling circle. From another perspective, establishing the controlling law for the inherent impurities doping within the closed-loop material flow could instructively enhance the performance of such recycled materials in the future. Moreover, only by revealing the effect of the overlooked impurities or by getting rid of impurities, can evolving technologies and mechanisms for direct regeneration and upcycling be reasonably evaluated.50
