CRITICAL REVIEW

Ongoing legacy contamination from a military radar station in Iceland: a case study

Contamination in and around military radar stations in the Arctic has been an ongoing concern since first identified in the 1980s. This study reports on the environmental impact from a DEW line US military station that was operated on Heiðarfjall mountain in northeast Iceland from 1957 to 1970. This review is conducted as a part of work of the POPs Expert Group of the Arctic Monitoring and Assessment Program (AMAP) for an assessment report on local sources vs. long-range transport of Persistent Organic Pollutants (POPs) in the Arctic. The main resource for this summary is an evaluation of results from several reports on Heiðarfjall Langanes, one from an Icelandic Environmental Authority in 1993 and another from the Canadian Environmental Science Group (ESG) at the Royal Military College of Canada, which was commissioned in 2017 by the owners of the land that was used for the station. The results are compared to findings in scientific papers and reports for contamination at other military radar stations in Canada and Alaska. This review shows considerable contamination on Heiðarfjal

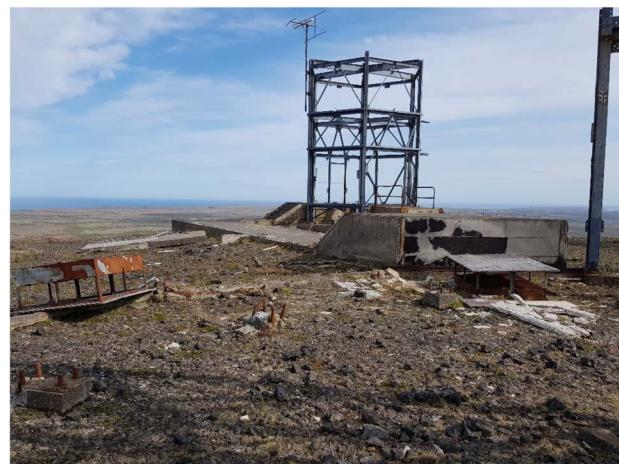
Fig. 4 The H-2 Station Radome area at Heiðarfjall, 26. 7. 2021 (M. J. Gunnarsdóttir).

The sites chosen for sampling by the ESG, see Fig. 3, were: (1) the Dump area (*ca.* 18.000 m^2) where debris, both during operating and later during clean-up, had been buried; (2) the Tropo area, with a communication building (still standing), and where two tropospheric communication dishes once stood; (3) the Sewage Outfall area; (4) the POL (petroleum oil and lubricant) Tank area, where a large fuel storage tank used to be situated. Sites 3 and 4 were on the southern edge of the summit area, directly above the Eiði farm; (5) the Garage area; (6) the Barracks area; (7) the Powerhouse area, and (8) Radome area (sites 5, 6, 7, and 8 are all situated at the Station area); (9) the lower-lying Catchment area, where a concrete drainage pipe was observed leading to a small pond; and (10) the Eiði stream area. Fig. 4 shows a recent picture of the Station area.

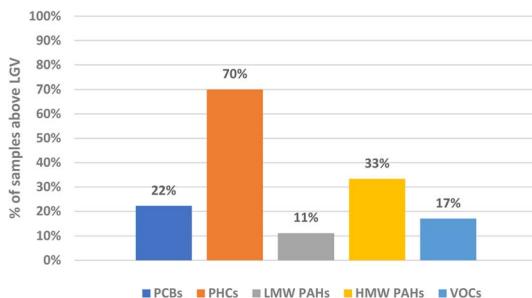
Fig. 5 Non-compliance of POPs with the LGW (lowest guideline value) in samples.¹⁰

POPs are non-compliant to the lowest guideline value, as shown in Fig. 5, from 11% for low molecular weight PAHs to

70% for PHCs. However, this is not representative as sampling is not evenly distributed and several sites are not tested for some POPs as shown in Table 1.

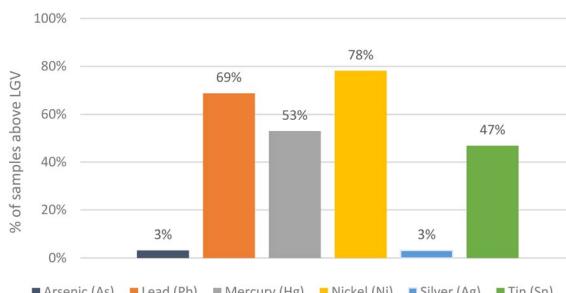
Fig. 8 Non-compliance with the lowest guideline value in samples of 6 primary trace elements, measured in 32 samples from the 10 areas chosen by the ESG for investigation at the H-2 area.¹⁰

Thirty-two samples were tested for 30 inorganic elements: four of the six primary trace elements were elevated at the sites: Pb, Hg, Ni, and Sn, with 47% to 78% of the samples exceeding the lowest guideline values, whereas silver and arsenic have less exceedance (3%). The five most impacted areas are the Catchment, Garage, Dump, Radome and Sewage outfall areas. The highest value for lead is at the Dump area (1700-fold), and lead is also high at the Radome and Garage areas (118-fold and 55-fold respectively), and Hg and Sn at the Catchment area (530-fold and 48-fold respectively). Many other inorganic elements were also above the lowest guideline values; for example

aluminium, antimony, cobalt, copper, iron, manganese, vanadium, and zinc were frequently above the guideline values. None of the six primary inorganic elements were above the guideline values at the Eiði farm area. However, ten other inorganic elements (not shown here) exceeded the lowest guidelines at the Eiði farm area, especially vanadium and antimony which were 50 and 20-fold higher than the lowest guideline values. Others were aluminium, chromium, cobalt, copper, iron, manganese, sulphur, and zinc, ranging from 2 to 7-fold higher (Fig. 8).
