Cite this: *Environ. Sci.: Water Res. Technol.*, 2021, 7, 274

## Drinking water contamination from the thermal degradation of plastics: implications for wildfire and structure fire response†

Plastic drinking water pipe thermal degradation and resulting water quality impacts were explored. Thermal damage prompted organic contaminant generation and leaching into drinking water, to include benzene and others. A high level of mass loss, specifically for the vinyl materials, was inversely proportional to leaching. Results should be considered by responders, utility, health and building officials before and after fire events.

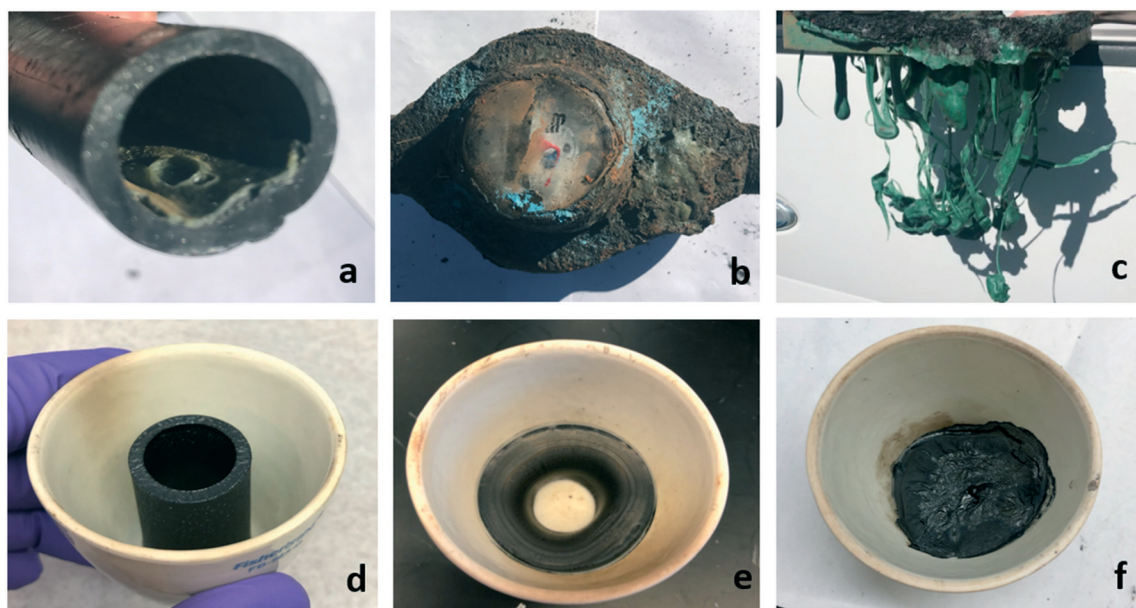
**Fig. 1** Images of fire-damaged water system components including (a) a HDPE plastic pipe, (b) a water meter, and (c) a water meter cover following the Camp Fire. Thermally degraded pipe samples in laboratory experiments include the (d) PEX-c pipe degraded at 300 °C, (e) HDPE pipe degraded at 300 °C, and (f) HDPE pipe degraded at 400 °C.

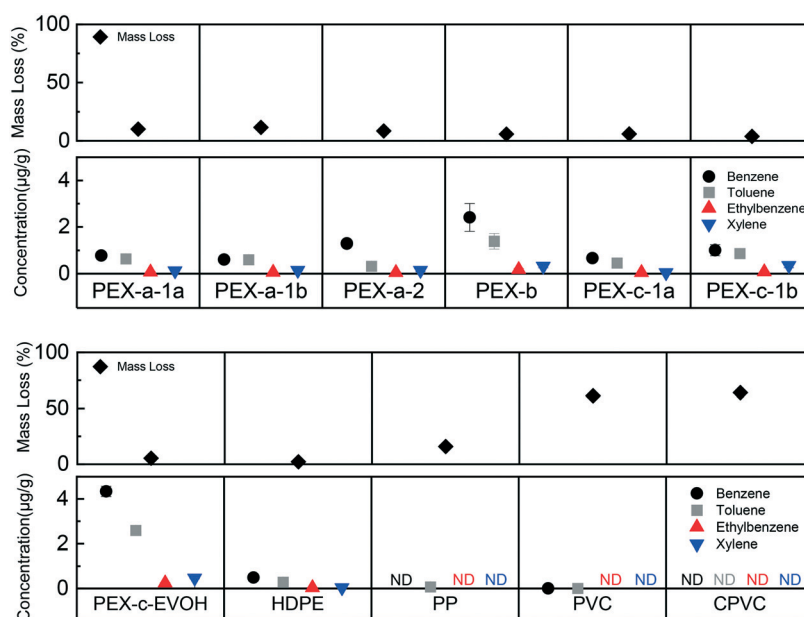
Fig. 2 Average amount of benzene, toluene, ethylbenzene, and xylene leaching observed after burning each material at 400 °C and extracting in water for 7 days. The error bars reflect the standard deviation of the measurements ( $n = 3$ ). If no error bars are visible, this indicates the error bars are smaller than the symbol size. ND indicates the compound was not detected above the MDL.

Results showed that plastic pipe thermal exposure can generate BTEX, which can then leach from cooled plastics into water. BTEX was not found from new and non-thermally degraded plastics in water, while 10 of 11 thermally degraded plastic pipes leached at least one BTEX component (Fig. 2). The chemical leaching differences between products is likely attributed to differences between plastic characteristics and experimental conditions. PE materials lost less mass due to isothermal heating (5 wt% to 10 wt%) compared to the PVC and CPVC samples (61 wt% and 64 wt%, respectively) (Fig. 2). A detectable, but significantly lower amount of benzene and toluene was observed for the PVC pipe, and no BTEX was found for the CPVC pipe (Fig. 2). Additionally, there was a general trend of compound concentration leaching across the plastics where benzene > toluene > ethylbenzene ≈ xylene (Fig. 2). This trend could be attributed to several factors including compound production, water solubility, air volatilization, polymer solubility parameters, and/or partitioning into the aqueous phase. Octanol-water coefficients and solubility values mirror the trend of concentrations observed (Table S4†), indicating that benzene would most readily partition into the aqueous phase.

The discovery that BTEX was generated by thermally degraded plastic pipes is supported by prior literature focused on air testing. Benzene and toluene tend to be formed during the first stage of decomposition for vinyl material thermal degradation.<sup>49</sup> Alkylated aromatics, such as ethylbenzene and xylene can be formed during a second degradation step due to chain scission and aromatization.<sup>49</sup> VOC release from HDPE into air during pyrolysis (lack of oxygen) or combustion (presence of oxygen) occurs due a similar scission and aromatization mechanism, and previous studies have observed all four BTEX compounds.<sup>50,51</sup> The results of this study suggest that BTEX may have been formed in the intact, but thermally degraded, plastics and subsequently leached into the water. The inverse relationship between BTEX in the aqueous phase and mass loss (Fig. 2) indicates that as structural integrity becomes compromised, as was the case for the vinyl materials (Fig. S2–S5†), the volatile compounds tend to partition into air. To the best of the authors' knowledge, there have been no prior PEX thermal degradation studies that have found BTEX compounds in the air. Primary degradation products of PEX have been reported to include linear hydrocarbons and cyclical siloxane compounds, although PEX pipe is created by crosslinking HDPE and medium density polyethylene resins.<sup>52</sup>

Little to no BTEX was found for the PP pipe, which has a similar structure to HDPE. The onset degradation temperature of the PP pipe (416 °C) was lower than that of the HDPE and PEX materials (Table 1), and unsurprisingly, the PP had more mass loss (~15 wt%) (Fig. 2) at the same temperature. In previous PP studies, benzene has been found in the air after pyrolysis between 300 °C to 600 °C.<sup>53,54</sup> No prior studies were found that examined BTEX release into water from thermally damaged PP materials.
