Cite this: *Environ. Sci.: Adv.*, 2024, 3, 972

Ongoing legacy contamination from a military radar station in Iceland: a case study

Contamination in and around military radar stations in the Arctic has been an ongoing concern since first identified in the 1980s. This study reports on the environmental impact from a DEW line US military station that was operated on Heiðarfjall mountain in northeast Iceland from 1957 to 1970. This review is conducted as a part of work of the POPs Expert Group of the Arctic Monitoring and Assessment Program (AMAP) for an assessment report on local sources vs. long-range transport of Persistent Organic Pollutants (POPs) in the Arctic. The main resource for this summary is an evaluation of results from several reports on Heiðarfjall Langanes, one from an Icelandic Environmental Authority in 1993 and another from the Canadian Environmental Science Group (ESG) at the Royal Military College of Canada, which was commissioned in 2017 by the owners of the land that was used for the station. The results are compared to findings in scientific papers and reports for contamination at other military radar stations in Canada and Alaska. This review shows considera

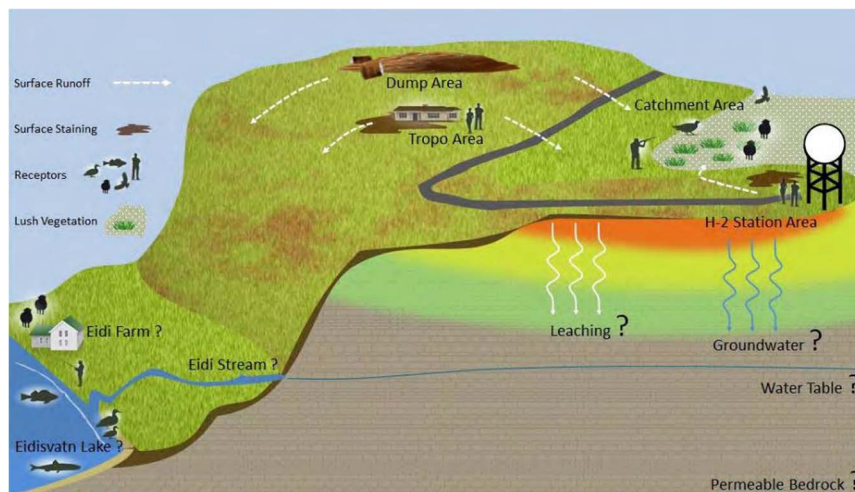
Fig. 3 Schematic picture of Heiðarfjall and the sites investigated by the ESG in 2017.¹⁰ Water source for Eidi farm is at the Eidi stream.

The sites chosen for sampling by the ESG, see Fig. 3, were: (1) the Dump area (*ca.* 18.000 m^2) where debris, both during operating and later during clean-up, had been buried; (2) the Tropo area, with a communication building (still standing), and where two tropospheric communication dishes once stood; (3) the Sewage Outfall area; (4) the POL (petroleum oil and lubricant) Tank area, where a large fuel storage tank used to be situated. Sites 3 and 4 were on the southern edge of the summit area, directly above the Eiði farm; (5) the Garage area; (6) the Barracks area; (7) the Powerhouse area, and (8) Radome area (sites 5, 6, 7, and 8 are all situated at the Station area); (9) the lower-lying Catchment area, where a concrete drainage pipe was observed leading to a small pond; and (10) the Eiði stream area. Fig. 4 shows a recent picture of the Station area.

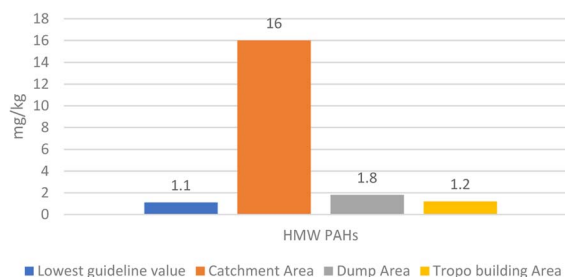
Fig. 7 HMW PAHs (mg kg⁻¹) tested in five areas with the content exceeding the lowest guideline value (1.1 mg kg⁻¹) in three areas. The highest values detected in the three areas are shown.

PAHs are released during incomplete combustion of petroleum products or from petroleum spill. They are persistent in the environment and several have multiple adverse health effects.²⁷ PAHs were summarized in two categories, low molecular weight PAHs (LMW PAHs) and high molecular weight PAHs (HMW PAHs), with the latter being more toxic and carcinogenic.⁵¹ Fifteen PAHs were tested (5 LMW and 10 HMW) in nine samples from five areas (Dump, Tropo, Sewage outfall, Powerhouse and Catchment), see Table 1, and found to exceed the lowest guideline value at three areas: Catchment, Dump and Tropo areas. The highest values in both categories (LMW and HMW) were found at the Catchment area (Table 2). See Fig. 7 for results for HMW PAHs.
