Cite this: *Environ. Sci.: Water Res. Technol.*, 2021, 7, 274

# Drinking water contamination from the thermal degradation of plastics: implications for wildfire and structure fire response†

Kristofer P. Isaacson,<sup>a</sup> Caitlin R. Proctor,<sup>id</sup> <sup>ab</sup> Q. Erica Wang,<sup>a</sup> Ethan Y. Edwards,<sup>id</sup> <sup>c</sup> Yoorae Noh,<sup>c</sup> Amisha D. Shah <sup>id</sup> <sup>ac</sup> and Andrew J. Whelton <sup>id</sup> <sup>\*ac</sup>

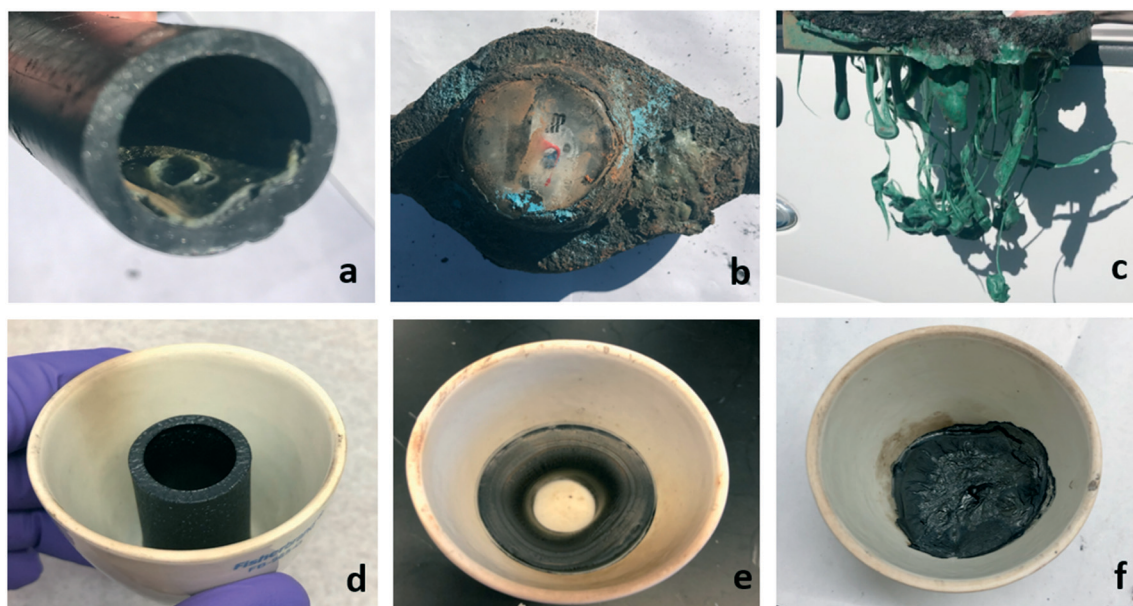
**Fig. 1** Images of fire-damaged water system components including (a) a HDPE plastic pipe, (b) a water meter, and (c) a water meter cover following the Camp Fire. Thermally degraded pipe samples in laboratory experiments include the (d) PEX-c pipe degraded at 300 °C, (e) HDPE pipe degraded at 300 °C, and (f) HDPE pipe degraded at 400 °C.

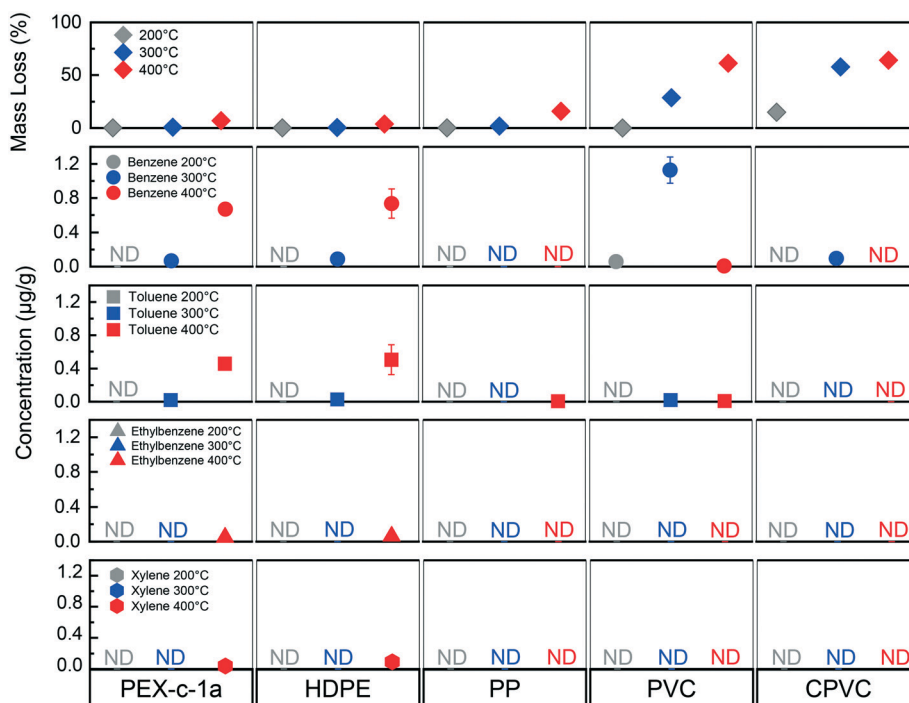
Fig. 3 Mean BTEX concentration after extracting each burned material at 200 °C, 300 °C, and 400 °C in water. The error bars reflect the standard deviation of the measurements ( $n = 3$ ). If no error bars are visible, it indicates they were smaller than the symbol size. ND indicates the compound was not detected.

Different concentrations of BTEX were found in water after changing the isothermal heating temperature, such that two patterns emerged (Fig. 3). For the HDPE and PEX pipes, the amount of BTEX that leached into the water increased as the plastic degradation temperature increased from 200 °C to 400 °C (Fig. 3). Conversely, the greatest benzene concentration was found for the PVC pipe when exposed to 300 °C, with relatively less concentrations at 200 °C and 400 °C (Fig. 3). The CPVC pipe showed a similar pattern for benzene as the PVC pipe, however, at much lower concentrations (Fig. 3). This spike phenomenon for vinyl materials can potentially be explained by the lower amount of mass loss, where not all benzene produced during degradation volatilized out of the solid. The 300 °C exposure temperature was greater than the onset degradation temperature (Table 1) where dehydrochlorination would occur. However, the PVC pipe mass loss was only 23 wt% as opposed to 61 wt% at the 400 °C condition resulting in a more structurally intact plastic after degradation (Fig. S2†).

Despite structural similarities for the vinyl pipes, benzene was only detected in water exposed to the CPVC pipe at a fraction of the amount it was found in water exposed to the PVC material (Fig. 3). This difference may be explained by the additional chlorine atoms present on the CPVC polymer chains resulting in a greater number of chlorine substituted aromatic products when CPVC was thermally degraded.<sup>34</sup> A previous CPVC pyrolysis study found significantly more

Compared to vinyl pipes, greater BTEX concentrations were found as the degradation temperature increased for the HDPE and PEX materials (Fig. 3). The onset degradation temperature for both of these materials exceeds 430 °C (Table 1) which can explain why little to no BTEX leaching was observed at 200 °C and 300 °C. The increase in leaching between 300 °C and 400 °C can be attributed to the plastic pipes beginning to degrade and generating BTEX and other compounds. Elevated temperatures lead to the polymer chain undergoing chain scission resulting in the formation of alkenes.<sup>32</sup> As the pipe is exposed to greater temperatures, the amount of polymer chain scission that occurs also increases. The increase in scission results in more alkene fragments that may subsequently undergo aromatization. A similar pattern was observed in a study of HDPE combustion by others, in which the benzene concentration in the air increased as the combustion temperatures increased from 500 °C to 800 °C.<sup>51</sup> However, the increase in potential BTEX formation does not necessarily indicate that this trend of increased leaching as a function of temperature will

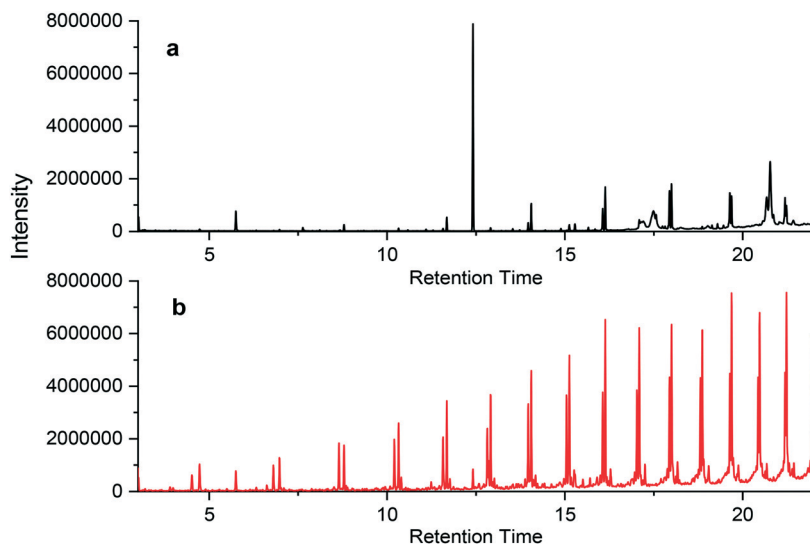
**Fig. 4** Chromatograms of PEX-c-1a when (a) unburned and (b) burned at 400 °C, where samples were extracted in *n*-hexane. The internal standard is the peak at 5.8 minutes.

**Leaching promoted by hexane extraction.** As expected, a greater number of peaks were observed in the *n*-hexane extracts (32 to 134) compared to the water extracts (3 to 22) for all plastics (see example for PEX-c-1a in Fig. 4 and all other pipe types in Fig. S17–S26†). For the degraded PEX, HDPE, and PP pipes, between 100 to 134 unique compounds were leached into *n*-hexane, whereas for the degraded PVC and CPVC pipes between 30 to 41 compounds were leached (Fig. 4 and S17–S26†). While most compounds extracted from the new pipes were either straight chain or branched alkanes of varying lengths (Table S3†), thermal exposure led alkenes to represent the majority of compounds detected in the leachate (Table S5†). These aliphatic hydrocarbons are products of alkane hydrocarbon chain scission and are not typical drinking water contaminants. They have low aqueous solubility, which is why they were only detected in the hexane extracts and are generally less toxic than their cyclical or aromatic counterparts.<sup>56,57</sup>

Generally, both the magnitude of the peak and the number of compounds increased after burning the materials. However, one notable exception occurred for the PEX-c pipes; one peak (retention time of 12.5 min) for the unburned pipe was significantly larger than that of any of the burned peaks (Fig. 4 and S21†). This peak likely represented the compound, di-*tert*-butylbenzene, which has been shown to be an ultraviolet light or radiolysis degradation product of the antioxidant Irgafos 168®.<sup>58,59</sup> This compound was only observed in the leachate of the PEX-c materials, in which the crosslinking occurs using beta irradiation. This may explain why the magnitude of this degradation product was so large.<sup>60</sup> This peak decreased substantially in the burned plastic extract (Fig. 4 and S21†), indicating it may have been thermally decomposed.
