Environmental Science Water Research & Technology

COMMUNICATION

Drinking water contamination from the thermal degradation of plastics: implications for wildfire and structure fire response†

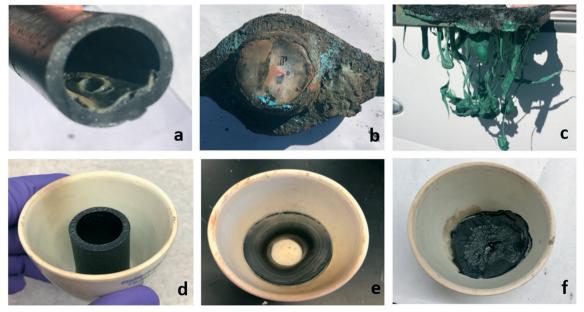
Fig. 1 Images of fire-damaged water system components including (a) a HDPE plastic pipe, (b) a water meter, and (c) a water meter cover following the Camp Fire. Thermally degraded pipe samples in laboratory experiments include the (d) PEX-c pipe degraded at 300 °C, (e) HDPE pipe degraded at 300 °C, and (f) HDPE pipe degraded at 400 °C.

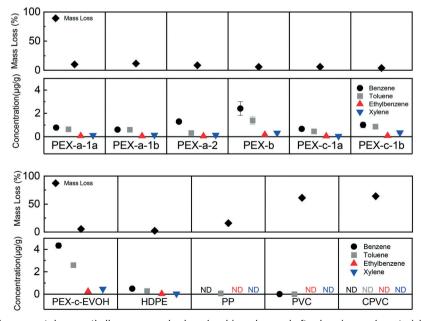
Fig. 2 Average amount of benzene, toluene, ethylbenzene, and xylene leaching observed after burning each material at 400 °C and extracting in water for 7 days. The error bars reflect the standard deviation of the measurements (n = 3). If no error bars are visible, this indicates the error bars are smaller than the symbol size. ND indicates the compound was not detected above the MDL.

Results showed that plastic pipe thermal exposure can generate BTEX, which can then leach from cooled plastics into water. BTEX was not found from new and non-thermally degraded plastics in water, while 10 of 11 thermally degraded plastic pipes leached at least one BTEX component (Fig. 2). The chemical leaching differences between products is likely attributed to differences between plastic characteristics and experimental conditions. PE materials lost less mass due to isothermal heating (5 wt% to 10 wt%) compared to the PVC and CPVC samples (61 wt% and 64 wt%, respectively) (Fig. 2). A detectable, but significantly lower amount of benzene and toluene was observed for the PVC pipe, and no BTEX was found for the CPVC pipe (Fig. 2). Additionally, there was a general trend of compound concentration leaching across the plastics where benzene > toluene > ethylbenzene \approx xylene (Fig. 2). This trend could be attributed to several factors including compound production, water solubility, air volatilization, polymer solubility parameters, and/or partitioning into the aqueous phase. Octanol-water coefficients and solubility values mirror the trend of concentrations observed (Table S4†), indicating that benzene would most readily partition into the aqueous phase.

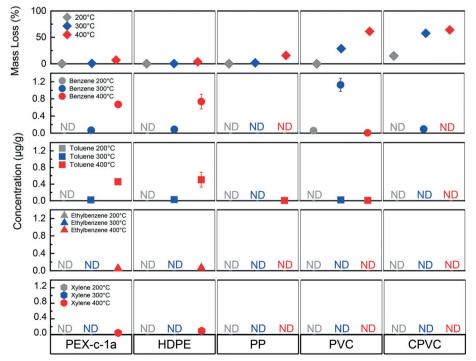
Fig. 3 Mean BTEX concentration after extracting each burned material at 200 °C, 300 °C, and 400 °C in water. The error bars reflect the standard deviation of the measurements (n = 3). If no error bars are visible, it indicates they were smaller than the symbol size. ND indicates the compound was not detected.

Different concentrations of BTEX were found in water after changing the isothermal heating temperature, such that two patterns emerged (Fig. 3). For the HDPE and PEX pipes, the amount of BTEX that leached into the water increased as the plastic degradation temperature increased from 200 °C to 400 °C (Fig. 3). Conversely, the greatest benzene concentration was found for the PVC pipe when exposed to 300 °C, with relatively less concentrations at 200 °C and 400 °C (Fig. 3). The CPVC pipe showed a similar pattern for benzene as the PVC pipe, however, at much lower concentrations (Fig. 3). This spike phenomenon for vinyl materials can potentially be explained by the lower amount of mass loss, where not all benzene produced during degradation volatilized out of the solid. The 300 °C exposure temperature was greater than the onset degradation temperature (Table 1) where dehydrochlorination would occur. However, the PVC pipe mass loss was only 23 wt% as opposed to 61 wt% at the 400 °C condition resulting in a more structurally intact plastic after degradation (Fig. S2†).

Compared to vinyl pipes, greater BTEX concentrations were found as the degradation temperature increased for the HDPE and PEX materials (Fig. 3). The onset degradation temperature for both of these materials exceeds 430 °C (Table 1) which can explain why little to no BTEX leaching was observed at 200 °C and 300 °C. The increase in leaching between 300 °C and 400 °C can be attributed to the plastic pipes beginning to degrade and generating BTEX and other compounds. Elevated temperatures lead to the polymer chain undergoing chain scission resulting in the formation of alkenes. 32 As the pipe is exposed to greater temperatures, the amount of polymer chain scission that occurs also increases. The increase in scission results in more alkene fragments that may subsequently undergo aromatization. A similar pattern was observed in a study of HDPE combustion by others, in which the benzene concentration in the air increased as the combustion temperatures increased from 500 °C to 800 °C. 51 However, the increase in potential BTEX formation does not necessarily indicate that this trend of increased leaching as a function of temperature will

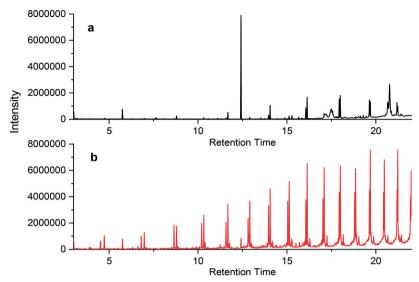
Fig. 4 Chromatographs of PEX-c-1a when (a) unburned and (b) burned at 400 °C, where samples were extracted in n-hexane. The internal standard is the peak at 5.8 minutes.

Leaching promoted by hexane extraction. As expected, a greater number of peaks were observed in the n-hexane extracts (32 to 134) compared to the water extracts (3 to 22) for all plastics (see example for PEX-c-1a in Fig. 4 and all other pipe types in Fig. S17-S26†). For the degraded PEX, HDPE, and PP pipes, between 100 to 134 unique compounds were leached into n-hexane, whereas for the degraded PVC and CPVC pipes between 30 to 41 compounds were leached (Fig. 4 and S17-S26†). While most compounds extracted from the new pipes were either straight chain or branched alkanes of varying lengths (Table S3†), thermal exposure led alkenes to represent the majority of compounds detected in the leachate (Table S5†). These aliphatic hydrocarbons are products of alkane hydrocarbon chain scission and are not typical drinking water contaminants. They have low aqueous solubility, which is why they were only detected in the hexane extracts and are generally less toxic than their cyclical or aromatic counterparts. 56,57

Generally, both the magnitude of the peak and the number of compounds increased after burning the materials. However, one notable exception occurred for the PEX-c pipes; one peak (retention time of 12.5 min) for the unburned pipe was significantly larger than that of any of the burned peaks (Fig. 4 and S21†). This peak likely represented the compound, di-tert-butylbenzene, which has been shown to be an ultraviolet light or radiolysis degradation product of the antioxidant Irgafos 168®.58,59 This compound was only observed in the leachate of the PEX-c materials, in which the crosslinking occurs using beta irradiation. This may explain why the magnitude of this degradation product was so large.60 This peak decreased substantially in the burned plastic extract (Fig. 4 and S21†), indicating it may have been thermally decomposed.
