Environmental Science Advances

CRITICAL REVIEW

Ongoing legacy contamination from a military radar station in Iceland: a case study

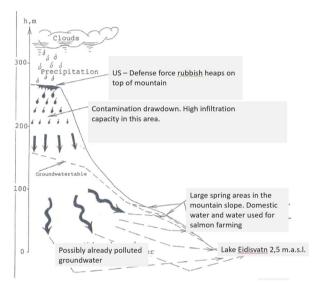
Transport model of pollution spread at Heiðarfjall.42

The engineering consultant's conclusion was that groundwater pollution would mostly spread southwards towards the farm, the estuary lake Eiðisvatn and the sea as shown in Fig. 2. Calculations of the pollution infiltration flow from the top of the mountain indicate that it would take at least 30 years to reach the springs on the south side of the mountain flowing to Eiði

and it would take at least another 70 years until it had disappeared, but some dilution could be expected. 42

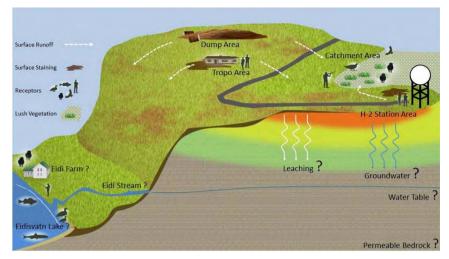
Fig. 3 Schematic picture of Heiðarfjall and the sites investigated by the ESG in 2017.10 Water source for Eidi farm is at the Eidi stream.

The sites chosen for sampling by the ESG, see Fig. 3, were: (1) the Dump area (*ca.* 18.000 m²) where debris, both during operating and later during clean-up, had been buried; (2) the Tropo area, with a communication building (still standing), and where two tropospheric communication dishes once stood; (3) the Sewage Outfall area; (4) the POL (petroleum oil and lubricant) Tank area, where a large fuel storage tank used to be situated. Sites 3 and 4 were on the southern edge of the summit area, directly above the Eiði farm; (5) the Garage area; (6) the Barracks area; (7) the Powerhouse area, and (8) Radome area (sites 5, 6, 7, and 8 are all situated at the Station area); (9) the lower-lying Catchment area, where a concrete drainage pipe was observed leading to a small pond; and (10) the Eiði stream area. Fig. 4 shows a recent picture of the Station area.
