Environmental Science Water Research & Technology

COMMUNICATION

Drinking water contamination from the thermal degradation of plastics: implications for wildfire and structure fire response†

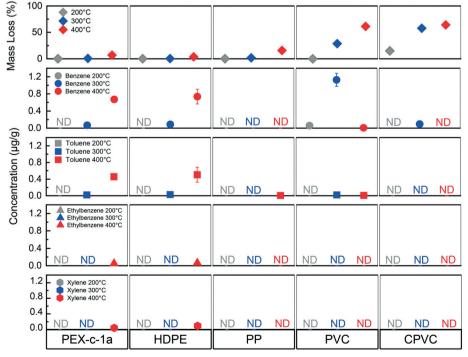
Fig. 3 Mean BTEX concentration after extracting each burned material at 200 °C, 300 °C, and 400 °C in water. The error bars reflect the standard deviation of the measurements (n = 3). If no error bars are visible, it indicates they were smaller than the symbol size. ND indicates the compound was not detected.

Different concentrations of BTEX were found in water after changing the isothermal heating temperature, such that two patterns emerged (Fig. 3). For the HDPE and PEX pipes, the amount of BTEX that leached into the water increased as the plastic degradation temperature increased from 200 °C to 400 °C (Fig. 3). Conversely, the greatest benzene concentration was found for the PVC pipe when exposed to 300 °C, with relatively less concentrations at 200 °C and 400 °C (Fig. 3). The CPVC pipe showed a similar pattern for benzene as the PVC pipe, however, at much lower concentrations (Fig. 3). This spike phenomenon for vinyl materials can potentially be explained by the lower amount of mass loss, where not all benzene produced during degradation volatilized out of the solid. The 300 °C exposure temperature was greater than the onset degradation temperature (Table 1) where dehydrochlorination would occur. However, the PVC pipe mass loss was only 23 wt% as opposed to 61 wt% at the 400 °C condition resulting in a more structurally intact plastic after degradation (Fig. S2†).

Compared to vinyl pipes, greater BTEX concentrations were found as the degradation temperature increased for the HDPE and PEX materials (Fig. 3). The onset degradation temperature for both of these materials exceeds 430 °C (Table 1) which can explain why little to no BTEX leaching was observed at 200 °C and 300 °C. The increase in leaching between 300 °C and 400 °C can be attributed to the plastic pipes beginning to degrade and generating BTEX and other compounds. Elevated temperatures lead to the polymer chain undergoing chain scission resulting in the formation of alkenes. 32 As the pipe is exposed to greater temperatures, the amount of polymer chain scission that occurs also increases. The increase in scission results in more alkene fragments that may subsequently undergo aromatization. A similar pattern was observed in a study of HDPE combustion by others, in which the benzene concentration in the air increased as the combustion temperatures increased from 500 °C to 800 °C. 51 However, the increase in potential BTEX formation does not necessarily indicate that this trend of increased leaching as a function of temperature will

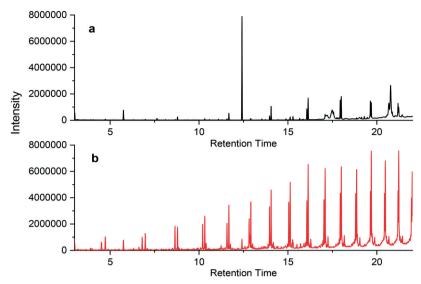
Fig. 4 Chromatographs of PEX-c-1a when (a) unburned and (b) burned at 400 °C, where samples were extracted in n-hexane. The internal standard is the peak at 5.8 minutes.

Leaching promoted by hexane extraction. As expected, a greater number of peaks were observed in the n-hexane extracts (32 to 134) compared to the water extracts (3 to 22) for all plastics (see example for PEX-c-1a in Fig. 4 and all other pipe types in Fig. S17-S26†). For the degraded PEX, HDPE, and PP pipes, between 100 to 134 unique compounds were leached into n-hexane, whereas for the degraded PVC and CPVC pipes between 30 to 41 compounds were leached (Fig. 4 and S17-S26†). While most compounds extracted from the new pipes were either straight chain or branched alkanes of varying lengths (Table S3†), thermal exposure led alkenes to represent the majority of compounds detected in the leachate (Table S5†). These aliphatic hydrocarbons are products of alkane hydrocarbon chain scission and are not typical drinking water contaminants. They have low aqueous solubility, which is why they were only detected in the hexane extracts and are generally less toxic than their cyclical or aromatic counterparts. 56,57

Generally, both the magnitude of the peak and the number of compounds increased after burning the materials. However, one notable exception occurred for the PEX-c pipes; one peak (retention time of 12.5 min) for the unburned pipe was significantly larger than that of any of the burned peaks (Fig. 4 and S21†). This peak likely represented the compound, di-tert-butylbenzene, which has been shown to be an ultraviolet light or radiolysis degradation product of the antioxidant Irgafos 168®.58,59 This compound was only observed in the leachate of the PEX-c materials, in which the crosslinking occurs using beta irradiation. This may explain why the magnitude of this degradation product was so large.60 This peak decreased substantially in the burned plastic extract (Fig. 4 and S21†), indicating it may have been thermally decomposed.
