Combined crystallographic study of king scallop (*Pecten maximus*) shells using SEM, EBSD and Raman spectroscopy

DOI: 10.1039/d5fd00029g

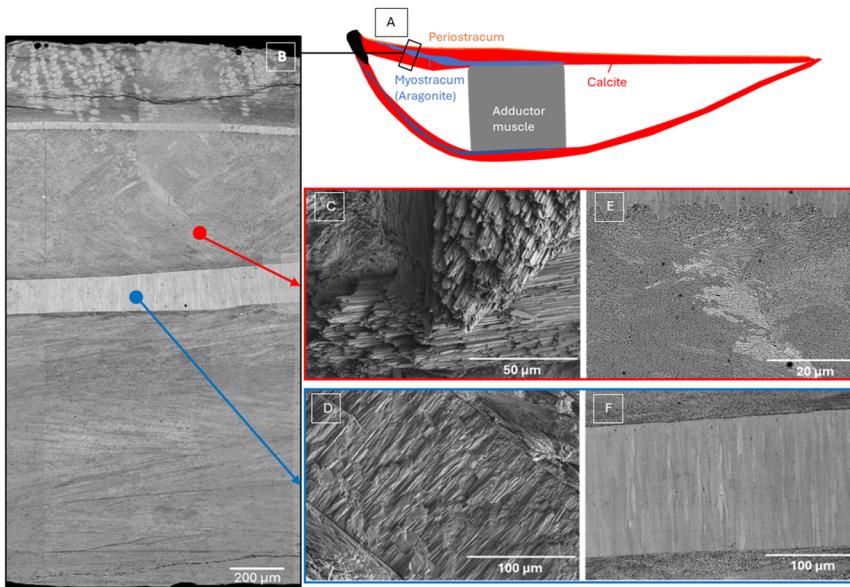
Fig. 1 (A) Schematic longitudinal section of a king scallop (*Pecten maximus*) shell, both valves. Of the organic parts only the adductor muscle is indicated showing its attachment to the shell via an aragonitic calcium carbonate layer. (B) Backscattered electrons stitched SEM images of a king scallop sample from a non-contaminated area after surface polishing. SEM images of king scallop in calcite (red) area: (C) secondary electron image of calcite foliated grains on laser cut surface and (E) backscattered electron image of calcite foliated grain after surface polishing. SEM images of king scallop myostracum aragonite prismatic layer (blue) area: (D) secondary electron image of myostracum layer on laser cut surface and (F) backscattered electron image of myostracum layer after surface polishing.

The soft tissues are attached to the shells *via* the myostracum layer (also known as the adductor muscle scar, see Fig. 1(A)), which bears tremendous contractile force and is crucial for the survival of molluscs.⁴ Previous studies have shown that this myostracum layer is generally composed of prismatic aragonite.⁵ However, to date, there are very few studies on the myostracum of king scallops *Pecten maximus* and its structural role for the bivalve including its impact on the fracture toughness.

Fig. 1 illustrates the scanning electron microscope (SEM) images of the cross-sectional surface of a king scallop sample from a non-contaminated area, as previously reported.^{11,12} Fig. 1(B) displays a secondary electron SEM image of sample's section after polishing, revealing the general distribution of calcite and myostracum aragonite layers in king scallop shell from a non-contaminated site. Fig. 1(C) and (E) highlight the well-oriented, foliated calcite with sharp, thin laths with asymmetrical triangular endings, arranged in parallel clusters, while Fig. 1(D) shows the myostracum aragonite layer after Er:YAG dental laser cut with clearly oriented prismatic grains. Fig. 1(F) presents the same section after polishing, where the myostracum exhibits clearly elongated grains, with visible backscattered electron (BSE) channeling contrast indicative of the high crystallinity of the aragonite phase.

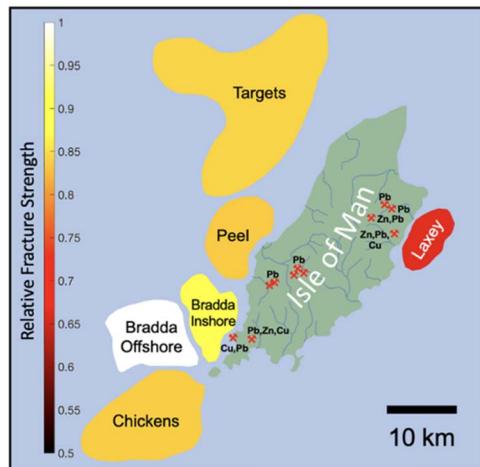
Fig. 2 Map of the relative mean fracture strength observed for *Pecten maximus* around the Isle of Man with the value for Bradda Offshore used to normalize the values for all other sites. Shells were collected from six sites around the Isle of Man in 2004. The color code indicates the value for the relative fracture strength. Laxey is the contaminated site, all the others are controls ($n = 20$ per site, 120 in total). The value for the Laxey site is 0.66 whereas the values for the other sites are all above 0.83. Red symbols assign major historical mining sites for zinc, lead and copper ores with the order of importance indicated by their sequence position.¹⁰

The samples were collected in the coastal waters around the Isle of Man, located in the northern Irish Sea. Details of the scallop population selection are provided in previous studies.^{9,10} Fig. 2 presents a map of the relative mean fracture strength observed for king scallops (*Pecten maximus*) around the Isle of Man, based on the collection site. Low fracture strength was observed in shells collected in the Laxey area, which is the closest to numerous previous metal ore mines and had the most highly contaminated sediment among sample sites. This provided us with an ideal opportunity to directly compare scallop populations from this contaminated site with those from sites with higher fracture strength/lower contamination levels, specifically the Bradda area. All other known environmental parameters, including water temperature, salinity, and nutrients, remained similar across the sites.

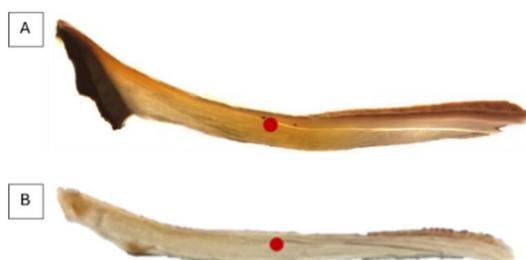
Fig. 3 (A) Scallop sample from non-contaminated Bradda area and (B) scallop sample from metal contaminated Laxey area, longitudinal section view. The region of interest is marked with a red circle.

one from Laxey, the contaminated site). The shells were cut using a diamond cut-off wheel (South Bay Technology Low Speed Diamond Wheel Saw MODEL 650) longitudinally (Fig. 3). The sectioned sample was then hand polished with lapping pads to a felt disk with a 50 nm colloidal silica suspension, to obtain a perfectly flat surface for future SEM observations and EBSD analysis. A 10 nm layer of carbon coating was necessary for conductivity. No etching process was applied.

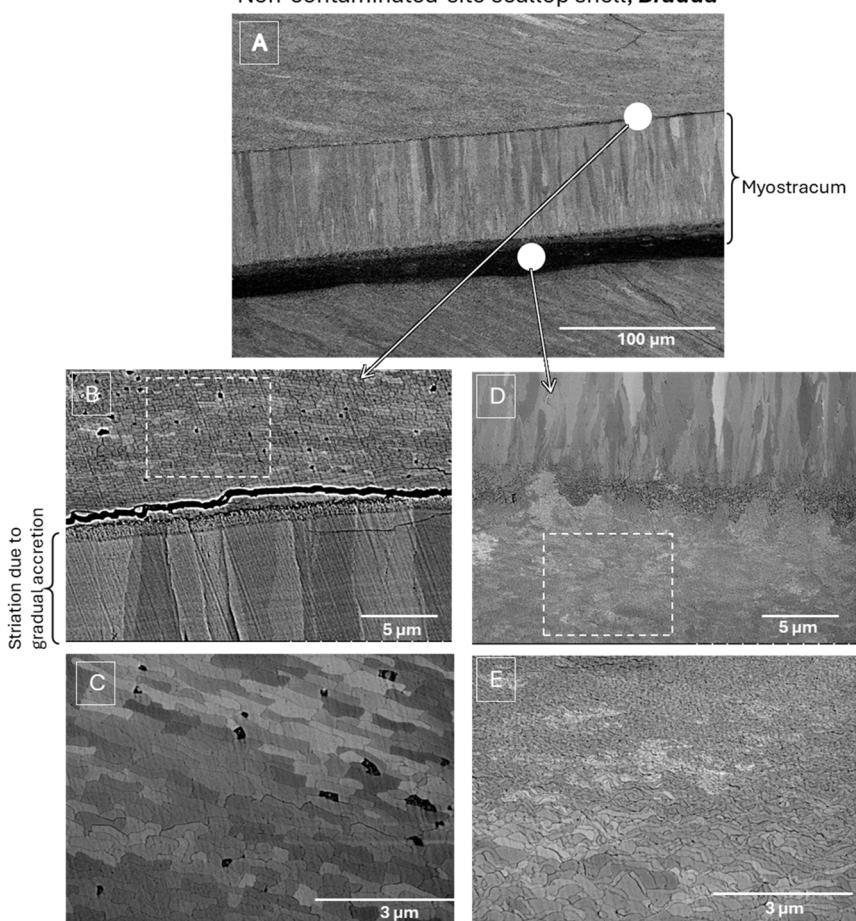
Fig. 4 BSE micrographs of the myostracum region for the scallop shell collected in the non-contaminated Bradda area. (A) A general view of the region of interest. (B) The upper boundaries between the myostracum and the shell bulk. (C) The microstructures of the scallop in the region at the top of the myostracum. (D) The lower boundaries between the myostracum and the shell bulk. (E) The microstructures of the shell in the region below the myostracum.

Fig. 4(A) and 5(A) display an overall microstructural organization for the longitudinal section around the myostracum region of scallop shells respectively from non-contaminated and contaminated sites. These backscattered electron images show channeling contrast and provide an overview of crystal orientation variations, particularly within the myostracum, which is, in both types of scallops, clearly visible and sandwiched between two foliated calcite areas. This allows us

First, it is observed that the overall organization was similar for both types of scallops. Focusing on the myostracum, it consists of elongated, oriented grains. However, the grains in the lower part of both myostracum layers are notably fine and small. These grains gradually increase in both length and width towards the upper part of the myostracum, while maintaining a consistent growth orientation, resulting in a clear size gradient. Despite this similarity between the two types of shells, a noticeable difference in morphology and distribution is observed. The grains in the myostracum within the shell from the non-contaminated site appear more elongated and regularly arranged.

Examining the calcitic regions surrounding the myostracum reveals notable differences in microstructure. Fig. 4(B), (C), 5(B) and (C) provide a closer view of the region above the myostracum. In both shell types, the shape and grain distribution are uniform and consistent in size (around 1 micron in size). The boundary between the aragonite myostracum and the calcitic bulk is clearly defined, with homogeneous grains in the upper calcitic region, contrasting with the larger, elongated grains of the upper myostracum. The contrast variations between the grains are due to slight differences in their relative orientations, due to the BSE channeling contrast.

The boundary between the two microstructures in the lower myostracum appears less distinct as can be observed in Fig. 4(D) and 5(D). Again, there is little

Near the myostracum, the calcite grains are nanocrystalline (see Fig. 4(E) and 5(E)) and a size gradient is observed as the distance from the myostracum increases. In the shell from contaminated site, this gradient extends over a larger

Furthermore, growth lines can be identified in the Raman maps associated with the accretion sequence during the myostracum formation. These growth lines are also visible in the SEM image of samples from both contaminated and non-contaminated sites and are shown in Fig. 4(B) and 5(B).

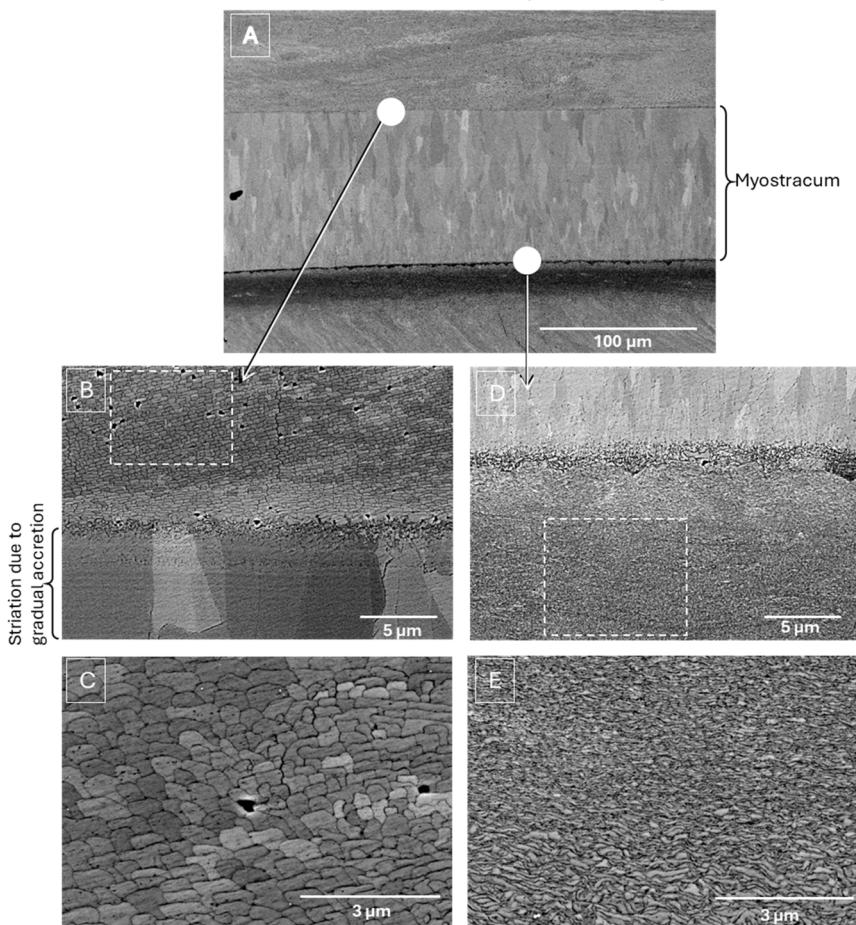
Fig. 5 BSE micrographs of the myostracum region for the scallop shell collected in the contaminated Laxey area. (A) A general view of the region of interest. (B) The upper boundaries between the myostracum and the shell bulk. (C) The microstructures of the scallop in the region at the top of the myostracum. (D) The lower boundaries between the myostracum and the shell bulk. (E) The microstructures of the shell in the region below the myostracum.

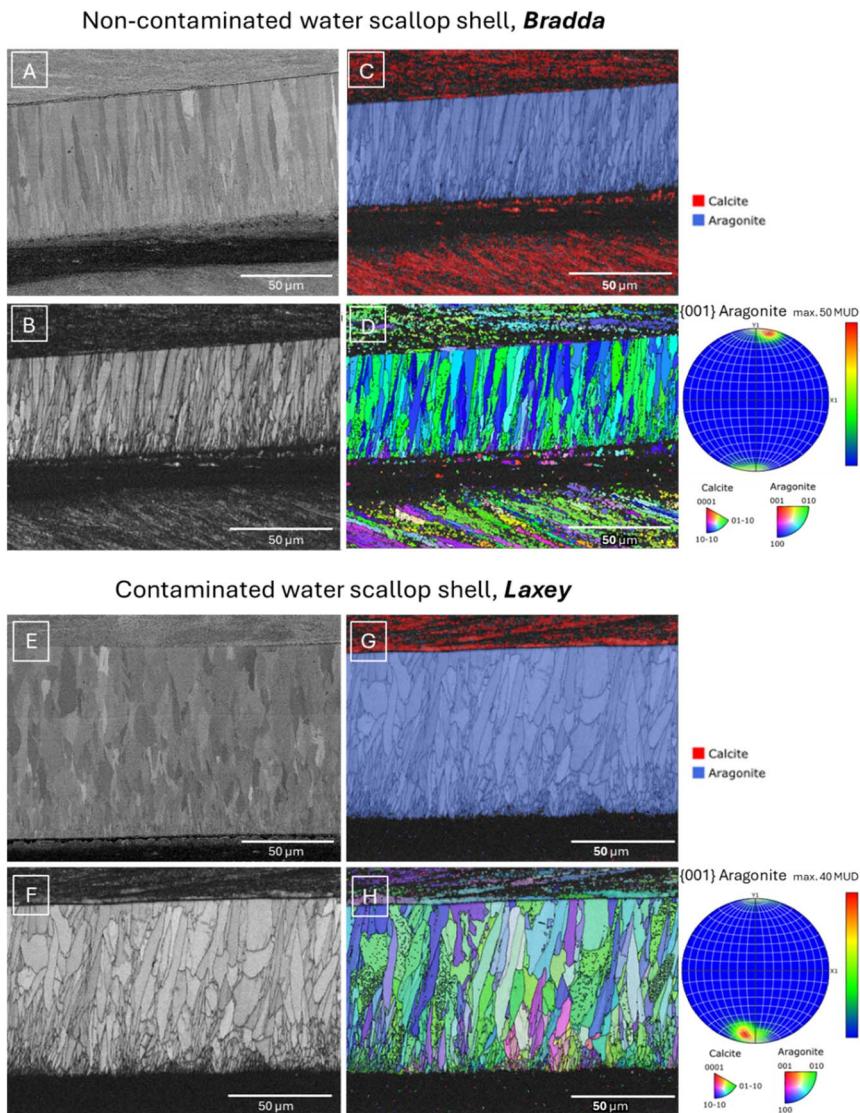
Fig. 6 (A) BSE image, (B) EBSD band contrast map, (C) EBSD phase map (D) IPF colored map and pole figure obtained on the myostracum region for the non-contaminated case. (E) BSE image, (F) EBSD band contrast map, (G) EBSD phase map (H) IPF colored map and pole figure obtained on the myostracum region for the shell from the contaminated site.

Following the SEM analysis, we performed EBSD analysis on an adjacent area, on the myostracum region. The EBSD maps presented in Fig. 6 provide the results obtained for both types of shell and give information on the crystallography of each shell section.

First, we can see on the phase map, in Fig. 6(C) and (G) that, in both cases, the well-oriented and crystallized myostracum layer is clearly composed of well-crystallized aragonite, surrounded by the calcite phase on top and a poorly indexed phase at the bottom. Thanks to the SEM images in Fig. 4(E) and 5(E), it was observed that the calcite grains beneath the myostracum are very fine. The extremely small size of these grains may partly explain the absence of EBSD detection in this region. However, calcite islands are detected at the lower boundary of the myostracum in the non-contamination affected shell, which are not observed in the contaminated shell, suggesting larger or better-crystallized calcite grains.

The EBSD orientation maps, presented in Fig. 6(D) and (H), focusing on the aragonite myostracum and accompanied by the pole figure, confirm the preferential orientation of the aragonite grains. When an oriented texture is present, pole figures reveal a cylindrical 'cluster' distribution. For both contaminated and non-contaminated sites scallop samples, we observe a concentration point with a nearly circular shape, indicating a clear, oriented texture of grains. A higher multiple uniform density (MUD) value reflects a stronger co-orientation. As we can see, the MUD value obtained in the myostracum region of the non-contamination affected sample is slightly higher than that of the shell from the contaminated site, revealing a slightly stronger co-orientation compared to the contaminated site sample. However, the difference remains too small to conclude any alteration of the myostracum microstructure due to pollution. The second phase of this project, with a more in-depth study on a selected panel of shells, will aim to obtain more data to validate these observations. Analyses of different areas throughout the entire length of the myostracum in the shells could also be interesting to observe the evolution of the crystallography of the myostracum as the shell grows.

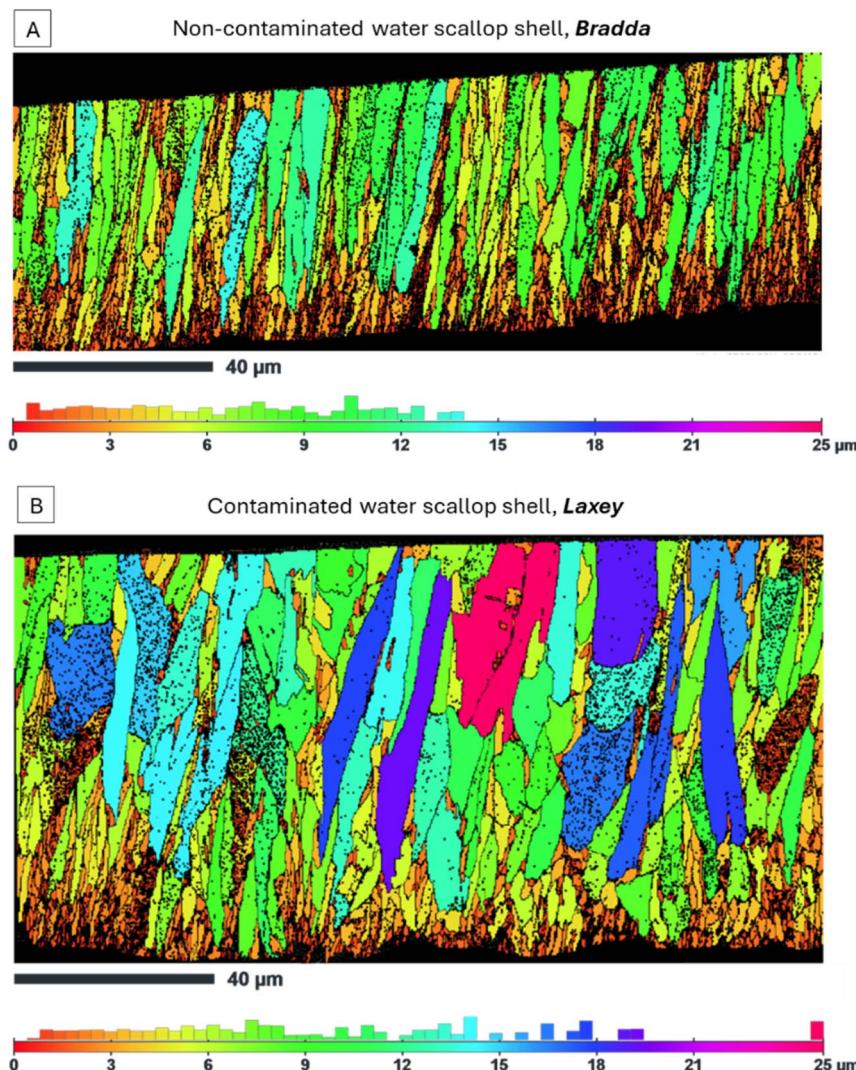
Fig. 7 EBSD grains maps with a color scale according to grain size (longest dimension) in the myostracum.

Additionally, EBSD analysis allows us to detect orientation variations, which helps determine the size of orientation domains or the grain size when grain boundaries are identified (non-indexed grain boundaries). Fig. 7 presents EBSD maps of the grain size distribution in the myostracum, for both shell types, with a colored scale corresponding to the grain longest dimension providing a quantitative analysis of the variation in grain size within the myostracum. The size variation is clearly visible, indicating submicron grain-sizes at the lower interface (red orange) which rapidly increase in size towards the upper interface.

The lower boundary is distinctly composed of small grains, which could reflect the early stages of growth since it is observable in both shells. The shell from the contaminated site, however, appears to have a broader grain distribution.

To obtain a more representative grain size distribution, it would be necessary to measure the grain sizes over a larger area to ensure a sufficient number of grains are sampled. However, even with the current map, it is already evident that the regular elongated shape observed in the non-contaminated site shell does not appear as consistently regular in the contaminated counterpart. In fact, surprisingly large grains can be observed (note turquoise, purple and magenta in Fig. 7(B)).

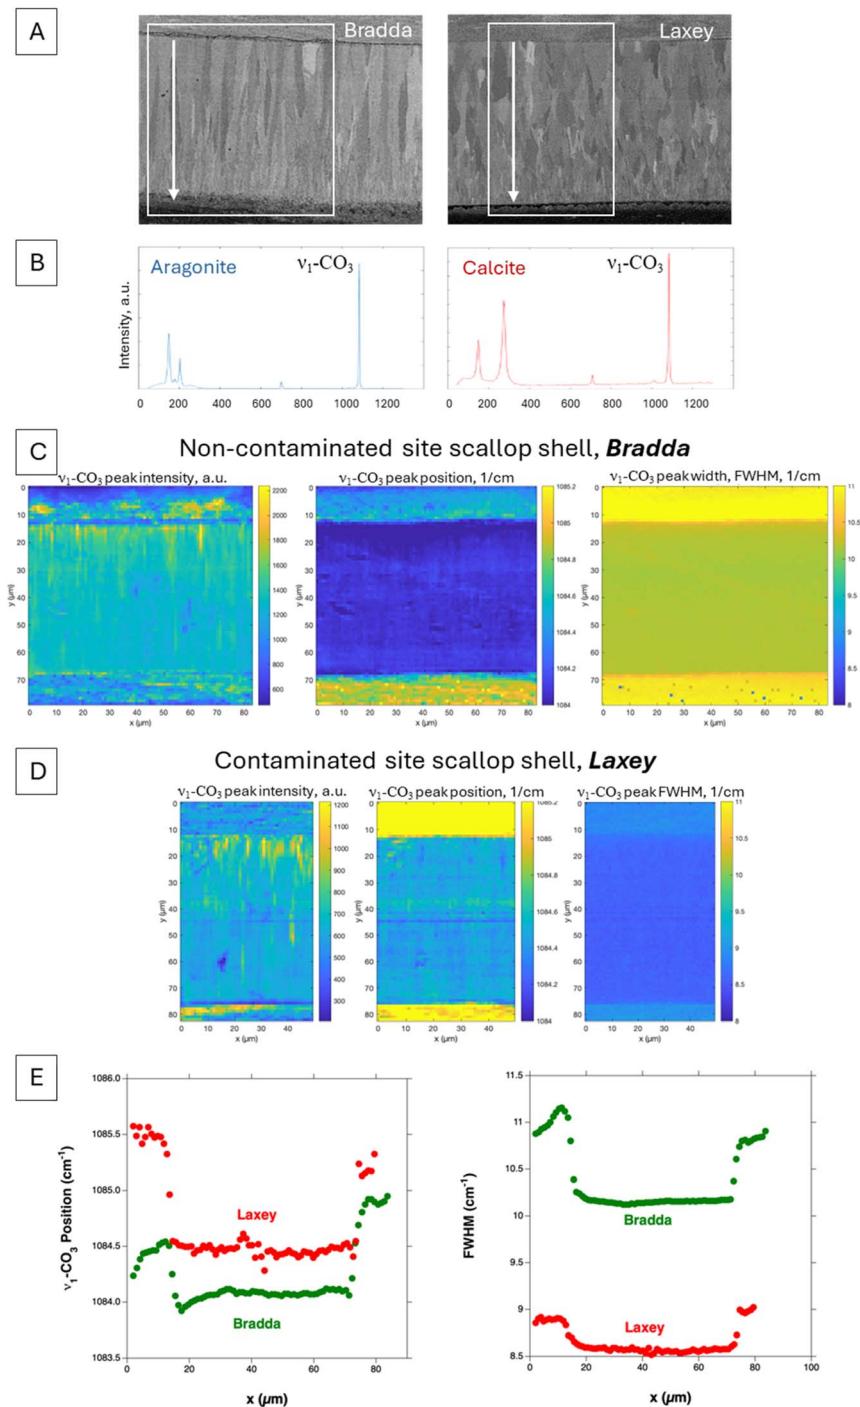
Fig. 8 (A) BSE images of a sample from non-contaminated (Bradda) and contaminated (Laxey) sites; (B) Raman spectra taken from the myostracum and foliated regions of the Bradda sample; (C) $\nu_1\text{-CO}_3$ Raman maps evaluating peak intensity, position and full width at half maximum of the Bradda and (D) and Laxey samples, (E) comparison of line profiles from top to bottom of the $\nu_1\text{-CO}_3$ Raman position and full width at half maximum for Bradda and Laxey samples.

The parallel Raman study also revealed differences in response between the regions at the upper and lower boundaries of the myostracum. The results are presented in Fig. 8. Using the $\nu_1\text{-CO}_3$ symmetric stretching mode for Raman

mapping, we observed, for all analysed samples, systematic shifts in the peak position above, below and across the myostracum, with a difference of 0.5 cm^{-1} between each. In comparison to the aragonitic myostracum, the top calcite domain is 0.5 cm^{-1} higher, while the lower domain differs by 1 cm^{-1} . The peak position in samples from the non-contaminated site is overall shifted to smaller wavelengths. Moreover, the $\nu_1\text{-CO}_3$ peak width is marginally higher for the non-contaminated site shells than in its contaminated counterpart. This variation in peak position and width may indicate intrinsic crystallite strain or be related to smaller grain sizes. It remains to be determined whether the crystallite size or intrinsic strain contribute to the peak shift and broadening. However, small and pre-strained crystallites have been identified in other mineralized tissues such as dental enamel, dentin, bone, and other bivalve shells indicating that it could be a “toughening” feature, rather than a random occurrence.²¹⁻²³
