Cite this: *Environ. Sci.: Water Res. Technol.*, 2021, 7, 274

Drinking water contamination from the thermal degradation of plastics: implications for wildfire and structure fire response†

Water impact

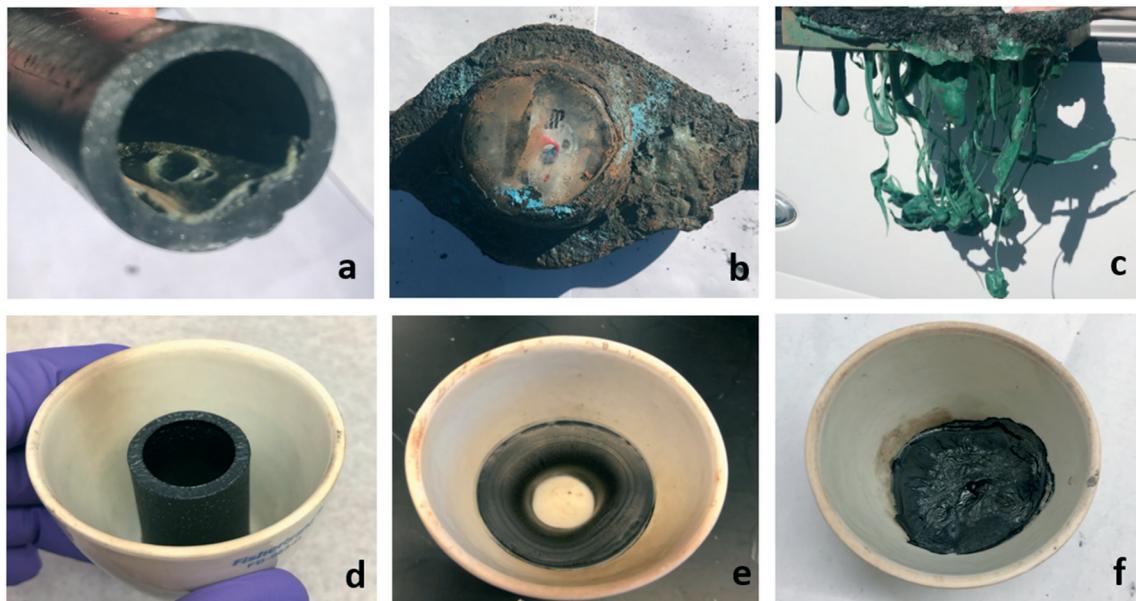
Fig. 1 Images of fire-damaged water system components including (a) a HDPE plastic pipe, (b) a water meter, and (c) a water meter cover following the Camp Fire. Thermally degraded pipe samples in laboratory experiments include the (d) PEX-c pipe degraded at 300 °C, (e) HDPE pipe degraded at 300 °C, and (f) HDPE pipe degraded at 400 °C.

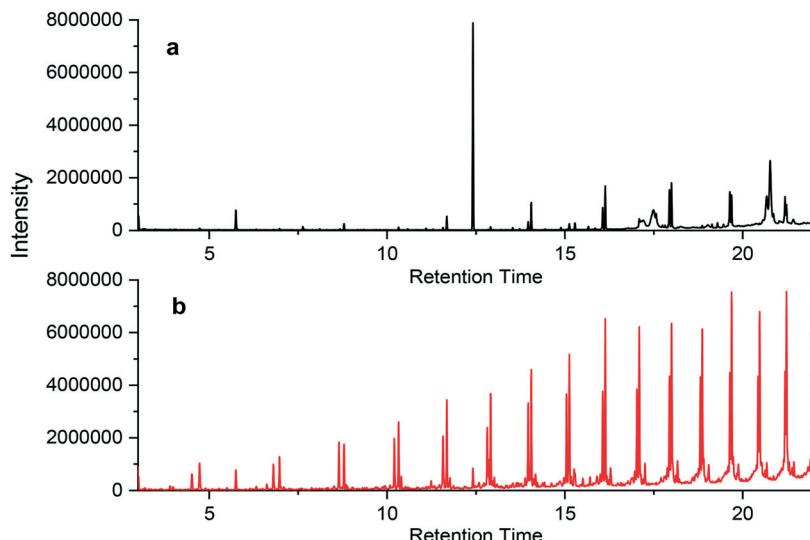
Fig. 4 Chromatographs of PEX-c-1a when (a) unburned and (b) burned at 400 °C, where samples were extracted in *n*-hexane. The internal standard is the peak at 5.8 minutes.

Leaching promoted by hexane extraction. As expected, a greater number of peaks were observed in the *n*-hexane extracts (32 to 134) compared to the water extracts (3 to 22) for all plastics (see example for PEX-c-1a in Fig. 4 and all other pipe types in Fig. S17–S26†). For the degraded PEX, HDPE, and PP pipes, between 100 to 134 unique compounds were leached into *n*-hexane, whereas for the degraded PVC and CPVC pipes between 30 to 41 compounds were leached (Fig. 4 and S17–S26†). While most compounds extracted from the new pipes were either straight chain or branched alkanes of varying lengths (Table S3†), thermal exposure led alkenes to represent the majority of compounds detected in the leachate (Table S5†). These aliphatic hydrocarbons are products of alkane hydrocarbon chain scission and are not typical drinking water contaminants. They have low aqueous solubility, which is why they were only detected in the hexane extracts and are generally less toxic than their cyclical or aromatic counterparts.^{56,57}

Generally, both the magnitude of the peak and the number of compounds increased after burning the materials. However, one notable exception occurred for the PEX-c pipes; one peak (retention time of 12.5 min) for the unburned pipe was significantly larger than that of any of the burned peaks (Fig. 4 and S21†). This peak likely represented the compound, di-*tert*-butylbenzene, which has been shown to be an ultraviolet light or radiolysis degradation product of the antioxidant Irgafos 168®.^{58,59} This compound was only observed in the leachate of the PEX-c materials, in which the crosslinking occurs using beta irradiation. This may explain why the magnitude of this degradation product was so large.⁶⁰ This peak decreased substantially in the burned plastic extract (Fig. 4 and S21†), indicating it may have been thermally decomposed.
