Ongoing legacy contamination from a military radar station in Iceland: a case study

Cite this: *Environ. Sci.: Adv.*, 2024, 3, 972

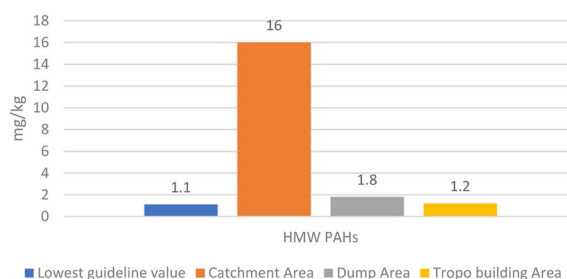
Fig. 7 HMW PAHs (mg kg⁻¹) tested in five areas with the content exceeding the lowest guideline value (1.1 mg kg⁻¹) in three areas. The highest values detected in the three areas are shown.

PAHs are released during incomplete combustion of petroleum products or from petroleum spill. They are persistent in the environment and several have multiple adverse health effects.²⁷ PAHs were summarized in two categories, low molecular weight PAHs (LMW PAHs) and high molecular weight PAHs (HMW PAHs), with the latter being more toxic and carcinogenic.⁵¹ Fifteen PAHs were tested (5 LMW and 10 HMW) in nine samples from five areas (Dump, Tropo, Sewage outfall, Powerhouse and Catchment), see Table 1, and found to exceed the lowest guideline value at three areas: Catchment, Dump and Tropo areas. The highest values in both categories (LMW and HMW) were found at the Catchment area (Table 2). See Fig. 7 for results for HMW PAHs.
