### PAPER

# washing facilitates the direct regeneration of spent cathodes from retired EV Li-ion batteries†

Removal of residual contaminants by minute-level

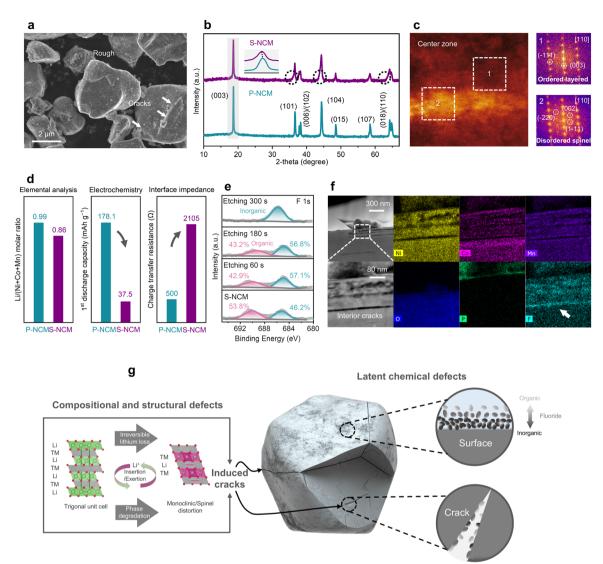
Fig. 1 Neglected chemical residuals on the 250k-miles-serviced cathode. (a) SEM image and (b) XRD pattern of the degraded S-NCM. The black dotted circle accentuates the subtle peaks that do not belong to the layered structure; (c) high-resolution HAADF-STEM images on the central area of the S-NCM particle and the FFT patterns of the selected dark and bright regions; (d) comprehensive comparison of lithium loss in degraded powders measured by ICP-OES, electrochemical capacity, and charge-transfer resistance analyses in the half-cell using S-NCM and P-NCM powders as cathode active materials; (e) F 1s XPS patterns of S-NCM powders for different sputtering times using an ion-beam. Based on the calculated integral area, the proportional values of the organics and inorganics in fluoride are presented in the patterns; (f) HAADF-STEM images based on focused ion beam cutting and an enlarged view displaying the interior microcracks. Corresponding EDS mapping analysis indicates the presence of F elements along these microcracks pointed out by a white arrow. (g) Deficiencies of S-NCM addressed before direct regeneration, including the compositional and structural aspects (e.g., irreversible lithium-ionic loss, phase degradation, internal and external cracks) and latent chemical defects (e.g., surface and crack-edge impurities enriching the F element).

To understand the surface state of the spent cathode, energy-dispersive spectroscopy (EDS) element mapping and X-ray photoelectron spectroscopy (XPS) were conducted. As shown in Fig. S7-S9, and Tables S5, S6 (ESI†), the S-NCM cathode surface residuals consisted of C, O, F, and P elements, and displayed a surface-rich gradient distribution, as revealed

by XPS with etching. The F 1s XPS peaks with etching for S-NCM are shown in Fig. 1e, where two F 1s peaks could be observed before sputtering, with the major peak centered at 685.5 eV, which was attributed to inorganic fluorides and the minor F 1s peak centered at 690.4 eV, which could be assigned to organic fluorides, with the ratio of 53.8% for organic flourides.<sup>29</sup> However, the organic-related F peak declined significantly after sputtering, and completely disappeared after 300 s Ar+ sputtering. The surface-rich distribution of organic fluoride was consistent with the cathode electrolyte interphase (CEI) composition previously reported.<sup>29,30</sup>

To further reveal the microscopic distribution of those F-rich residuals, SEM combined with time-of-flight secondary ion mass spectrometry (SEM-ToF-SIMS) characterization was conducted for the cycled cathode. The results are shown in Fig. S10 and Videos S1, S2 (ESI†). Based on the spatial distribution of F secondary ion fragments, it was confirmed that fluoride impurities were primarily deposited on the particle surface. Moreover, during the long-time battery service, it could be observed from the HAADF-STEM image and corresponding element mapping (see Fig. 1f) that, in the S-NCM cathode, the fluorides could spread into the interior of the cathode along the intragranular cracks. Coincidentally, from the selected FFT figure shown in Fig. S4 (ESI†), the existence of an amorphous ring was observed along the intragranular cracking, which may be related to the fluorides also observed in the bulk. To sum up, the collected S-NCM exhibited limited structural and compositional degradation, while preserving the fluoride-containing impurities aggregated on the surface and along the intragranular cracks, as illustrated in Fig. 1g.

Furthermore, it was previously widely accepted that the source of F-rich impurities in the spent cathode was due to decomposition of the PVDF binder during the heat delamination process at around 350 °C; 11,23-25,31 however, during the thermal decomposition of PVDF, most the fluoride-containing products were gas species (i.e., HF) and fragments (-CF- and -CH-CF-), 32-34 which are subject to ejection instead of propagating along the cathode intragranular cracks. To confirm the source of those observed residual impurities, four kinds of cathodes with varying cycling conditions were collected and examined, namely cathode laminates with/without electrolyte filling, and laminates from 125k and 250k miles-serviced batteries, as listed in Table S7 (ESI†). The SEM images and electrochemical performance are shown in Fig. S11 and S12 (ESI†). Compared with the pristine one (sample A), the other spent cathodes from battery formation and cycling exhibited a rough surface and limited discharge capacity. Notably, the laminate from formation only but with no cycling (sample B), which it was believed would retain the full lithium inventory and show negligible structural degradation since it had not undergone charge/discharge cycling, showed a poor discharge capacity, which was the same as the other long-cycled ones. Moreover, the heat exfoliation used to pyrolyze the adhesive binders deteriorated the original CEI layer on the spent cathodes and generated more harmful byproducts (e.g., Li<sub>2</sub>CO<sub>3</sub>, Li<sub>3</sub>PO<sub>4</sub>, LiF). This, combined with electrolyte decomposition during electrochemical cycling, exacerbates chemical degradation, resulting in a significant capacity decline. Therefore, the above comparison revealed that the cathode residual impurities should originate from the electrolyte components (such as LiPF<sub>6</sub>, DMC, ethylene carbonate (EC)) decomposition during battery formation, cycling, and common heat exfoliation, leading to severe capacity loss in spent cathodes (Fig. 1d).

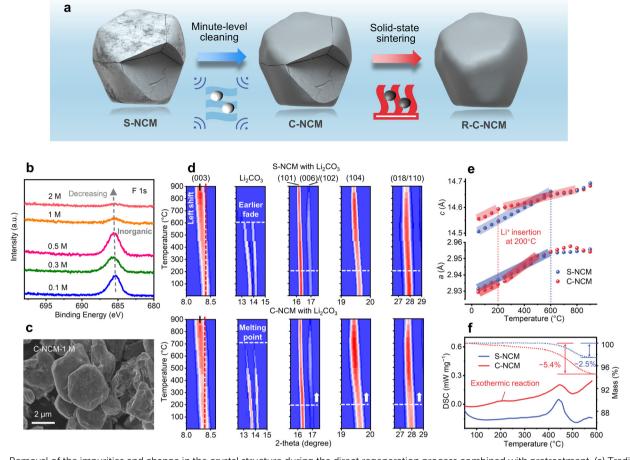
Fig. 2 Removal of the impurities and change in the crystal structure during the direct regeneration process combined with pretreatment. (a) Traditional direct regeneration path using solid-state sintering and the minute-level pretreatment introduced in an advanced path targeted to the critical obstacles within degraded cathode materials; (b) F 1s XPS fine patterns of C-NCM undergoing ultrasonic stirring in solutions with different concentrations; (c) SEM image of C-NCM obtained by soaking S-NCM in 1 M HNO<sub>3</sub> solution; (d) partial in situ XRD patterns of S-NCM and C-NCM mixed with a Li resource, keeping a constant heating rate (20 °C min<sup>-1</sup>) and holding the temperature for diffraction at 50 °C intervals; (e) evolution of the unit cell parameters a and c for S-NCM (blue symbols) and C-NCM (red symbols) mixed with Li slate through Rietveld refinement. The earlier Li<sup>+</sup> insertion at 200 °C changed the variation tendency of the unit parameters for the sample after cleaning. (f) Heat generation measured by DSC from mixtures.

To reveal the effect of the residuals during the direct regeneration of the recycled cathode, in situ XRD characterizations were compared following the regeneration of S-NCM and C-NCM. During the heating, the unit cell lattice first nearly linearly expanded until there was a differentiation of the expansion ratio caused by the lithium insertion. As shown in Fig. 2d, the shift of the (003) peak of C-NCM was less pronounced than that of S-NCM when heating to 900 °C, indicating its unit cell lattice c was not expanded as much as for the S-NCM due to its more efficient lithium insertion. Therefore, more lithium insertion was observed for the C-NCM cathode. Correspondingly, the Li<sub>2</sub>CO<sub>3</sub> in the mixture of S-NCM and C-NCM also performed differently, whereby the Li<sub>2</sub>CO<sub>3</sub> in the

C-NCM cathode was consumed gradually until it disappeared at its melting point around 730 °C, while the Li<sub>2</sub>CO<sub>3</sub> in the S-NCM cathode completely vanished at around only 600 °C, and this earlier consumption of the lithium source may be attributed to the reaction between Li<sub>2</sub>CO<sub>3</sub> and the residual impurities (such as LiF, LiOH, and Li<sub>3</sub>PO<sub>4</sub>) by co-melting, vaporizing, and replenishing in S-NCM.42 Equivalently, the high angle reflection peak intensity spanning from (006) to (110), representing the layered structure, significantly increased starting from around 200 °C for the C-NCM cathode after the purifying treatment compared to there being no obvious enhancement for S-NCM, indicting the better repair of the layered structure during heating. To further unveil the underlying mechanism, Rietveld refinement of each XRD pattern was conducted, which can depict the continuous change of the unit cell parameters during regeneration. Generally, the unit cell parameter c decreases and a increases with the insertion of Li ions into a layered structure, similar to in the discharge process.<sup>28</sup> As shown in Fig. 2e, the lattice evolution of the S- and C-NCM

cathodes were compared. For C-NCM, the lattice c expansion slope became obviously flatter at 200  $^{\circ}$ C, denoting a lattice cshrinkage at this temperature induced by the Li-ion insertion and repairing. However, for the S-NCM without undergoing purifying treatment for the residuals, the lattice expanded still nearly linearly with no obvious lithium insertion until 600 °C. Concurrently, the lattice a expansion slope became steeper at 200 °C for C-NCM. Last but not least, Differential scanning calorimetry (DSC) characterization was also conducted during the regeneration process to confirm the lithium insertion pattern for the S- and C-NCM cathodes, which can trace the lithium replenishment associated with the exothermic reaction as reported by others. 43 As shown in Fig. 2f, the characteristic exothermic reaction at around 200 °C was only observed for C-NCM, confirmed the earlier lithium insertion after the purifying treatment. The earlier lithium insertion was also supported by the CO<sub>2</sub> gas release observed during Li<sub>2</sub>CO<sub>3</sub> decomposition to supply the lithium source for the C-NCM cathode, as shown Fig. S23 (ESI†). Moreover, from the thermogravimetric results shown in Fig. 2f, the weight loss of C-NCM was 5.4%, which was significantly larger than that of S-NCM of 2.5%, indicating that more Li<sub>2</sub>CO<sub>3</sub> was activated and decomposed to provide the lithium source for C-NCM. 43,44 To sum up, through multiple in situ and ex situ characterizations, we proved that, with a purifying pretreatment, the direct regeneration could be facilitated to start at a lower temperature of 200 °C from the spent cathode.

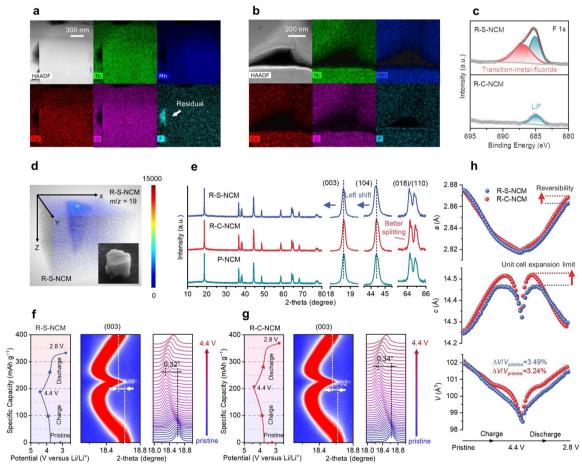
Fig. 3 Chemical and structural details of the regenerated cathode materials under the influence of impurities. (a) HAADF-STEM images and (b) corresponding EDS element mappings of R-S-NCM and R-C-NCM particles, focusing on the pores of the packing particles. (c) F 1s XPS high-resolution patterns of R-S-NCM and R-C-NCM powders. (d) Pseudo-three-dimensional distribution of F element and SEM image of the corresponding R-S-NCM particle. (e) Full patterns and characteristic peak comparison of the regenerated and pristine NCM cathodes with Cu Kα radiation at a scan rate of 8° min<sup>-1</sup>. (f) 1st charge-discharge curves, corresponding XRD patterns of R-S-NCM, and (g) (003) peak position variation when the cell charge from pristine to 4.4 V and comparison with R-C-NCM. (h) Lattice parameters a, c, and the unit cell volume V of R-S-NCM and R-C-NCM in the 1st chargedischarge test according to the refinement.

Furthermore, the crystal structure of the regenerated cathode could also be affected by the residual impurities. As shown in Fig. 3e and Fig. S28 (ESI†), the XRD pattern indicated a layered structure with no impurities phase for both the R-S-NCM and R-C-NCM cathodes. However, the R-C-NCM cathode had a higher (003)/(104) intensity ratio and larger splitting degree for the (018)/(110) peaks compared to R-S-NCM, suggesting its more ideal layered structure similar to P-NCM cathodes. After regeneration accompanied by impurities, the diffraction peaks of R-S-NCM were shifted toward a low-angle direction, indicating the lattice expansion, as supported by the refined parameters (Table S11, ESI†) and in situ experiments (Fig. 2d). Furthermore, in situ XRD was performed during the 1st charge/ discharge process for both regenerated cathodes (see Fig. 3f and g). The R-C-NCM cathode showed a higher capacity with a smaller offset (0.02°) of the (003) peak position than the

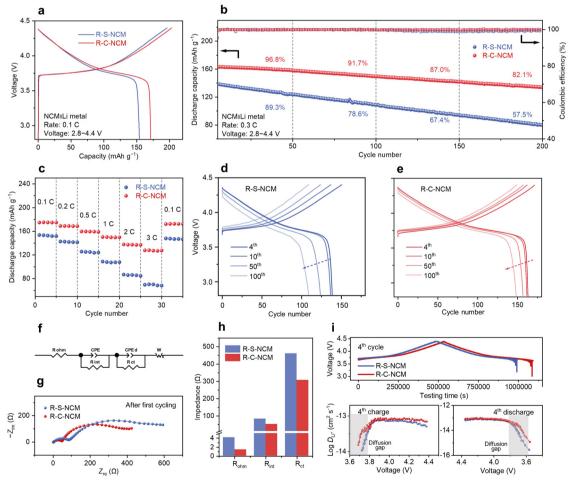
Fig. 4 Electrochemical deterioration for the regenerated NCM cathodes with impurity residue. (a) Initial galvanostatic charge-discharge curves of R-S-NCM and R-C-NCM at 0.1C (1C = 150 mA h  $g^{-1}$ ) and (b) long cycling test and capacity retention in a half-cell. (c) Rate capabilities of R-S-NCM and R-C-NCM. Charge-discharge curves of (d) R-S-NCM, (e) R-C-NCM in the voltage range of 2.8-4.4 V (vs. Li/Li<sup>+</sup>) at different cycles. (f) Equivalent circuit applied in the EIS measurements. Nyquist plots of (g) R-S-NCM and R-C-NCM and (h) fitting results showing the Ohmic resistance (Rohm), interface resistance (R<sub>int</sub>), and charge-transfer resistance (R<sub>Ct</sub>). (i) GITT curves and the calculated Li<sup>+</sup>-diffusion rate of R-S-NCM and R-C-NCM for the 4th cycle number after activation in the same charge-discharge period. The shadow area indicates low Li<sup>+</sup> diffusion in a certain voltage range.

As shown in Fig. 4a and Fig. S30 (ESI†), the initial discharge capacity increased from 154.1 mA h g<sup>-1</sup> for R-S-NCM to 171.4 mA h  $g^{-1}$  for R-C-NCM after the purifying treatment, although this was slightly lower than for P-NCM. In Fig. 4b and Fig. S31 (ESI†), the R-C-NCM cathode exhibit 91.7% and 82.1% capacity retention after 100 cycles and 200 cycles, respectively, compared with 91.6% and 78.3% for P-NCM, and 78.6% and

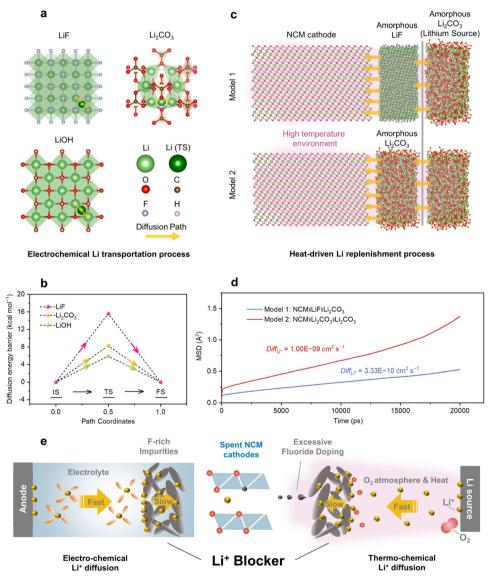
Fig. 5 Role of the F-rich impurities as a blocker in electrochemical and thermochemical Li<sup>+</sup> diffusion as ascertained from thermodynamic and kinetic simulations. (a) Illustrations of the selected migration pathways with a similar distance for Li<sup>+</sup> inside the crystal lattice of three common components. The initial state, transition state, and final state of Li<sup>+</sup> transportation are denoted as IS, TS, and FS, respectively. (b) Calculated energy diffusion barrier for Li ions in selected phases. (c) Two models for stimulating the kinetics of Li transportation in direct regeneration. Model 1 consists of the NCM cathode substrate, the amorphous LiF layer, and  $\text{Li}_2\text{CO}_3$  as a lithium source in direct regeneration, which is denoted as  $\text{NCM} \| \text{Li}_F \| \text{Li}_2\text{CO}_3$ . In Model 2 ( $\text{NCM} \| \text{Li}_2\text{CO}_3 \| \text{Li}_$ short), the middle LiF layer is replaced by a common residual alkali (Li<sub>2</sub>CO<sub>3</sub>), which is used to simulate the regeneration of NCM cathodes after cleaning pretreatment. Each shape symbol is the same as for Fig. 5a. (d) MSD of the Li atoms in 20 ns and calculated Li<sup>+</sup> diffusivity based on the above model. "E –  $9^{\prime\prime}$  means  $10^{-9}$ . (e) Mechanism diagram for preventing the NCM cathodes from reusing and directly regenerating under the influence of impurities.

According to the above results (Fig. 1d, Fig. S6, S16 (ESI†), and Fig. 4h, i), the migration rate of lithium ions was significantly influenced by the residual impurities; therefore it was crucial to theoretically investigate their influence on capacity delivery in the reuse case and during direct regeneration. Considering the impurities were mostly concentrated at the surface before and after regeneration, and that F-rich residuals could be observed, as shown in Fig. S9 and S10 (ESI†) and Fig. 3c, we chose three representative inorganic components (LiF, Li2CO3, and LiOH) in the CEI layer<sup>48</sup> or residual alkali<sup>49</sup> to calculate the Li<sup>+</sup> diffusion from a thermodynamic perspective, and their structures are shown in Fig. 5a. By maintaining a similar distance and concentration of mobile Li-ions, the diffusion energy barrier of lithium ions  $(\Delta E_{\text{Li}^+})$  during the cycling of spent cathodes within the different crystal structures (Fig. 5b) allowed valid comparisons. We found that the  $\Delta E_{\text{Li}^+}$  of the LiF phase, as a common inorganic component from CEI, was about 2 and 3 times higher than that of the LiOH and Li<sub>2</sub>CO<sub>3</sub> phases from

Fig. 5b. Therefore, this result confirmed that the presence of fluoride-rich impurity residuals on the cathode surface significantly increased the diffusion resistance of Li ions when cycling, ultimately exacerbating the cell impedance and interfacial parasitic reactions (Fig. 1d). To comprehend the largerscale kinetic characteristics and understand the effect of impurity coatings during heating for regeneration of the spent cathodes, two molecular dynamics models were established for simulating Li<sup>+</sup> transportation at 1000 K over 20 ns. Specifically, Model 1 was devised to include an impurity barrier consisting of a LiF layer (Fig. 5c and Fig. S33, ESI†). Through computing the mean square displacement (MSD) of Li atoms and fitting curves (Fig. 5d), we determined that the Li diffusivity (Diff<sub>Li</sub>+) of Model 1 was  $3.33 \times 10^{-10}$ , which was an order of magnitude lower than that of Model 2 (1.00  $\times$  10<sup>-9</sup>). The differences in molecular dynamics models under practical conditions suggest that fluoride-rich impurity coatings increase the resistance to Li-ion diffusion into spent cathodes with Li deficiencies during thermo-driven regeneration, leading to inadequate compositional and structural recovery.

As illustrated in Fig. 5e, the impurity phase containing the F element served as an electro- and thermo-diffusion blocker of Li ions hindering the reuse and direct regeneration of the spent cathode. In the spent cathodes collected by physical pretreatment and collection from used lithium-ion batteries, the ubiquitous electrolyte was decomposed to form an ion barrier with slow ion diffusivity. However, these impurities have long been overlooked in most studies (Table S2, ESI†), mainly due to the use of lab-scale degraded cathodes and fine manual separation pretreatment. In previous studies, 12-16,42 the latent impact of the residual impurities on direct regeneration remains untouched because impurities are easily converted into other inconspicuous matter in extreme physical or chemical regeneration environments. Looking ahead, the direct regeneration of nextgeneration sensitive cathode materials, such as Li-rich Mnbased, Co-free, and ultra-high-Ni cathode materials, faces serious challenges from these latent impurities if they enter the recycling circle. From another perspective, establishing the controlling law for the inherent impurities doping within the closed-loop material flow could instructively enhance the performance of such recycled materials in the future. Moreover, only by revealing the effect of the overlooked impurities or by getting rid of impurities, can evolving technologies and mechanisms for direct regeneration and upcycling be reasonably evaluated.50
