ARTICLE

in situ monitoring of corrosion processes by coupled micro-XRF/micro-XRD mapping to understand degradation mechanisms of reinforcing bars in hydraulic binders from historical monuments

Historic monuments have been partly built since the Antiquity with iron or steel reinforcement sealed in mortars or hydraulic binders. But the presence of chloride in the environment can weaken the structures due to the corrosion of these metallic parts, leading to the cracking of the binder. In this context, in order to better understand the first steps of these corrosion mechanisms a chemical cell has been designed to operate in-situ analyses of the phases precipitated when a chlorinated solution is introduced at the vicinity of the bar. For that chemical and structural characterisation (micro-XRF and micro-XRD respectively) has been performed under synchrotron radiation on Soleil-DiffAbs beamline. Moreover complementary SEM-EDS analyses have been carried out before and after the in-situ cell experiment in order to determine the final localisation inside the crack network of the corrosion products. The results show first that iron can spread up to 1 mm of the metallic bar inside the pores

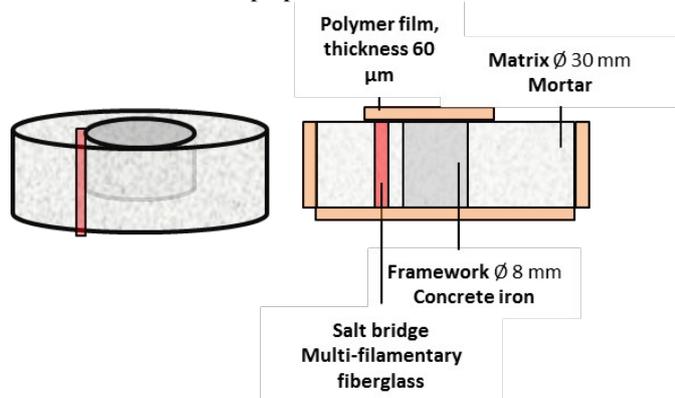
Figure 1: schematic diagram of the in-situ cell, left, perspective view, right, transverse view

Cells composed of mortar and steel bare bars have been studied. Mortar has been chosen because of its similarity to materials employed in ancient building¹⁸. Mortar has been prepared with a water/cement ratio of 0.5 and sand/cement ratio of 3 using a CEMI 52.5 N CP2 cement type. The cells were designed following the protocol presented below (Figure 1). First the steel bar ($\Phi=1$ cm, H=12 cm) is maintained vertically at the center of a cylindrical plastic mold ($\Phi=3$ cm, H=12 cm). Along the bar, a multifilament glass yarn ($\Phi=2$ mm, H=12 cm) is fastened. Mortar is cast in the mold and the whole dried during 28 days at ambient conditions. After that the plastic mold is removed, the obtained cylinder embedded in epoxy resin before sections of 1 centimeter thickness are cut with a diamond wheel saw to prepare the cells in cross section mode.

Each cross section was prepared as follows: it is first ground with SiC papers and then polish with a 3 μm diamond paste under ethanol. On the front of the cells an adhesive polymer film is applied in order to avoid the air penetration through the observation side, but without obstruction for micro-XRD and micro-XRF analyses. For the experiment the cells were wetted by capillarity through the glass filament trapped in the binder at the vicinity of the steel bar, ensuring a penetration of the chlorinated solution at the binder / iron interface.

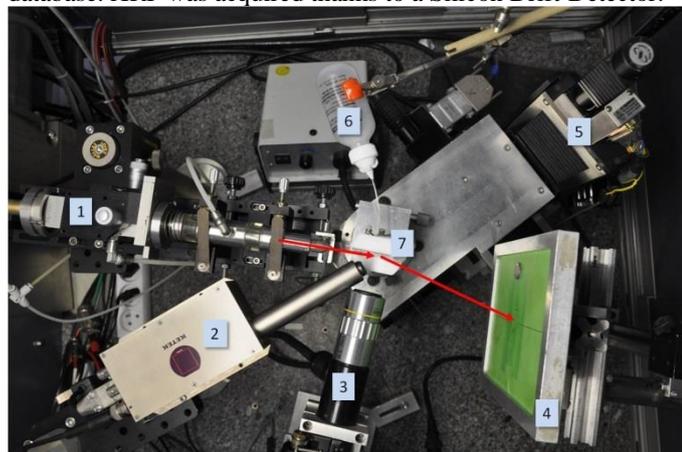
Figure 2 : *in situ* setup monitoring, rotating anode X-ray generator; 1. X-ray (Mo, $\lambda_{\text{K}\alpha} = 0,709 \text{ \AA}$), 2. XRF detector, 3. OM, 4. Image plate, 5. Translation table, 6. Chlorinated solution, 7. Cell

For micro-XRD measurements, a Mo anticathode of a rotating anode X-ray generator delivered a monochromatic beam at 17.48 keV focused to a 50 μm \times 30 μm surface (flux of about 10^6 ph.s⁻¹) using a Xenocs® FOX2D Mo 25_25P diffraction optic (Figure 2). This optic is a curved mirror with graded multilayer coatings that monochromatizes the incident beam from a single reflection. The cells were placed at an angle of 3° from the incident beam in order to work in reflection mode, and the spot size at the sample surface was about 1000 μm (horizontal finger print due to incident angle) \times 30 μm . Diffraction patterns were collected during about 1h30 using a two-dimensional detector (image plate). Data processing was carried out with the EVA software and the ICDD-JCPDS database. XRF was acquired thanks to a Silicon Drift Detector.

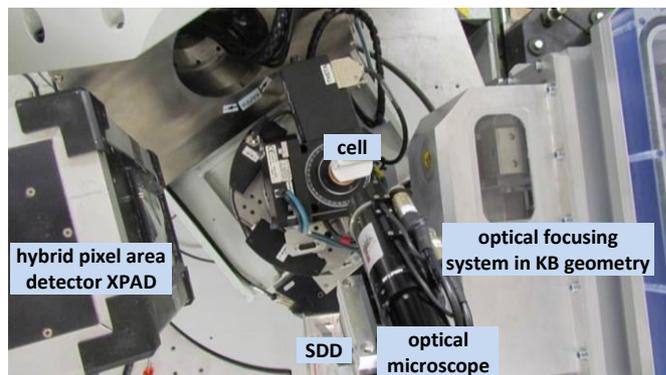
Figure 3 : DiffAbs experimental setup, SOLEIL synchrotron, 1) experimental cell, 2)

optical system that consists of two trapezoidal shape flat and orthogonally placed curved mirrors under grazing incidence (in Kirkpatrick Baez geometry) was used for the present experiment to focus the beam down to 10 \times 10 μm^2 with a flux about $10^{10} - 10^{11}$ ph.s⁻¹. The cell has been placed under the beam with an incident angle of 5°, implying beam size finger print about 150 μm \times 10 μm (H \times V fwhm) on the sample.

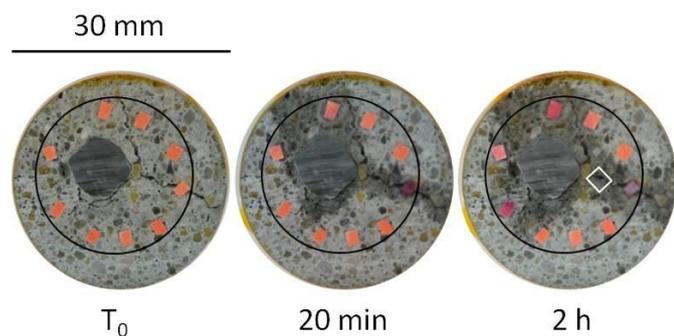
Figure 4: Cell C02-E03, Monitoring of the capillary penetration of a chlorinated solution (0.5M NaCl)

The penetration of the solution was assessed thanks to macrophotography. This monitoring of the capillary penetration of the chlorinated solution (Figure 4) shows a propagation from the inert multifilament yarn to the binder all around the steel / mortar interface. For the three studied cells the stabilization of the propagation front, i.e. when no macroscopic evolution of the migration front is observed when a drop of solution is added, is comprised between 1 and 4 hours. These different values are due to the variable mortar porosity between the different cells, despite same preparation conditions. The macroscopic cracks present in the cell because of the shrinkage of the mortar during dry curing seem to facilitate the fast and long-distance spreading of the chlorinated solution in the mortar.

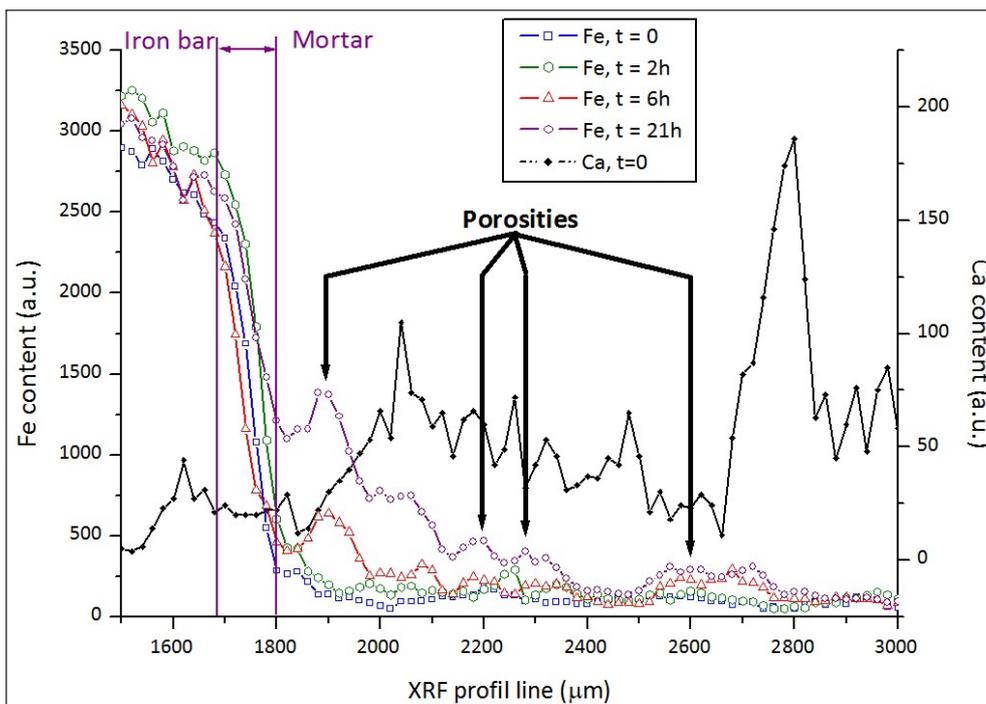
Figure 5 : cell C09-C04, micro-XRF profiles obtained with the laboratory setup

Iron content profiles obtained on the C09-C04 cell at various durations of experiment are presented on Figure 5. The profile obtained at $t=0$ shows the initial location of the rebar. The fact that the decrease does not form a sharp step is due to the size of the beam, enlarged horizontally because of the low incidence angle setup. The 600 μm large beam averages the irregularity of the metal/binder interface. Consequently the part of the profile between 1700 and 1800 μm cannot be considered to study the Fe migration in the binder because it is constituted of a mix of signal coming from the metal, a thin initial corrosion layer, and the binder. For higher distance values, it can be considered that the observations are made in the initial binder as showed by the increase of the Ca content. At these locations, the profile of Fe content obtained at $t=0$ shows the initial distribution of this element in the binder. Fe content is very low (note that the XRF detection limit of iron is of 2 order of magnitude lower than EDS). After 2 hours the Fe content in the binder begins to increase significantly and continuously until the last measurement after 21 hours. For each acquisition time, the profile decreases from the rebar to the outer part of the binder, confirming that the source of the iron is the corrosion of the rebar. Nevertheless, despite this trend, the profiles all show important irregularities. These local increases of the iron content are probably due to larger porosities, and in some case, as for $t=6\text{h}$ and 21h between 2500 and 2800 μm , they can still be filled by corrosion product precipitation. Thus, after 21h, iron has migrated more than 1 mm far from the initial metal/binder interface. Post mortem analyses performed by SEM-EDS (Figure 6) confirm this observation. The migration paths of Fe species in the binder seem to follow in priority the larger cracks and pores. These cracks and pore appear in black before the experiment on Figure 2, at the end of the experiment, they are completely filled with iron corrosion products.

micro-XRF profiles show that, in the conditions of the experiments, the iron corrosion products migrate in the pores of the binder before precipitating. After 21h of corrosion, this migration process allowed significant quantities of iron to be transported at more than 1 mm of the binder/rebar interface. It seems nevertheless as shown on micro-XRD maps that this migration is hindered by phase precipitation: the 40h maps are similar to the 32h ones. To migrate relatively far from the metal/binder interface, iron is dissolved in the pore solution under the form of complexed Fe^{2+} ions at basic pH. Refait et al^{22, 23} and Rémaizeilles et al^{21, 24} studied in different papers the evolution of solutions containing Fe^{2+} and Cl^- compounds that oxidise under aerated conditions. Let us discuss the present results considering these former studies.

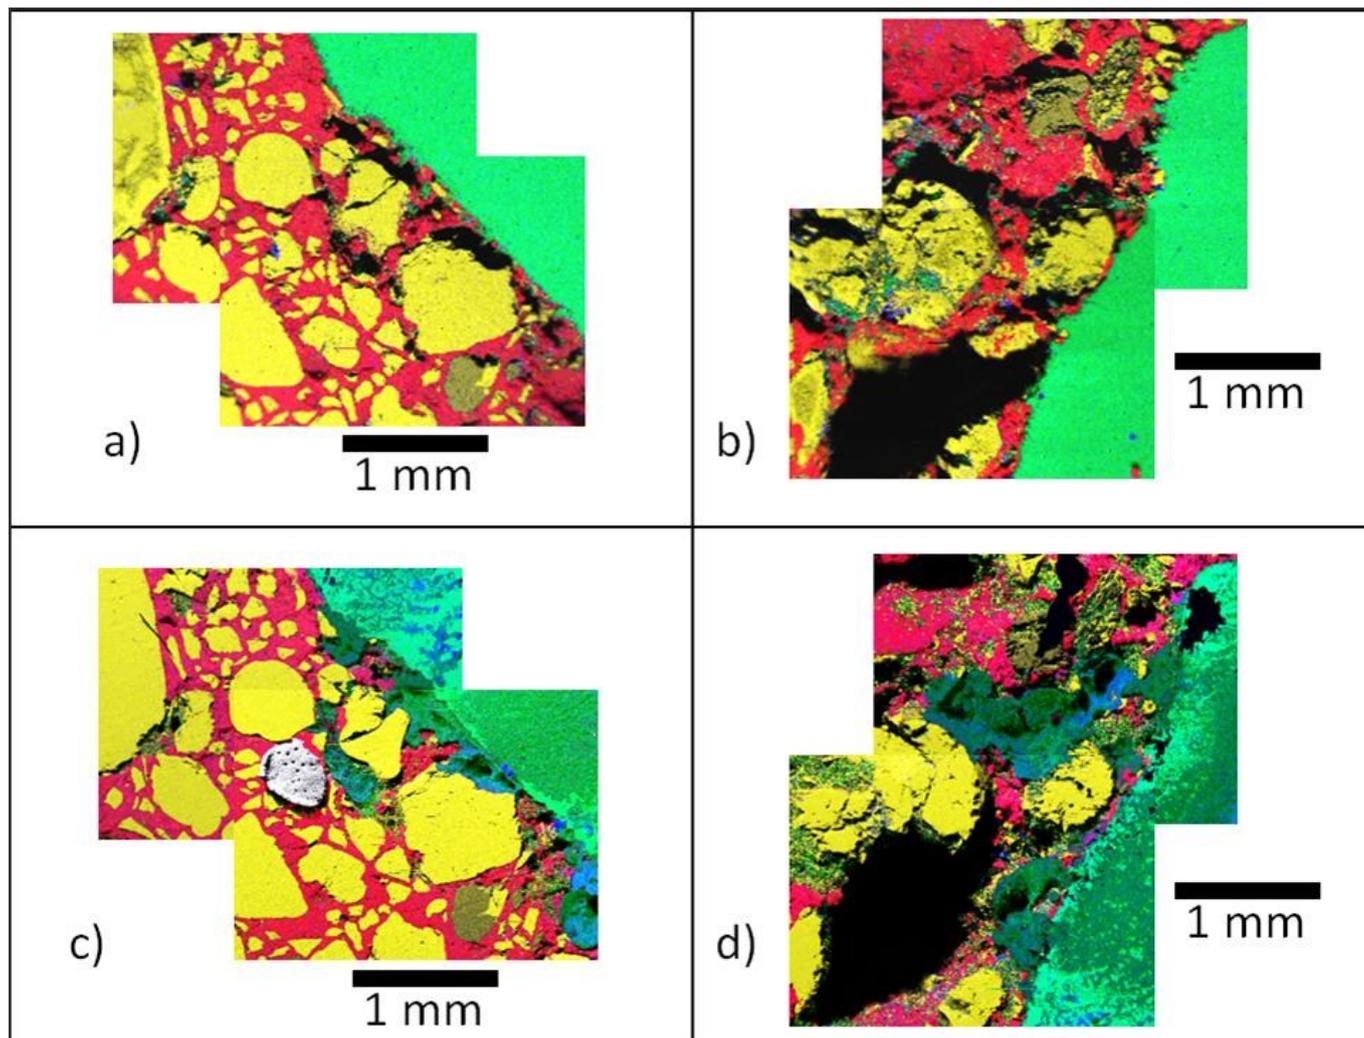
Figure 6 : Cell C02-E03, EDS maps (Fe = green, Ca = red, Si = yellow, Cl = blue): a) & b) Respectively zone 1 & 2 before the corrosion ; c) & d) Respectively zone 1 & 2 after the "in-situ" monitoring of the corrosion process showing the presence of iron inside the cement paste. The gray array on c) is due to an artefact linked to a thick C deposition before SEM observation.

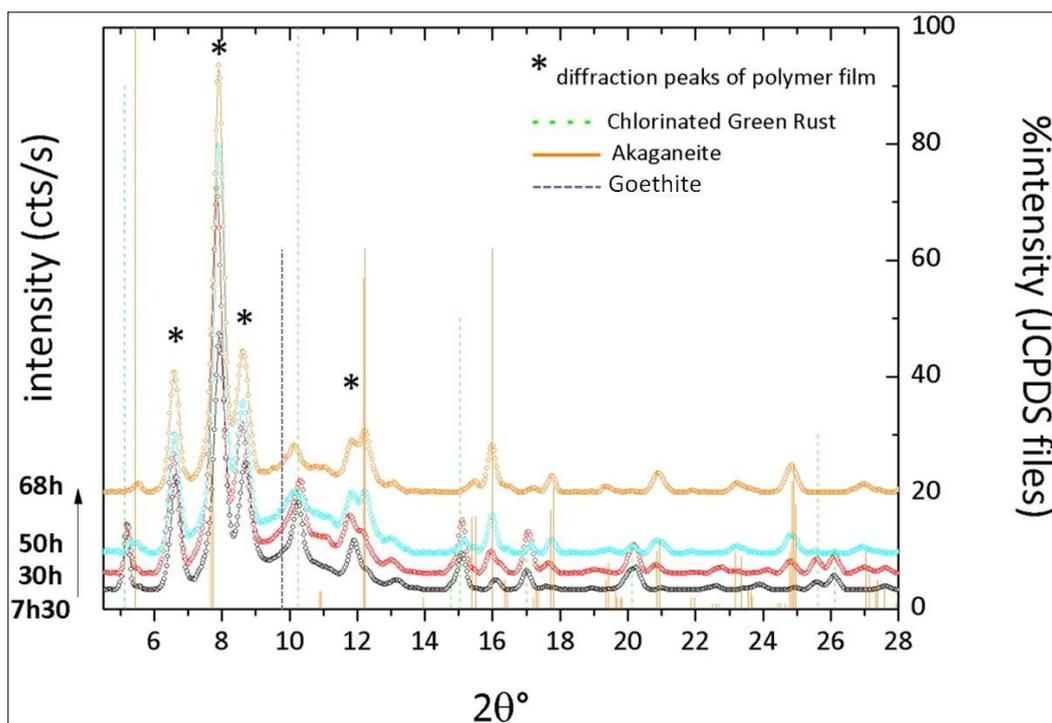
Figure 7: Cell C07-C01, X-Ray diffraction patterns obtained on the laboratory setup from 7h30 to 68h of corrosion

The micro-XRD patterns obtained « in situ » at the distance of 1950 μm during experiment on the laboratory rotating anode setup (Figure 7) show after 7h30 of corrosion, the presence of chlorinated green rust and a minority of akaganeite ($\beta\text{-FeOOH}$). The chlorinated green rust is a compound rarely observed on corrosion products because of its low chemical stability when it is exposed to air and has been mainly studied in laboratory²¹.

While the green rust is the main product at the beginning of the corrosion processes, it seems to progressively disappear in favour of akaganeite. It can be noted that a shoulder at 9.7° appears and could be due to the presence of goethite ($\alpha\text{-FeOOH}$). After 50 hours the peaks of GR are weaker but still present. After 68 hours there is no green rust anymore and akaganeite is the main product detected.

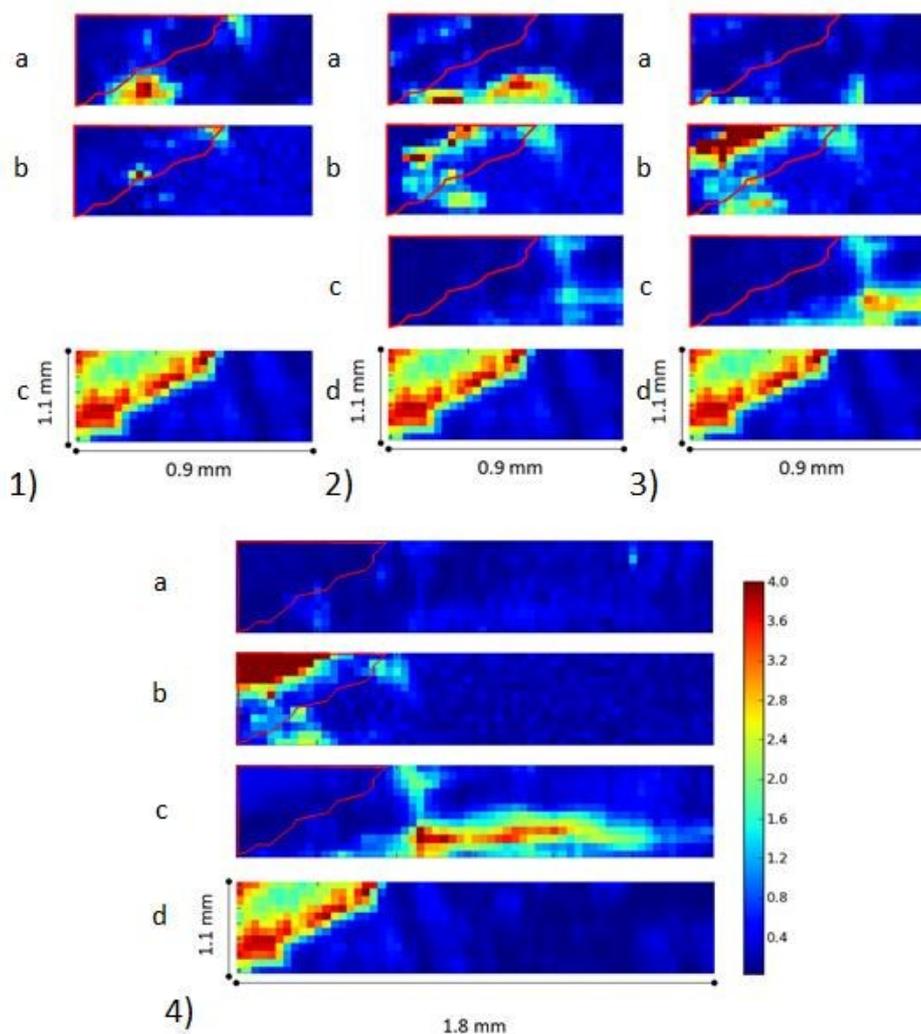
Figure 8 : Cell C02-E03, X-Ray diffraction maps obtained on the DiffAbs beamline at the Synchrotron Soleil : distribution of a) chlorinated green rust ; b) akaganeite ; c) goethite ; d) iron ; after 1) 1h, 2) 8h, 3) 20h and 4) 44h of monitoring.

The micro-XRD diffraction maps, obtained on DiffAbs beamline with a much smaller beam than on the laboratory setup, 1h after the beginning of the in situ experiment (Figure 8-1), confirm that the main phase formed near the iron rebar is the chlorinated green rust. At some locations, spots of akaganeite appear. After 4 hours (not shown here) the same observations are noted, with an increase of the intensities for each phases and a spreading of the green rust precipitation zone towards the external zone farther from the iron rebar. The same phenomenon is observed at 8 hours i.e. akaganeite precipitates locally near the bar, green rust zones extends and for both phases an increase of the peak intensities attests of a tendency to higher amounts. But at the same time some goethite appeared at a farther distance of the steel bar. It has to be noted that during

the experiment, it appears that the akaganeite dominance area grows and shifts on the surface of the transverse section of the bars probably due to a local peel off of the adhesive film in contact with the solution. The same observations can be done after 12 and 16 hours of experiment (not shown here). After 20 hours, green rust starts to disappear whereas akaganeite remains present near the metal and goethite at a farther distance of it. After 32h of experiment, the green rust has completely disappeared from the map and the system is stabilized as shown on the 44h maps. The following maps show the presence of goethite from 0.6 to 1.6 millimeter from the steel bar. Thus, chlorinated green rust, akaganeite and goethite could be dominant, simultaneously in different areas, roughly depending on the distance from the metal/binder interface.

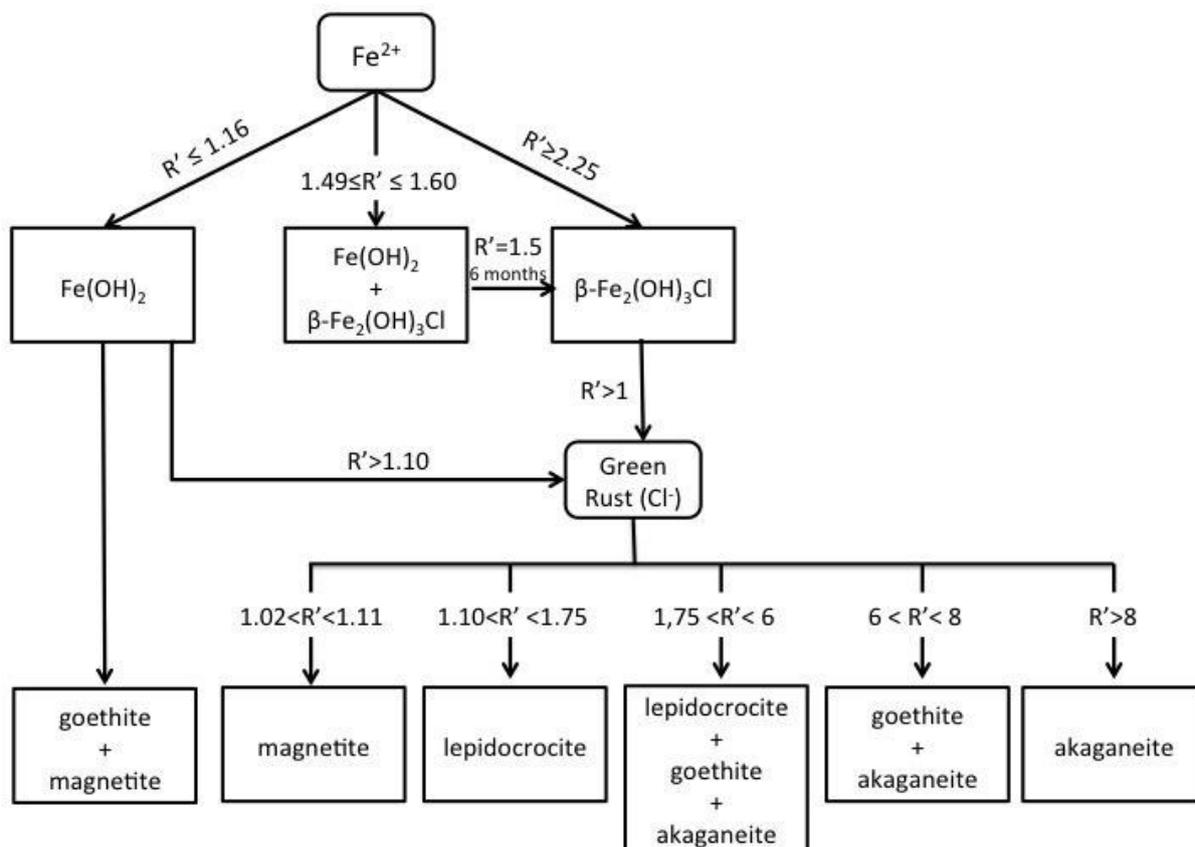
Figure 9 : Summarized diagram of phase formation during the iron oxidation process in chloride medium. $R = R'/2$, $[\text{NaOH}] = 0.4 \text{ mol.L}^{-1}$ ^{22, 23 21, 24}

These authors discussed the oxidation mechanisms of the Fe(II) containing phases (obtained by mixing NaOH and FeCl₂·4H₂O) in function of two parameters: $R = [\text{Fe}^{2+}]/[\text{OH}^-]$ and $R' = [\text{Cl}^-]/[\text{OH}^-]$. The diagram of Figure 9 sums up a part of these results corresponding to “low” oxidation rates, i.e. without adding of H₂O₂ and obtained in aerated conditions in a stirred solution. First it is interesting to note that despite variations of the stirring rate, the time for oxidizing Fe²⁺ species in aerated conditions is in the same order of magnitude than the one observed in the present study. For example, in ²³ for $R'=3$, it takes about 4 hours to obtain akaganeite from the initial solution. This time increases with R' and can reach sometimes 10 hours. Here, in the pore network of the binder, despite O₂ can access the solution, it is probable that this access is hindered compared to the stirred solution. Thus the oxidation duration to obtain the final product is slightly higher and can reach several 10 hours. However the evolution paths of the phases precipitated in both laboratory or cell conditions are very comparable. In the cell experiment it can be supposed in a first approximation that in the pores $R'=5$ (i.e. $[\text{OH}^-]=0.1\text{ mol}\cdot\text{L}^{-1}$ and $[\text{Cl}^-]=0.5\text{ mol}\cdot\text{L}^{-1}$). The evolution path of the phases for $R' = 5$ shows that the oxidation of Fe²⁺ should first lead to the formation of $\beta\text{-Fe}_2(\text{OH})_3\text{Cl}$ and then to the chlorinated green rust (Fe^{II}₃Fe^{III}(OH)₈[Cl·nH₂O]). The first compound was not observed here: after at least 1 hour, the only detected compound by micro-XRD is the chlorinated green rust. The fact that the first micro-XRD map was acquired 1h after the NaCl introduction could explain the absence of the first transient phase that has already disappeared.

In the following stages of the oxidation process proposed in Figure 9, the green rust progressively transformed into Fe(III)

oxihydroxides. For $R' = 5$ the product are a mix of lepidocrocite ($\gamma\text{-FeOOH}$), goethite ($\alpha\text{-FeOOH}$) and akaganeite ($\beta\text{-FeOOH}$). Actually Refait et al ^{22, 23} indicate that the higher R' is, the less lepidocrocite is observed and the more goethite and akaganeite. This is in relatively good agreement with the observations made by micro-XRD mapping for the present study: after 8h akaganeite and goethite begin to replace green rust. After 22h this latter green rust has quasi totally disappeared and is totally transformed after 32h in both akaganeite and goethite depending on the location towards the steel bar. In the cell in-situ, compared to the oxidation processes observed in the laboratory by Refait, Rémazeilles and co-workers for a $R'=5$, no lepidocrocite is observed. This can be explained by several factors. The first one is that in the cell the dissolved oxygen content could be lower although the conditions are aerated and limit the kinetic of formation lepidocrocite. Moreover for the relatively high R' parameter, not so far from 6 the nature of the final phases is also influenced by the parameter R . During studies presented on Figure 9, R was always fixed at $R'/2$, but other experiments performed by Rémazeilles ²⁴ showed that for a given R' , a decrease of R (i.e. a decrease of $[\text{Fe}^{2+}]$) favours the precipitation of goethite versus akaganeite. This could explain at the same time that precipitation of goethite seems to be more important farther from the metal/binder interface, where the iron concentration is lower, as demonstrated by the XRF profile.
