Cite this: *Environ. Sci.: Water Res. Technol.*, 2021, 7, 274

This study was conducted to determine if the thermal degradation of various plastic drinking water pipes (*i.e.*, PEX, HDPE, PP, PVC, and CPVC) may be a source of drinking water contamination. Widespread volatile organic compound (VOC) contamination was found in water distribution systems following three wildfires in California. A potential source of this contamination was thought to be due to the degradation of plastic components in drinking water distribution systems. Eleven plastic drinking water pipes, across eight brands, were exposed to elevated temperatures (200 °C to 400 °C), and subsequently submerged in water or in *n*-hexane to observe the extent of VOC leaching. Results indicated that thermally damaged drinking water pipes can be sources of VOC leaching, with ten of the eleven materials leaching benzene, a carcinogen, into water. As exposure temperature increased, an increase in VOC leaching was observed in the polyethylene materials. Conversely, in the vinyl materials the significant mass loss associated with high exposure temperature was inversely proportional to the amount of BTEX leaching that was observ

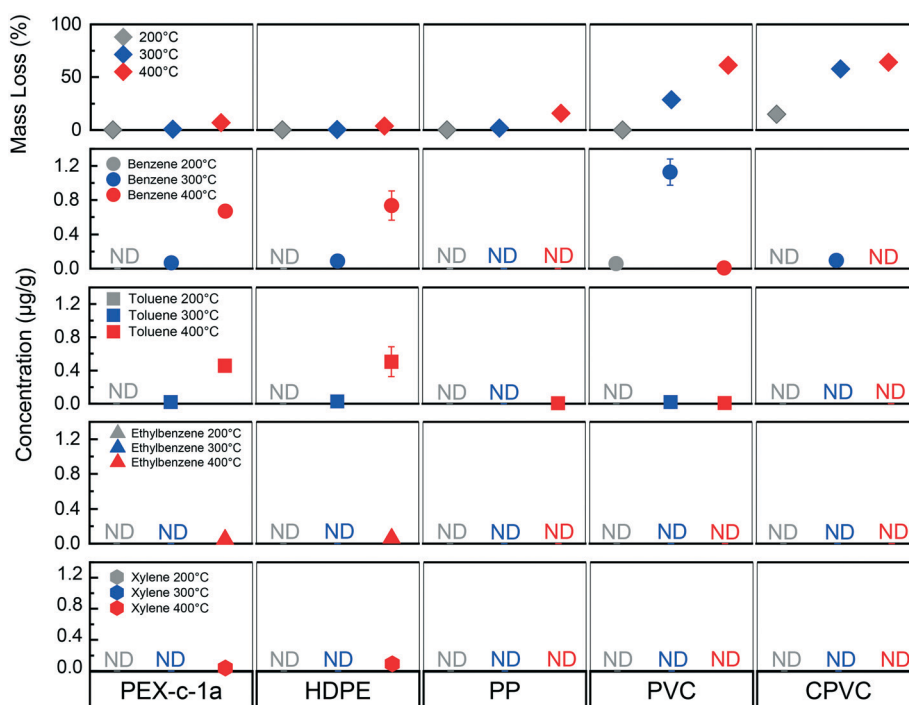
Fig. 3 Mean BTEX concentration after extracting each burned material at 200 °C, 300 °C, and 400 °C in water. The error bars reflect the standard deviation of the measurements ($n = 3$). If no error bars are visible, it indicates they were smaller than the symbol size. ND indicates the compound was not detected.

Different concentrations of BTEX were found in water after changing the isothermal heating temperature, such that two patterns emerged (Fig. 3). For the HDPE and PEX pipes, the amount of BTEX that leached into the water increased as the plastic degradation temperature increased from 200 °C to 400 °C (Fig. 3). Conversely, the greatest benzene concentration was found for the PVC pipe when exposed to 300 °C, with relatively less concentrations at 200 °C and 400 °C (Fig. 3). The CPVC pipe showed a similar pattern for benzene as the PVC pipe, however, at much lower concentrations (Fig. 3). This spike phenomenon for vinyl materials can potentially be explained by the lower amount of mass loss, where not all benzene produced during degradation volatilized out of the solid. The 300 °C exposure temperature was greater than the onset degradation temperature (Table 1) where dehydrochlorination would occur. However, the PVC pipe mass loss was only 23 wt% as opposed to 61 wt% at the 400 °C condition resulting in a more structurally intact plastic after degradation (Fig. S2†).

Despite structural similarities for the vinyl pipes, benzene was only detected in water exposed to the CPVC pipe at a fraction of the amount it was found in water exposed to the PVC material (Fig. 3). This difference may be explained by the additional chlorine atoms present on the CPVC polymer chains resulting in a greater number of chlorine substituted aromatic products when CPVC was thermally degraded.³⁴ A previous CPVC pyrolysis study found significantly more

Compared to vinyl pipes, greater BTEX concentrations were found as the degradation temperature increased for the HDPE and PEX materials (Fig. 3). The onset degradation temperature for both of these materials exceeds 430 °C (Table 1) which can explain why little to no BTEX leaching was observed at 200 °C and 300 °C. The increase in leaching between 300 °C and 400 °C can be attributed to the plastic pipes beginning to degrade and generating BTEX and other compounds. Elevated temperatures lead to the polymer chain undergoing chain scission resulting in the formation of alkenes.³² As the pipe is exposed to greater temperatures, the amount of polymer chain scission that occurs also increases. The increase in scission results in more alkene fragments that may subsequently undergo aromatization. A similar pattern was observed in a study of HDPE combustion by others, in which the benzene concentration in the air increased as the combustion temperatures increased from 500 °C to 800 °C.⁵¹ However, the increase in potential BTEX formation does not necessarily indicate that this trend of increased leaching as a function of temperature will
