Cite this: *Environ. Sci.: Water Res. Technol.*, 2021, 7, 274

Drinking water contamination from the thermal degradation of plastics: implications for wildfire and structure fire response†

Water impact

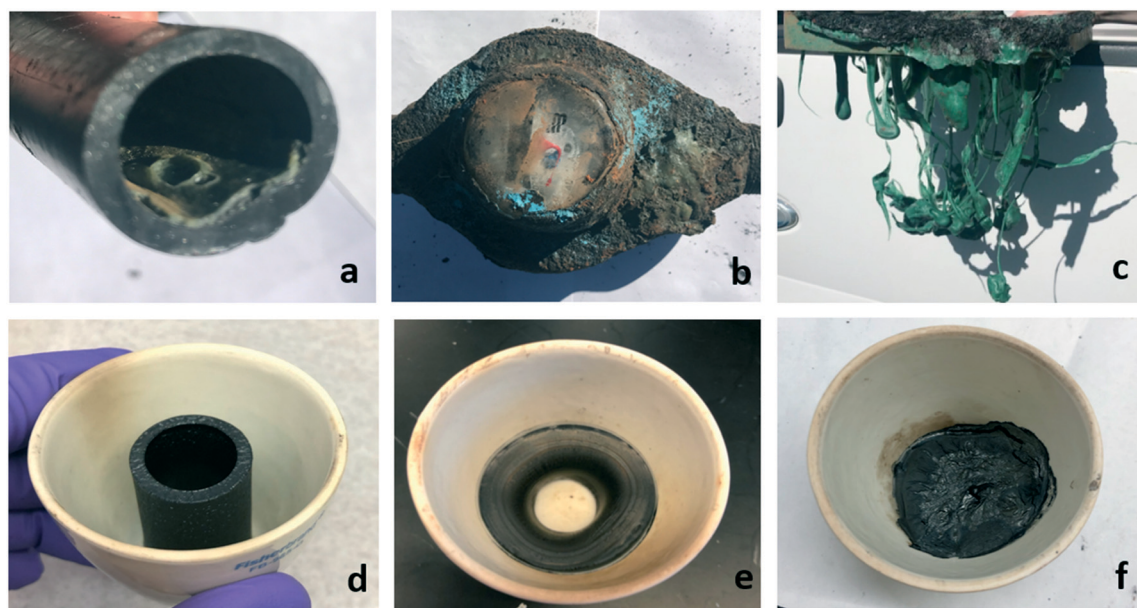
Fig. 1 Images of fire-damaged water system components including (a) a HDPE plastic pipe, (b) a water meter, and (c) a water meter cover following the Camp Fire. Thermally degraded pipe samples in laboratory experiments include the (d) PEX-c pipe degraded at 300 °C, (e) HDPE pipe degraded at 300 °C, and (f) HDPE pipe degraded at 400 °C.

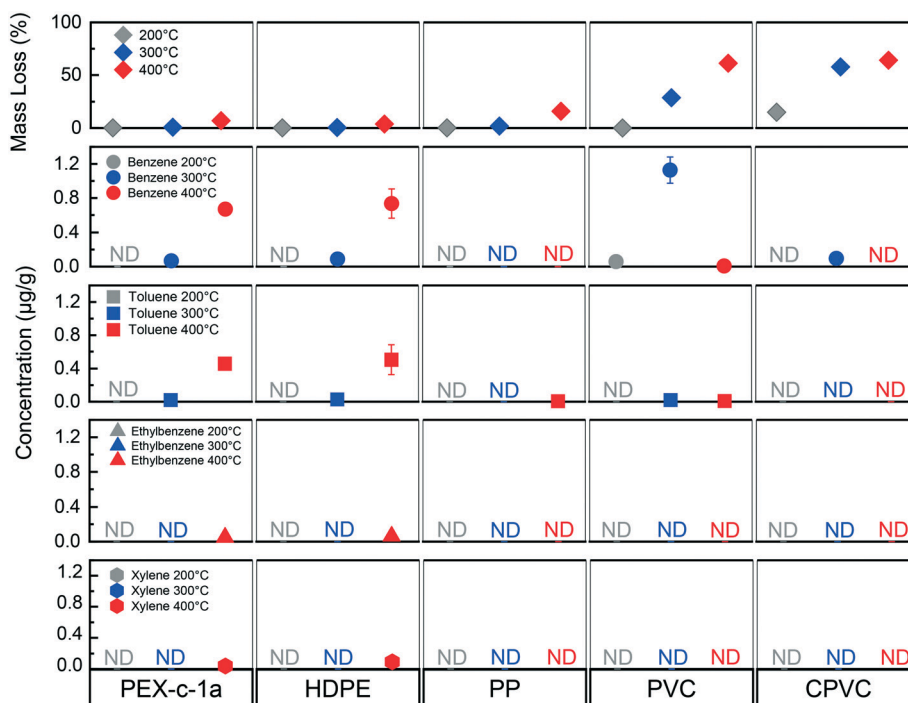
Fig. 3 Mean BTEX concentration after extracting each burned material at 200 °C, 300 °C, and 400 °C in water. The error bars reflect the standard deviation of the measurements ($n = 3$). If no error bars are visible, it indicates they were smaller than the symbol size. ND indicates the compound was not detected.

Different concentrations of BTEX were found in water after changing the isothermal heating temperature, such that two patterns emerged (Fig. 3). For the HDPE and PEX pipes, the amount of BTEX that leached into the water increased as the plastic degradation temperature increased from 200 °C to 400 °C (Fig. 3). Conversely, the greatest benzene concentration was found for the PVC pipe when exposed to 300 °C, with relatively less concentrations at 200 °C and 400 °C (Fig. 3). The CPVC pipe showed a similar pattern for benzene as the PVC pipe, however, at much lower concentrations (Fig. 3). This spike phenomenon for vinyl materials can potentially be explained by the lower amount of mass loss, where not all benzene produced during degradation volatilized out of the solid. The 300 °C exposure temperature was greater than the onset degradation temperature (Table 1) where dehydrochlorination would occur. However, the PVC pipe mass loss was only 23 wt% as opposed to 61 wt% at the 400 °C condition resulting in a more structurally intact plastic after degradation (Fig. S2†).

Despite structural similarities for the vinyl pipes, benzene was only detected in water exposed to the CPVC pipe at a fraction of the amount it was found in water exposed to the PVC material (Fig. 3). This difference may be explained by the additional chlorine atoms present on the CPVC polymer chains resulting in a greater number of chlorine substituted aromatic products when CPVC was thermally degraded.³⁴ A previous CPVC pyrolysis study found significantly more

Compared to vinyl pipes, greater BTEX concentrations were found as the degradation temperature increased for the HDPE and PEX materials (Fig. 3). The onset degradation temperature for both of these materials exceeds 430 °C (Table 1) which can explain why little to no BTEX leaching was observed at 200 °C and 300 °C. The increase in leaching between 300 °C and 400 °C can be attributed to the plastic pipes beginning to degrade and generating BTEX and other compounds. Elevated temperatures lead to the polymer chain undergoing chain scission resulting in the formation of alkenes.³² As the pipe is exposed to greater temperatures, the amount of polymer chain scission that occurs also increases. The increase in scission results in more alkene fragments that may subsequently undergo aromatization. A similar pattern was observed in a study of HDPE combustion by others, in which the benzene concentration in the air increased as the combustion temperatures increased from 500 °C to 800 °C.⁵¹ However, the increase in potential BTEX formation does not necessarily indicate that this trend of increased leaching as a function of temperature will
