## Ongoing legacy contamination from a military radar station in Iceland: a case study

Cite this: *Environ. Sci.: Adv.*, 2024, 3, 972

María J. Gunnarsdottir

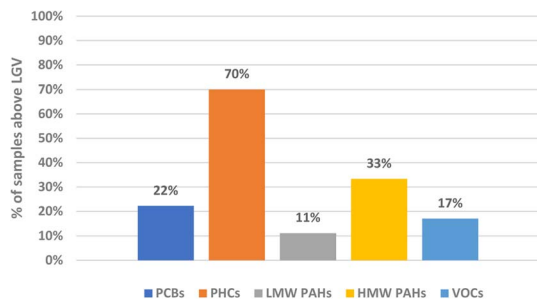
Fig. 5 Non-compliance of POPs with the LGV (lowest guideline value) in samples.<sup>10</sup>

POPs are non-compliant to the lowest guideline value, as shown in Fig. 5, from 11% for low molecular weight PAHs to

70% for PHCs. However, this is not representative as sampling is not evenly distributed and several sites are not tested for some POPs as shown in Table 1.
