Cite this: *Energy Environ. Sci.*,  
2025, 18, 264Removal of residual contaminants by minute-level  
washing facilitates the direct regeneration of  
spent cathodes from retired EV Li-ion batteries†Yi Guo,<sup>‡a</sup> Yang Li,<sup>‡bcd</sup> Kai Qiu,<sup>d</sup> Yan Li,<sup>e</sup> Weijing Yuan,<sup>b</sup> Chenxi Li,<sup>b</sup> Xinyu Rui,<sup>a</sup>  
Lewei Shi,<sup>b</sup> Yukun Hou,<sup>a</sup> Saiyue Liu,<sup>a</sup> Dongsheng Ren,<sup>\*a</sup> Tiening Tan,<sup>\*d</sup>  
Gaolong Zhu,<sup>d</sup> Languang Lu,<sup>a</sup> Shengming Xu,<sup>idf</sup> Biao Deng,<sup>g</sup> Xiang Liu<sup>id</sup><sup>\*b</sup> and  
Minggao Ouyang<sup>id</sup><sup>\*a</sup>

The direct regeneration of spent cathodes stands out as an environmentally and economically benign strategy within the battery ecosystem, eclipsing the cumbersome metallurgical approaches. Before addressing the lithium loss and structural degradation, it is crucial to focus on the residual contaminants within the spent cathode collected from retired Li-ion batteries after industrial exfoliation processes. Here, comprehensive characterizations and calculations show that in contrast to metal scraps, the electrolyte decompos

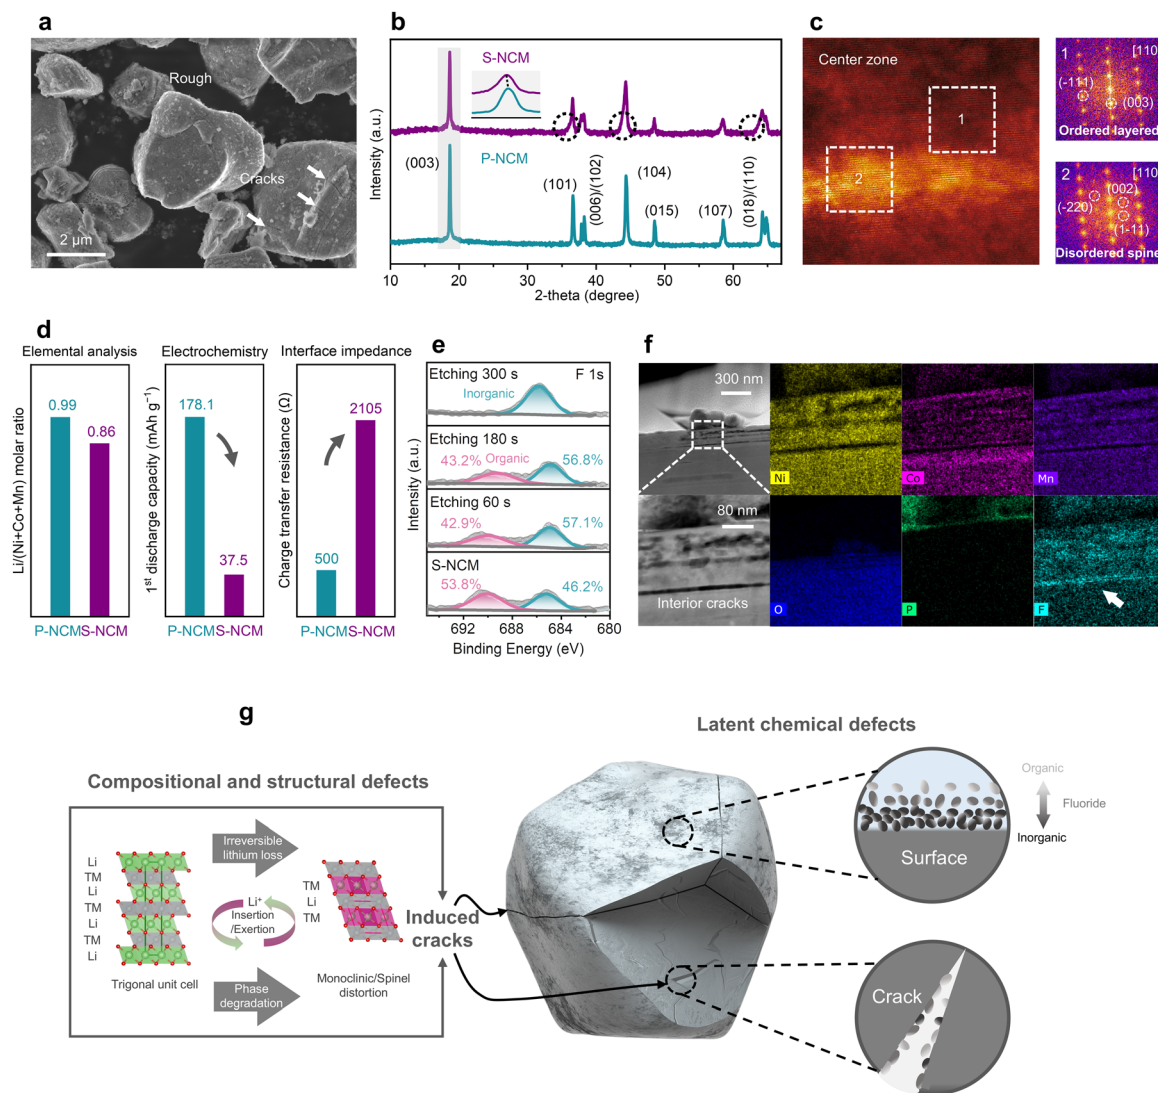
**Fig. 1** Neglected chemical residuals on the 250k-miles-serviced cathode. (a) SEM image and (b) XRD pattern of the degraded S-NCM. The black dotted circle accentuates the subtle peaks that do not belong to the layered structure; (c) high-resolution HAADF-STEM images on the central area of the S-NCM particle and the FFT patterns of the selected dark and bright regions; (d) comprehensive comparison of lithium loss in degraded powders measured by ICP-OES, electrochemical capacity, and charge-transfer resistance analyses in the half-cell using S-NCM and P-NCM powders as cathode active materials; (e) F 1s XPS patterns of S-NCM powders for different sputtering times using an ion-beam. Based on the calculated integral area, the proportional values of the organics and inorganics in fluoride are presented in the patterns; (f) HAADF-STEM images based on focused ion beam cutting and an enlarged view displaying the interior microcracks. Corresponding EDS mapping analysis indicates the presence of F elements along these microcracks pointed out by a white arrow. (g) Deficiencies of S-NCM addressed before direct regeneration, including the compositional and structural aspects (e.g., irreversible lithium-ionic loss, phase degradation, internal and external cracks) and latent chemical defects (e.g., surface and crack-edge impurities enriching the F element).

To understand the surface state of the spent cathode, energy-dispersive spectroscopy (EDS) element mapping and X-ray photoelectron spectroscopy (XPS) were conducted. As shown in Fig. S7–S9, and Tables S5, S6 (ESI<sup>†</sup>), the S-NCM cathode surface residuals consisted of C, O, F, and P elements, and displayed a surface-rich gradient distribution, as revealed

by XPS with etching. The F 1s XPS peaks with etching for S-NCM are shown in Fig. 1e, where two F 1s peaks could be observed before sputtering, with the major peak centered at 685.5 eV, which was attributed to inorganic fluorides and the minor F 1s peak centered at 690.4 eV, which could be assigned to organic fluorides, with the ratio of 53.8% for organic fluorides.<sup>29</sup> However, the organic-related F peak declined significantly after sputtering, and completely disappeared after 300 s Ar<sup>+</sup> sputtering. The surface-rich distribution of organic fluoride was consistent with the cathode electrolyte interphase (CEI) composition previously reported.<sup>29,30</sup>

To further reveal the microscopic distribution of those F-rich residuals, SEM combined with time-of-flight secondary ion mass spectrometry (SEM-ToF-SIMS) characterization was conducted for the cycled cathode. The results are shown in Fig. S10 and Videos S1, S2 (ESI†). Based on the spatial distribution of F<sup>−</sup> secondary ion fragments, it was confirmed that fluoride impurities were primarily deposited on the particle surface. Moreover, during the long-time battery service, it could be observed from the HAADF-STEM image and corresponding element mapping (see Fig. 1f) that, in the S-NCM cathode, the fluorides could spread into the interior of the cathode along the intragranular cracks. Coincidentally, from the selected FFT figure shown in Fig. S4 (ESI†), the existence of an amorphous ring was observed along the intragranular cracking, which may be related to the fluorides also observed in the bulk. To sum up, the collected S-NCM exhibited limited structural and compositional degradation, while preserving the fluoride-containing impurities aggregated on the surface and along the intragranular cracks, as illustrated in Fig. 1g.

Furthermore, it was previously widely accepted that the source of F-rich impurities in the spent cathode was due to decomposition of the PVDF binder during the heat delamination process at around 350 °C;<sup>11,23–25,31</sup> however, during the thermal decomposition of PVDF, most the fluoride-containing products were gas species (*i.e.*, HF) and fragments (−CF− and −CH−CF−),<sup>32–34</sup> which are subject to ejection instead of propagating along the cathode intragranular cracks. To confirm the source of those observed residual impurities, four kinds of cathodes with varying cycling conditions were collected and examined, namely cathode laminates with/without electrolyte filling, and laminates from 125k and 250k miles-serviced batteries, as listed in Table S7 (ESI†). The SEM images and electrochemical performance are shown in Fig. S11 and S12 (ESI†). Compared with the pristine one (sample A), the other spent cathodes from battery formation and cycling exhibited a rough surface and limited discharge capacity. Notably, the laminate from formation only but with no cycling (sample B), which it was believed would retain the full lithium inventory and show negligible structural degradation since it had not undergone charge/discharge cycling, showed a poor discharge capacity, which was the same as the other long-cycled ones. Moreover, the heat exfoliation used to pyrolyze the adhesive binders deteriorated the original CEI layer on the spent cathodes and generated more harmful byproducts (*e.g.*, Li<sub>2</sub>CO<sub>3</sub>, Li<sub>3</sub>PO<sub>4</sub>, LiF). This, combined with electrolyte decomposition during electrochemical cycling, exacerbates chemical degradation, resulting in a significant capacity decline. Therefore, the above comparison revealed that the cathode residual impurities should originate from the electrolyte components (such as LiPF<sub>6</sub>, DMC, ethylene carbonate (EC)) decomposition during battery formation, cycling, and common heat exfoliation, leading to severe capacity loss in spent cathodes (Fig. 1d).

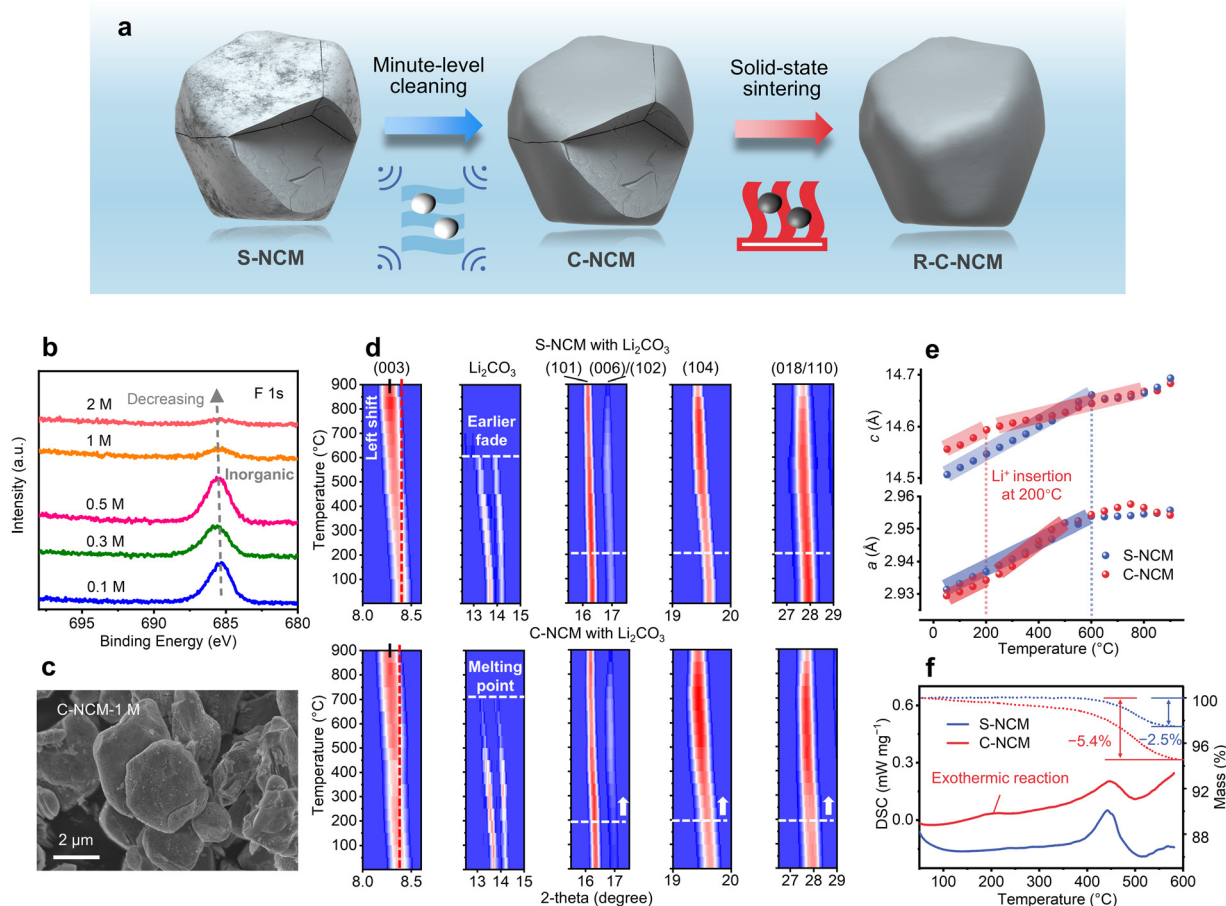
**Fig. 2** Removal of the impurities and change in the crystal structure during the direct regeneration process combined with pretreatment. (a) Traditional direct regeneration path using solid-state sintering and the minute-level pretreatment introduced in an advanced path targeted to the critical obstacles within degraded cathode materials; (b) F 1s XPS fine patterns of C-NCM undergoing ultrasonic stirring in solutions with different concentrations; (c) SEM image of C-NCM obtained by soaking S-NCM in 1 M HNO<sub>3</sub> solution; (d) partial *in situ* XRD patterns of S-NCM and C-NCM mixed with a Li resource, keeping a constant heating rate (20 °C min<sup>−1</sup>) and holding the temperature for diffraction at 50 °C intervals; (e) evolution of the unit cell parameters *a* and *c* for S-NCM (blue symbols) and C-NCM (red symbols) mixed with Li slate through Rietveld refinement. The earlier Li<sup>+</sup> insertion at 200 °C changed the variation tendency of the unit parameters for the sample after cleaning. (f) Heat generation measured by DSC from mixtures.

To reveal the effect of the residuals during the direct regeneration of the recycled cathode, *in situ* XRD characterizations were compared following the regeneration of S-NCM and C-NCM. During the heating, the unit cell lattice first nearly linearly expanded until there was a differentiation of the expansion ratio caused by the lithium insertion. As shown in Fig. 2d, the shift of the (003) peak of C-NCM was less pronounced than that of S-NCM when heating to 900 °C, indicating its unit cell lattice *c* was not expanded as much as for the S-NCM due to its more efficient lithium insertion. Therefore, more lithium insertion was observed for the C-NCM cathode. Correspondingly, the Li<sub>2</sub>CO<sub>3</sub> in the mixture of S-NCM and C-NCM also performed differently, whereby the Li<sub>2</sub>CO<sub>3</sub> in the

C-NCM cathode was consumed gradually until it disappeared at its melting point around 730 °C, while the Li<sub>2</sub>CO<sub>3</sub> in the S-NCM cathode completely vanished at around only 600 °C, and this earlier consumption of the lithium source may be attributed to the reaction between Li<sub>2</sub>CO<sub>3</sub> and the residual impurities (such as LiF, LiOH, and Li<sub>3</sub>PO<sub>4</sub>) by co-melting, vaporizing, and replenishing in S-NCM.<sup>42</sup> Equivalently, the high angle reflection peak intensity spanning from (006) to (110), representing the layered structure, significantly increased starting from around 200 °C for the C-NCM cathode after the purifying treatment compared to there being no obvious enhancement for S-NCM, indicating the better repair of the layered structure during heating. To further unveil the underlying mechanism, Rietveld refinement of each XRD pattern was conducted, which can depict the continuous change of the unit cell parameters during regeneration. Generally, the unit cell parameter *c* decreases and *a* increases with the insertion of Li ions into a layered structure, similar to in the discharge process.<sup>28</sup> As shown in Fig. 2e, the lattice evolution of the S- and C-NCM

cathodes were compared. For C-NCM, the lattice  $c$  expansion slope became obviously flatter at 200 °C, denoting a lattice  $c$  shrinkage at this temperature induced by the Li-ion insertion and repairing. However, for the S-NCM without undergoing purifying treatment for the residuals, the lattice expanded still nearly linearly with no obvious lithium insertion until 600 °C. Concurrently, the lattice  $a$  expansion slope became steeper at 200 °C for C-NCM. Last but not least, Differential scanning calorimetry (DSC) characterization was also conducted during the regeneration process to confirm the lithium insertion pattern for the S- and C-NCM cathodes, which can trace the lithium replenishment associated with the exothermic reaction as reported by others.<sup>43</sup> As shown in Fig. 2f, the characteristic exothermic reaction at around 200 °C was only observed for C-NCM, confirmed the earlier lithium insertion after the purifying treatment. The earlier lithium insertion was also supported by the CO<sub>2</sub> gas release observed during Li<sub>2</sub>CO<sub>3</sub> decomposition to supply the lithium source for the C-NCM cathode, as shown Fig. S23 (ESI<sup>†</sup>). Moreover, from the thermogravimetric results

shown in Fig. 2f, the weight loss of C-NCM was 5.4%, which was significantly larger than that of S-NCM of 2.5%, indicating that more Li<sub>2</sub>CO<sub>3</sub> was activated and decomposed to provide the lithium source for C-NCM.<sup>43,44</sup> To sum up, through multiple *in situ* and *ex situ* characterizations, we proved that, with a purifying pretreatment, the direct regeneration could be facilitated to start at a lower temperature of 200 °C from the spent cathode.

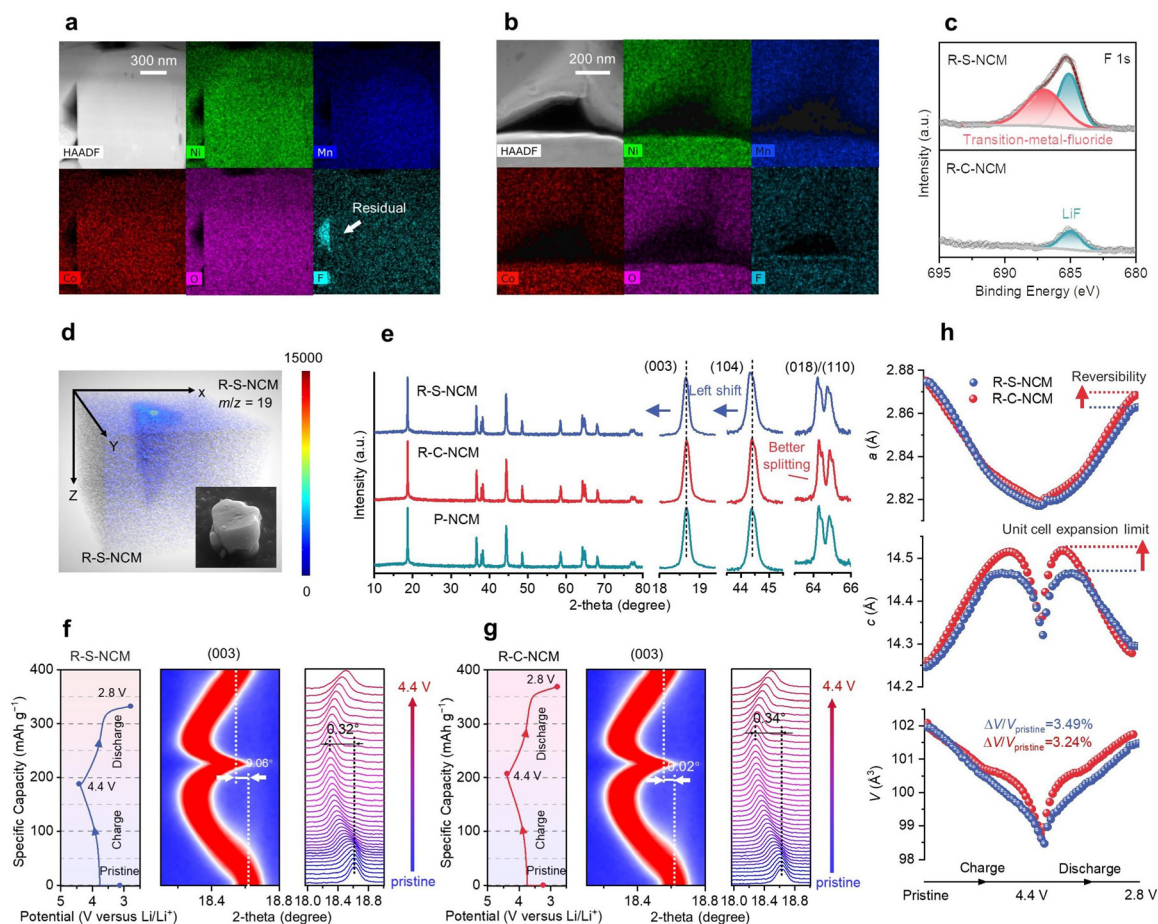
**Fig. 3** Chemical and structural details of the regenerated cathode materials under the influence of impurities. (a) HAADF-STEM images and (b) corresponding EDS element mappings of R-S-NCM and R-C-NCM particles, focusing on the pores of the packing particles. (c) F 1s XPS high-resolution patterns of R-S-NCM and R-C-NCM powders. (d) Pseudo-three-dimensional distribution of F element and SEM image of the corresponding R-S-NCM particle. (e) Full patterns and characteristic peak comparison of the regenerated and pristine NCM cathodes with Cu K $\alpha$  radiation at a scan rate of 8° min<sup>-1</sup>. (f) 1st charge-discharge curves, corresponding XRD patterns of R-S-NCM, and (g) (003) peak position variation when the cell charge from pristine to 4.4 V and comparison with R-C-NCM. (h) Lattice parameters  $a$ ,  $c$ , and the unit cell volume  $V$  of R-S-NCM and R-C-NCM in the 1st charge-discharge test according to the refinement.

Furthermore, the crystal structure of the regenerated cathode could also be affected by the residual impurities. As shown in Fig. 3e and Fig. S28 (ESI†), the XRD pattern indicated a layered structure with no impurities phase for both the R-S-NCM and R-C-NCM cathodes. However, the R-C-NCM cathode had a higher (003)/(104) intensity ratio and larger splitting degree for the (018)/(110) peaks compared to R-S-NCM, suggesting its more ideal layered structure similar to P-NCM cathodes. After regeneration accompanied by impurities, the diffraction peaks of R-S-NCM were shifted toward a low-angle direction, indicating the lattice expansion, as supported by the refined parameters (Table S11, ESI†) and *in situ* experiments (Fig. 2d). Furthermore, *in situ* XRD was performed during the 1st charge/discharge process for both regenerated cathodes (see Fig. 3f and g). The R-C-NCM cathode showed a higher capacity with a smaller offset (0.02°) of the (003) peak position than the

57.5% for R-S-NCM, indicating the R-C-NCM cathode had better cycling stability, even compared to the pristine one. As for the rate performance, the R-C-NCM cathode demonstrated a better high-rate capability (Fig. 4c and Fig. S30, ESI†) at 3C ( $127.8 \text{ mA h g}^{-1}$ ) compared to R-S-NCM ( $69.8 \text{ mA h g}^{-1}$ ) and P-NCM ( $108.9 \text{ mA h g}^{-1}$ ), which was commonly observed on the regenerated NCM cathodes and may be attributed to appropriate F element doping.<sup>12,47</sup> The plateau at  $\sim 3.6 \text{ V}$  in the voltage profiles (Fig. 4d and e and Fig. S30, ESI†) for R-S-NCM nearly disappears after 100 cycles, suggesting that R-S-NCM had a rising polarization after long-term cycling. Based on the cyclic voltammetry curves at different scan rates and calculations (Fig. S31 and Table S12, ESI†), the fitting line slope for R-S-NCM was found to be the lowest among all the samples. According to the equivalent circuit (Fig. 4f), the calculated impedance values ( $R_{\text{ohm}}$ ,  $R_{\text{int}}$ , and  $R_{\text{ct}}$ ) of R-C-NCM (Fig. 4g and h) were 1.4, 51.1, and  $307.1 \Omega$ , respectively, and were smaller than that of R-S-NCM. These results indicate the deteriorated kinetics of  $\text{Li}^+$  transportation due to the residual impurities, especially on the surfaces of the regenerated cathodes. According to the chemical state of the electrode surface (Fig. S32, ESI†), R-C-NCM exposed less inorganic fluoride and more lattice oxide, leading to the suppressed interfacial resistance growing during the long-term cycling. Furthermore, the galvanostatic intermittent titration technique (GITT) test also revealed the kinetic characteristics of the solid phase. The current pulse profile and calculated Li-ion diffusion coefficient ( $D_{\text{Li}^+}$ ) after activation are shown in Fig. 4i. The average  $D_{\text{Li}^+}$  values of R-C-NCM and R-S-NCM were calculated to be  $5.78 \times 10^{-14}$  and  $2.99 \times 10^{-14}$  for the charge process (and  $4.56 \times 10^{-14}$  and  $4.29 \times 10^{-14}$  for the discharge process), suggesting that residual impurities penetrating the interior bulk after regeneration hamper  $\text{Li}^+$  hopping within the lattice of the NCM cathode, as supported by the observed F element (Fig. 3c and Fig. S27, ESI†).

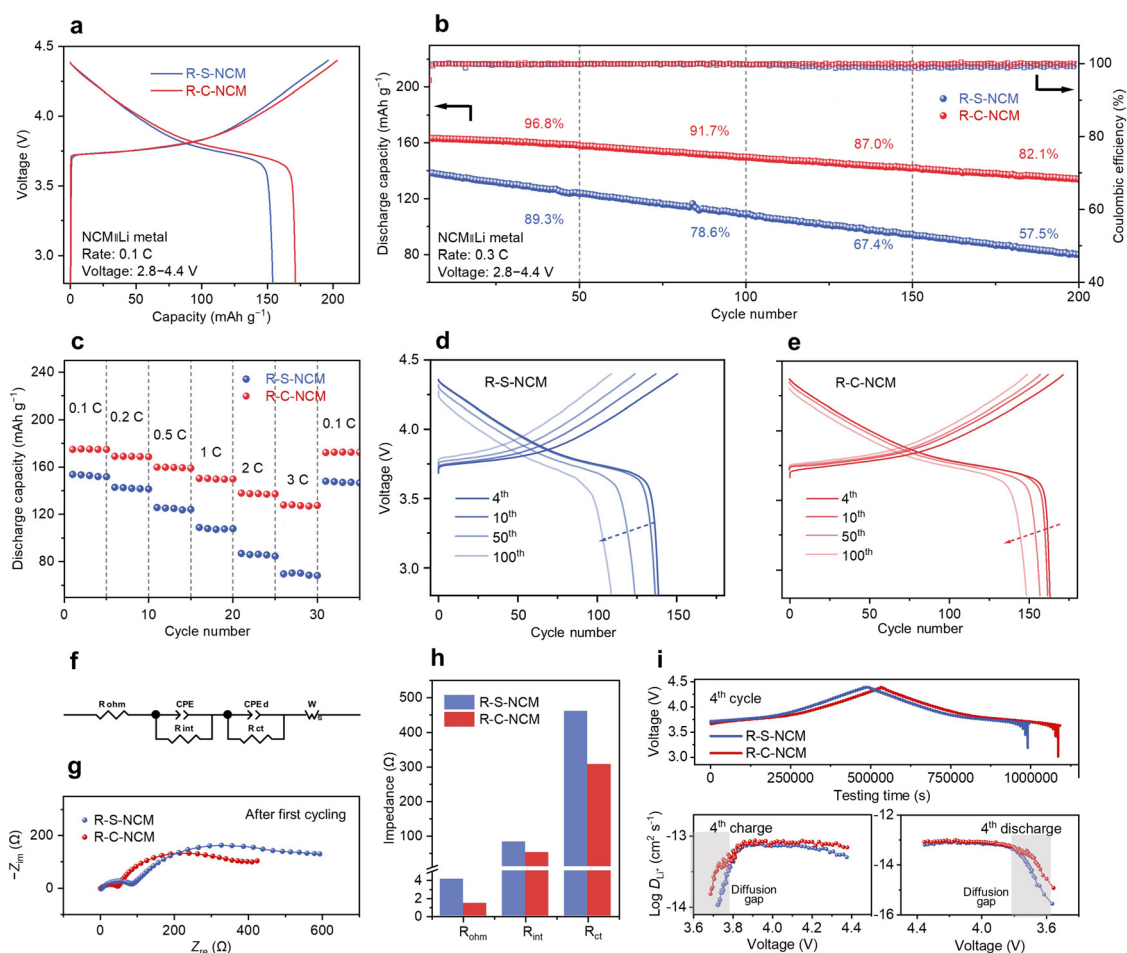
**Fig. 4** Electrochemical deterioration for the regenerated NCM cathodes with impurity residue. (a) Initial galvanostatic charge–discharge curves of R-S-NCM and R-C-NCM at 0.1C (1C = 150 mA h g<sup>−1</sup>) and (b) long cycling test and capacity retention in a half-cell. (c) Rate capabilities of R-S-NCM and R-C-NCM. Charge–discharge curves of (d) R-S-NCM, (e) R-C-NCM in the voltage range of 2.8–4.4 V (vs. Li/Li<sup>+</sup>) at different cycles. (f) Equivalent circuit applied in the EIS measurements. Nyquist plots of (g) R-S-NCM and R-C-NCM and (h) fitting results showing the Ohmic resistance ( $R_{ohm}$ ), interface resistance ( $R_{int}$ ), and charge-transfer resistance ( $R_{ct}$ ). (i) GITT curves and the calculated  $Li^+$ -diffusion rate of R-S-NCM and R-C-NCM for the 4th cycle number after activation in the same charge–discharge period. The shadow area indicates low  $Li^+$  diffusion in a certain voltage range.

As shown in Fig. 4a and Fig. S30 (ESI<sup>†</sup>), the initial discharge capacity increased from 154.1  $\text{mA h g}^{-1}$  for R-S-NCM to 171.4  $\text{mA h g}^{-1}$  for R-C-NCM after the purifying treatment, although this was slightly lower than for P-NCM. In Fig. 4b and Fig. S31 (ESI<sup>†</sup>), the R-C-NCM cathode exhibit 91.7% and 82.1% capacity retention after 100 cycles and 200 cycles, respectively, compared with 91.6% and 78.3% for P-NCM, and 78.6% and

According to the above results (Fig. 1d, Fig. S6, S16 (ESI†), and Fig. 4h, i), the migration rate of lithium ions was significantly influenced by the residual impurities; therefore it was crucial to theoretically investigate their influence on capacity delivery in the reuse case and during direct regeneration. Considering the impurities were mostly concentrated at the surface before and after regeneration, and that F-rich residuals could be observed, as shown in Fig. S9 and S10 (ESI†) and Fig. 3c, we chose three representative inorganic components ( $\text{LiF}$ ,  $\text{Li}_2\text{CO}_3$ , and  $\text{LiOH}$ ) in the CEI layer<sup>48</sup> or residual alkali<sup>49</sup> to calculate the  $\text{Li}^+$  diffusion from a thermodynamic perspective, and their structures are shown in Fig. 5a. By maintaining a similar distance and concentration of mobile Li-ions, the diffusion energy barrier of lithium ions ( $\Delta E_{\text{Li}^+}$ ) during the cycling of spent cathodes within the different crystal structures (Fig. 5b) allowed valid comparisons. We found that the  $\Delta E_{\text{Li}^+}$  of the  $\text{LiF}$  phase, as a common inorganic component from CEI, was about 2 and 3 times higher than that of the  $\text{LiOH}$  and  $\text{Li}_2\text{CO}_3$  phases from

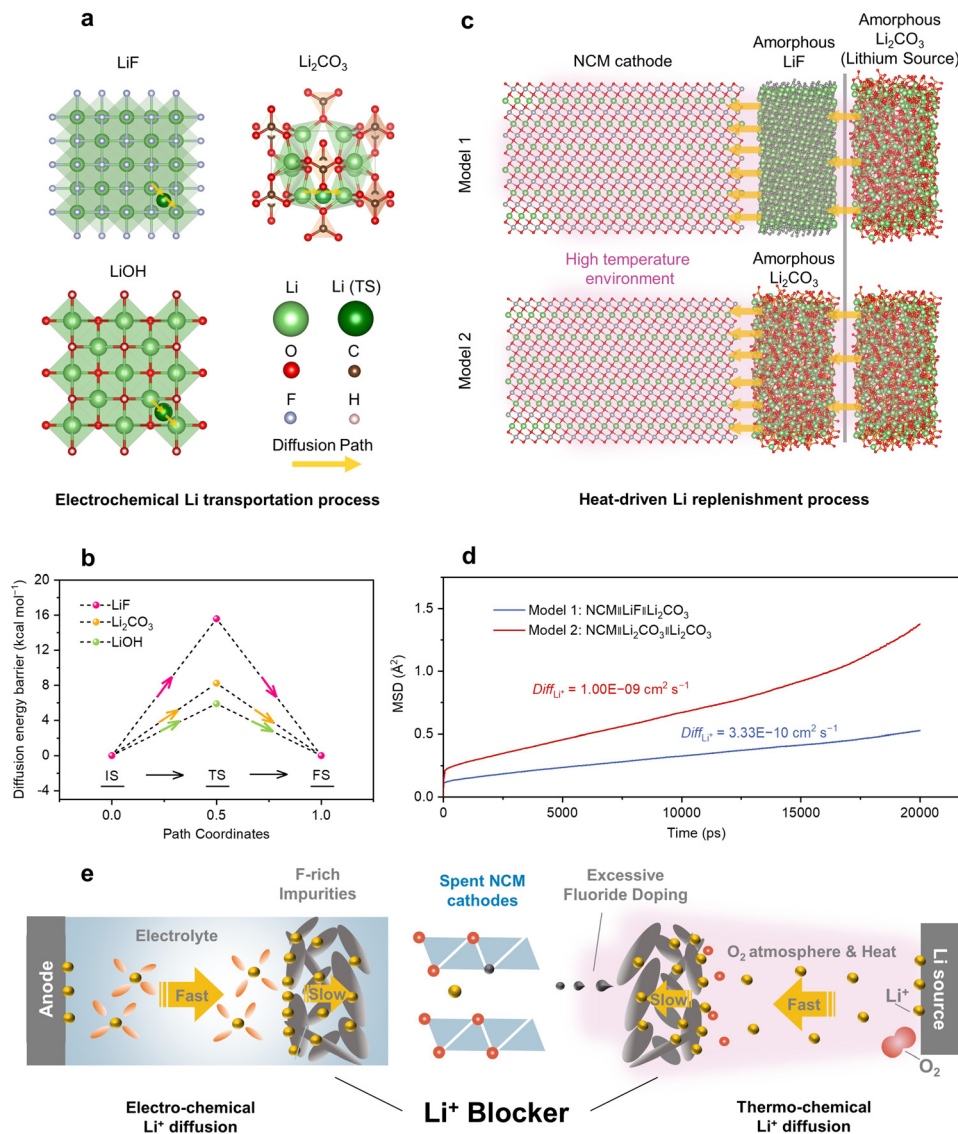
**Fig. 5** Role of the F-rich impurities as a blocker in electrochemical and thermochemical  $\text{Li}^+$  diffusion as ascertained from thermodynamic and kinetic simulations. (a) Illustrations of the selected migration pathways with a similar distance for  $\text{Li}^+$  inside the crystal lattice of three common components. The initial state, transition state, and final state of  $\text{Li}^+$  transportation are denoted as IS, TS, and FS, respectively. (b) Calculated energy diffusion barrier for Li ions in selected phases. (c) Two models for stimulating the kinetics of Li transportation in direct regeneration. Model 1 consists of the NCM cathode substrate, the amorphous LiF layer, and  $\text{Li}_2\text{CO}_3$  as a lithium source in direct regeneration, which is denoted as NCM||LiF|| $\text{Li}_2\text{CO}_3$ . In Model 2 (NCM|| $\text{Li}_2\text{CO}_3$ || $\text{Li}_2\text{CO}_3$  in short), the middle LiF layer is replaced by a common residual alkali ( $\text{Li}_2\text{CO}_3$ ), which is used to simulate the regeneration of NCM cathodes after cleaning pretreatment. Each shape symbol is the same as for Fig. 5a. (d) MSD of the Li atoms in 20 ns and calculated  $\text{Li}^+$  diffusivity based on the above model. "E – 9" means  $10^{-9}$ . (e) Mechanism diagram for preventing the NCM cathodes from reusing and directly regenerating under the influence of impurities.

Fig. 5b. Therefore, this result confirmed that the presence of fluoride-rich impurity residuals on the cathode surface significantly increased the diffusion resistance of Li ions when cycling, ultimately exacerbating the cell impedance and interfacial parasitic reactions (Fig. 1d). To comprehend the larger-scale kinetic characteristics and understand the effect of impurity coatings during heating for regeneration of the spent cathodes, two molecular dynamics models were established for simulating  $\text{Li}^+$  transportation at 1000 K over 20 ns. Specifically, Model 1 was devised to include an impurity barrier consisting of a  $\text{LiF}$  layer (Fig. 5c and Fig. S33, ESI†). Through computing the mean square displacement (MSD) of Li atoms and fitting curves (Fig. 5d), we determined that the Li diffusivity ( $\text{Diff}_{\text{Li}^+}$ ) of Model 1 was  $3.33 \times 10^{-10}$ , which was an order of magnitude lower than that of Model 2 ( $1.00 \times 10^{-9}$ ). The differences in molecular dynamics models under practical conditions suggest that fluoride-rich impurity coatings increase the resistance to Li-ion diffusion into spent cathodes with Li deficiencies during thermo-driven regeneration, leading to inadequate compositional and structural recovery.

As illustrated in Fig. 5e, the impurity phase containing the F element served as an electro- and thermo-diffusion blocker of Li ions hindering the reuse and direct regeneration of the spent cathode. In the spent cathodes collected by physical pretreatment and collection from used lithium-ion batteries, the ubiquitous electrolyte was decomposed to form an ion barrier with slow ion diffusivity. However, these impurities have long been overlooked in most studies (Table S2, ESI†), mainly due to the use of lab-scale degraded cathodes and fine manual separation pretreatment. In previous studies,<sup>12–16,42</sup> the latent impact of the residual impurities on direct regeneration remains untouched because impurities are easily converted into other inconspicuous matter in extreme physical or chemical regeneration environments. Looking ahead, the direct regeneration of next-generation sensitive cathode materials, such as Li-rich Mn-based, Co-free, and ultra-high-Ni cathode materials, faces serious challenges from these latent impurities if they enter the recycling circle. From another perspective, establishing the controlling law for the inherent impurities doping within the closed-loop material flow could instructively enhance the performance of such recycled materials in the future. Moreover, only by revealing the effect of the overlooked impurities or by getting rid of impurities, can evolving technologies and mechanisms for direct regeneration and upcycling be reasonably evaluated.<sup>50</sup>
