# Combined crystallographic study of king scallop (*Pecten maximus*) shells using SEM, EBSD and Raman spectroscopy

Lise Guichaoua,<sup>a</sup> Natalie Reznikov,<sup>b</sup> Bryce D. Stewart,<sup>c</sup> Roland Kröger<sup>e</sup> and Raynald Gauvin<sup>a</sup>

DOI: 10.1039/d5fd00029g

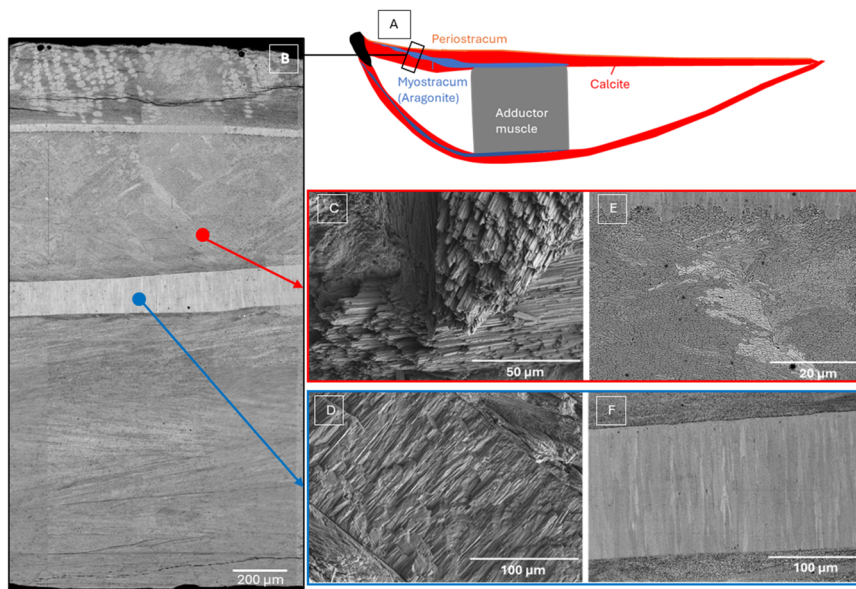
**Fig. 1** (A) Schematic longitudinal section of a king scallop (*Pecten maximus*) shell, both valves. Of the organic parts only the adductor muscle is indicated showing its attachment to the shell via an aragonitic calcium carbonate layer. (B) Backscattered electrons stitched SEM images of a king scallop sample from a non-contaminated area after surface polishing. SEM images of king scallop in calcite (red) area: (C) secondary electron image of calcite foliated grains on laser cut surface and (E) backscattered electron image of calcite foliated grain after surface polishing. SEM images of king scallop myostracum aragonite prismatic layer (blue) area: (D) secondary electron image of myostracum layer on laser cut surface and (F) backscattered electron image of myostracum layer after surface polishing.

The soft tissues are attached to the shells *via* the myostracum layer (also known as the adductor muscle scar, see Fig. 1(A)), which bears tremendous contractile force and is crucial for the survival of molluscs.<sup>4</sup> Previous studies have shown that this myostracum layer is generally composed of prismatic aragonite.<sup>5</sup> However, to date, there are very few studies on the myostracum of king scallops *Pecten maximus* and its structural role for the bivalve including its impact on the fracture toughness.

Fig. 1 illustrates the scanning electron microscope (SEM) images of the cross-sectional surface of a king scallop sample from a non-contaminated area, as previously reported.<sup>11,12</sup> Fig. 1(B) displays a secondary electron SEM image of sample's section after polishing, revealing the general distribution of calcite and myostracum aragonite layers in king scallop shell from a non-contaminated site. Fig. 1(C) and (E) highlight the well-oriented, foliated calcite with sharp, thin laths with asymmetrical triangular endings, arranged in parallel clusters, while Fig. 1(D) shows the myostracum aragonite layer after Er:YAG dental laser cut with clearly oriented prismatic grains. Fig. 1(F) presents the same section after polishing, where the myostracum exhibits clearly elongated grains, with visible backscattered electron (BSE) channeling contrast indicative of the high crystallinity of the aragonite phase.

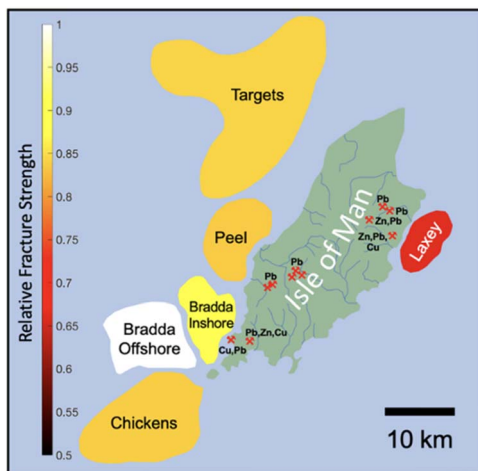
Fig. 2 Map of the relative mean fracture strength observed for *Pecten maximus* around the Isle of Man with the value for Bradda Offshore used to normalize the values for all other sites. Shells were collected from six sites around the Isle of Man in 2004. The color code indicates the value for the relative fracture strength. Laxey is the contaminated site, all the others are controls ( $n = 20$  per site, 120 in total). The value for the Laxey site is 0.66 whereas the values for the other sites are all above 0.83. Red symbols assign major historical mining sites for zinc, lead and copper ores with the order of importance indicated by their sequence position.<sup>10</sup>

The samples were collected in the coastal waters around the Isle of Man, located in the northern Irish Sea. Details of the scallop population selection are provided in previous studies.<sup>9,10</sup> Fig. 2 presents a map of the relative mean fracture strength observed for king scallops (*Pecten maximus*) around the Isle of Man, based on the collection site. Low fracture strength was observed in shells collected in the Laxey area, which is the closest to numerous previous metal ore mines and had the most highly contaminated sediment among sample sites. This provided us with an ideal opportunity to directly compare scallop populations from this contaminated site with those from sites with higher fracture strength/lower contamination levels, specifically the Bradda area. All other known environmental parameters, including water temperature, salinity, and nutrients, remained similar across the sites.

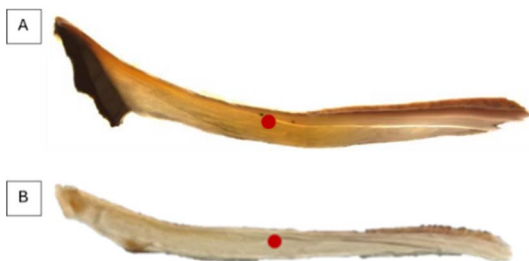
Fig. 3 (A) Scallop sample from non-contaminated Bradda area and (B) scallop sample from metal contaminated Laxey area, longitudinal section view. The region of interest is marked with a red circle.

one from Laxey, the contaminated site). The shells were cut using a diamond cut-off wheel (South Bay Technology Low Speed Diamond Wheel Saw MODEL 650) longitudinally (Fig. 3). The sectioned sample was then hand polished with lapping pads to a felt disk with a 50 nm colloidal silica suspension, to obtain a perfectly flat surface for future SEM observations and EBSD analysis. A 10 nm layer of carbon coating was necessary for conductivity. No etching process was applied.

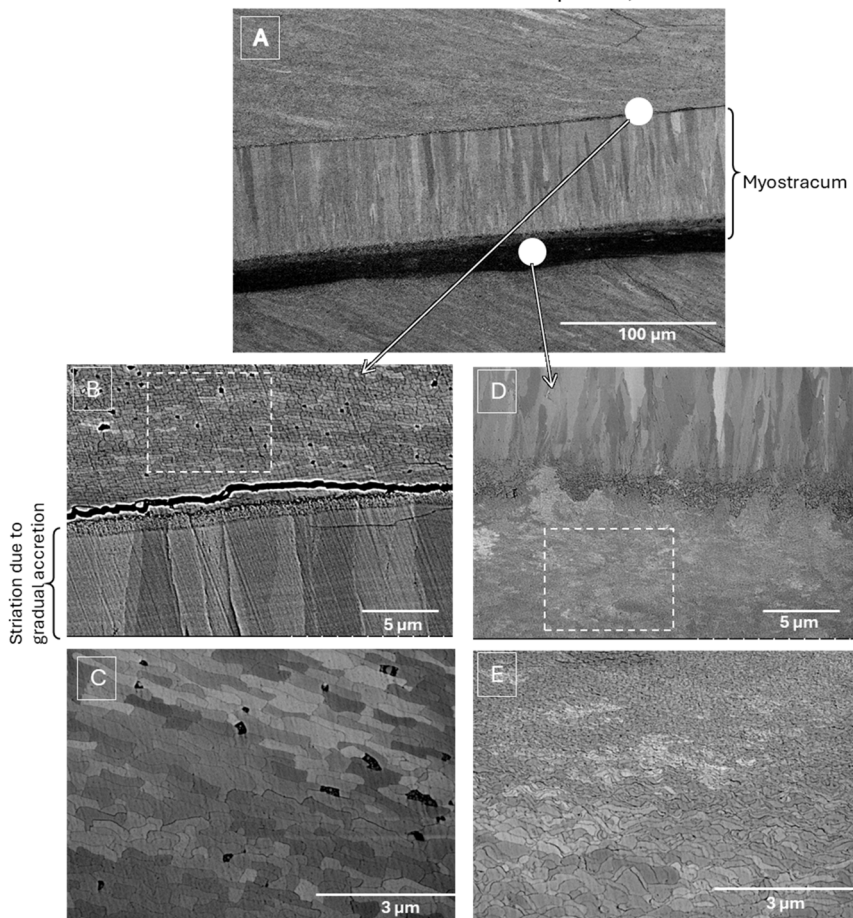
Non-contaminated site scallop shell, *Bradda*

Fig. 4 BSE micrographs of the myostracum region for the scallop shell collected in the non-contaminated Bradda area. (A) A general view of the region of interest. (B) The upper boundaries between the myostracum and the shell bulk. (C) The microstructures of the scallop in the region at the top of the myostracum. (D) The lower boundaries between the myostracum and the shell bulk. (E) The microstructures of the shell in the region below the myostracum.

Fig. 4(A) and 5(A) display an overall microstructural organization for the longitudinal section around the myostracum region of scallop shells respectively from non-contaminated and contaminated sites. These backscattered electron images show channeling contrast and provide an overview of crystal orientation variations, particularly within the myostracum, which is, in both types of scallops, clearly visible and sandwiched between two foliated calcite areas. This allows us

First, it is observed that the overall organization was similar for both types of scallops. Focusing on the myostracum, it consists of elongated, oriented grains. However, the grains in the lower part of both myostracum layers are notably fine and small. These grains gradually increase in both length and width towards the upper part of the myostracum, while maintaining a consistent growth orientation, resulting in a clear size gradient. Despite this similarity between the two types of shells, a noticeable difference in morphology and distribution is observed. The grains in the myostracum within the shell from the non-contaminated site appear more elongated and regularly arranged.

Examining the calcitic regions surrounding the myostracum reveals notable differences in microstructure. Fig. 4(B), (C), 5(B) and (C) provide a closer view of the region above the myostracum. In both shell types, the shape and grain distribution are uniform and consistent in size (around 1 micron in size). The boundary between the aragonite myostracum and the calcitic bulk is clearly defined, with homogeneous grains in the upper calcitic region, contrasting with the larger, elongated grains of the upper myostracum. The contrast variations between the grains are due to slight differences in their relative orientations, due to the BSE channeling contrast.

The boundary between the two microstructures in the lower myostracum appears less distinct as can be observed in Fig. 4(D) and 5(D). Again, there is little

Near the myostracum, the calcite grains are nanocrystalline (see Fig. 4(E) and 5(E)) and a size gradient is observed as the distance from the myostracum increases. In the shell from contaminated site, this gradient extends over a larger

Furthermore, growth lines can be identified in the Raman maps associated with the accretion sequence during the myostracum formation. These growth lines are also visible in the SEM image of samples from both contaminated and non-contaminated sites and are shown in Fig. 4(B) and 5(B).

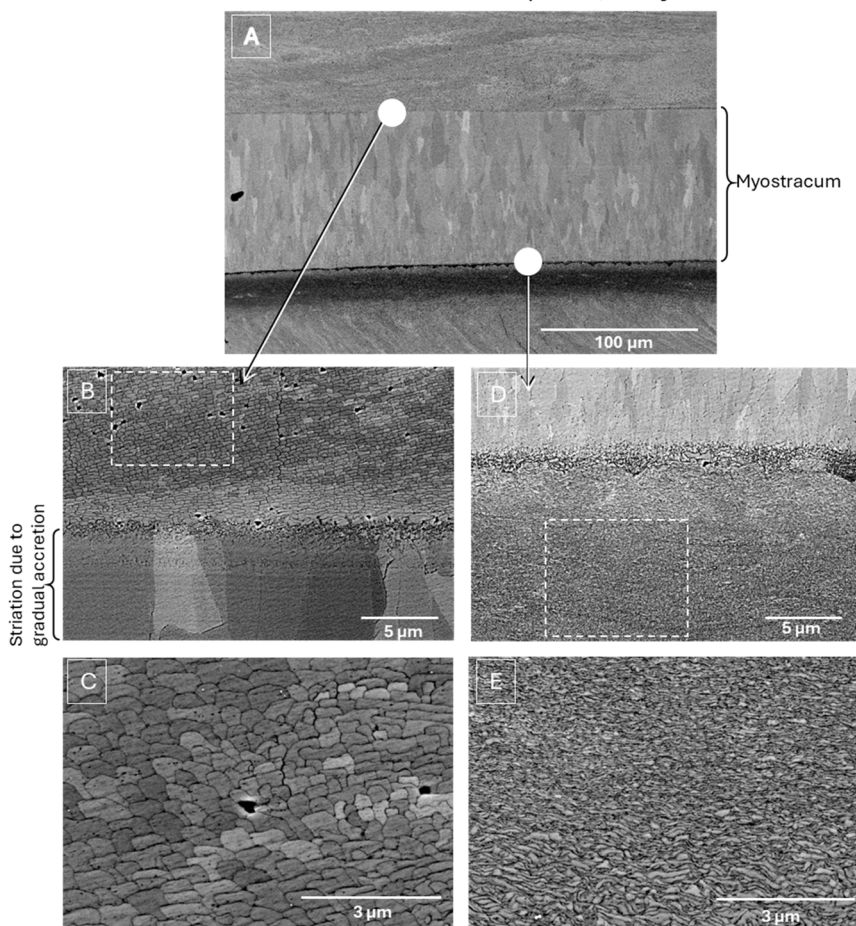
Contaminated site scallop shell, *Laxey*

Fig. 5 BSE micrographs of the myostracum region for the scallop shell collected in the contaminated Laxey area. (A) A general view of the region of interest. (B) The upper boundaries between the myostracum and the shell bulk. (C) The microstructures of the scallop in the region at the top of the myostracum. (D) The lower boundaries between the myostracum and the shell bulk. (E) The microstructures of the shell in the region below the myostracum.

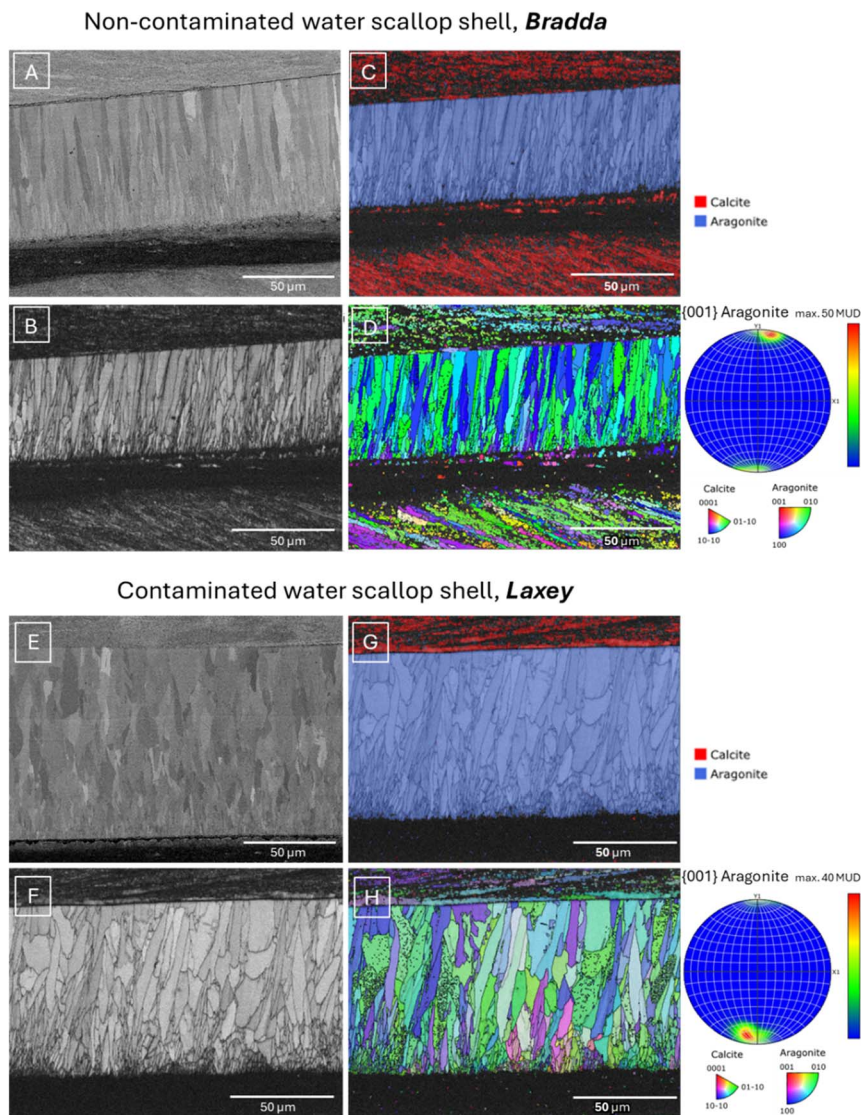
**Fig. 6** (A) BSE image, (B) EBSD band contrast map, (C) EBSD phase map (D) IPF colored map and pole figure obtained on the myostracum region for the non-contaminated case. (E) BSE image, (F) EBSD band contrast map, (G) EBSD phase map (H) IPF colored map and pole figure obtained on the myostracum region for the shell from the contaminated site.

Following the SEM analysis, we performed EBSD analysis on an adjacent area, on the myostracum region. The EBSD maps presented in Fig. 6 provide the results obtained for both types of shell and give information on the crystallography of each shell section.

First, we can see on the phase map, in Fig. 6(C) and (G) that, in both cases, the well-oriented and crystallized myostracum layer is clearly composed of well-crystallized aragonite, surrounded by the calcite phase on top and a poorly indexed phase at the bottom. Thanks to the SEM images in Fig. 4(E) and 5(E), it was observed that the calcite grains beneath the myostracum are very fine. The extremely small size of these grains may partly explain the absence of EBSD detection in this region. However, calcite islands are detected at the lower boundary of the myostracum in the non-contamination affected shell, which are not observed in the contaminated shell, suggesting larger or better-crystallized calcite grains.

The EBSD orientation maps, presented in Fig. 6(D) and (H), focusing on the aragonite myostracum and accompanied by the pole figure, confirm the preferential orientation of the aragonite grains. When an oriented texture is present, pole figures reveal a cylindrical 'cluster' distribution. For both contaminated and non-contaminated sites scallop samples, we observe a concentration point with a nearly circular shape, indicating a clear, oriented texture of grains. A higher multiple uniform density (MUD) value reflects a stronger co-orientation. As we can see, the MUD value obtained in the myostracum region of the non-contamination affected sample is slightly higher than that of the shell from the contaminated site, revealing a slightly stronger co-orientation compared to the contaminated site sample. However, the difference remains too small to conclude any alteration of the myostracum microstructure due to pollution. The second phase of this project, with a more in-depth study on a selected panel of shells, will aim to obtain more data to validate these observations. Analyses of different areas throughout the entire length of the myostracum in the shells could also be interesting to observe the evolution of the crystallography of the myostracum as the shell grows.

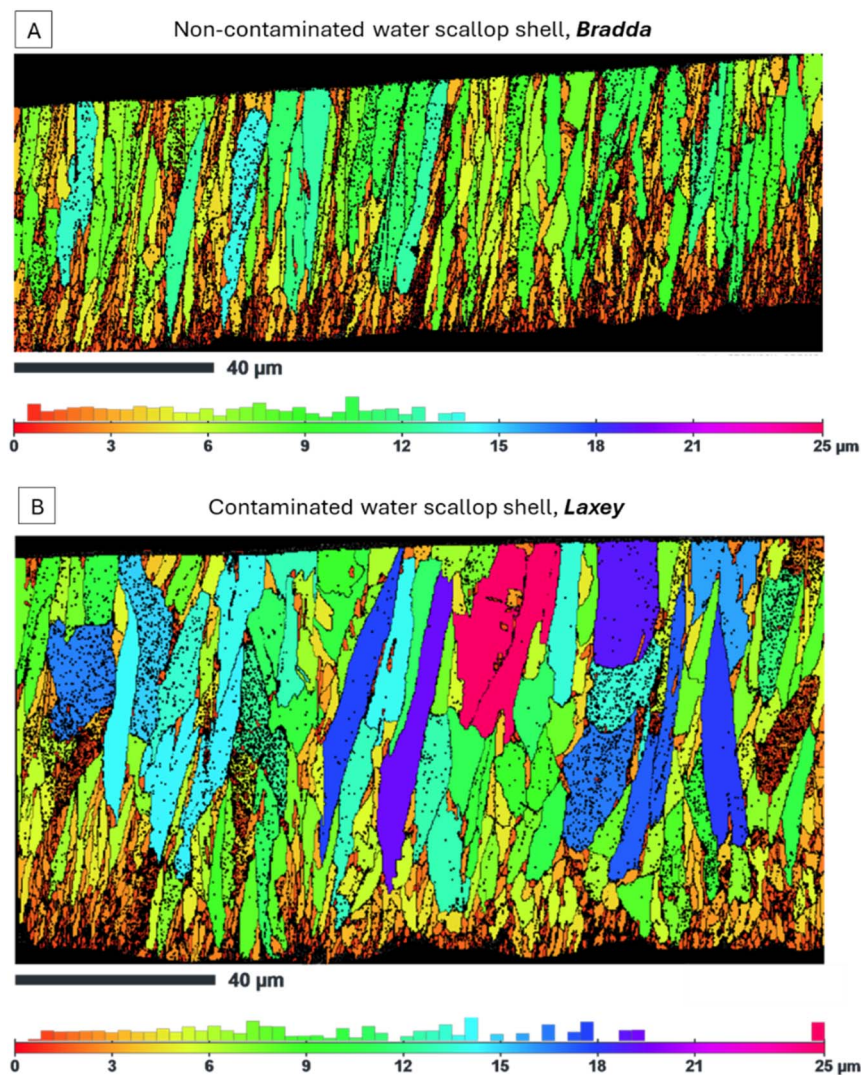
Fig. 7 EBSD grains maps with a color scale according to grain size (longest dimension) in the myostracum.

Additionally, EBSD analysis allows us to detect orientation variations, which helps determine the size of orientation domains or the grain size when grain boundaries are identified (non-indexed grain boundaries). Fig. 7 presents EBSD maps of the grain size distribution in the myostracum, for both shell types, with a colored scale corresponding to the grain longest dimension providing a quantitative analysis of the variation in grain size within the myostracum. The size variation is clearly visible, indicating submicron grain-sizes at the lower interface (red orange) which rapidly increase in size towards the upper interface.

The lower boundary is distinctly composed of small grains, which could reflect the early stages of growth since it is observable in both shells. The shell from the contaminated site, however, appears to have a broader grain distribution.

To obtain a more representative grain size distribution, it would be necessary to measure the grain sizes over a larger area to ensure a sufficient number of grains are sampled. However, even with the current map, it is already evident that the regular elongated shape observed in the non-contaminated site shell does not appear as consistently regular in the contaminated counterpart. In fact, surprisingly large grains can be observed (note turquoise, purple and magenta in Fig. 7(B)).

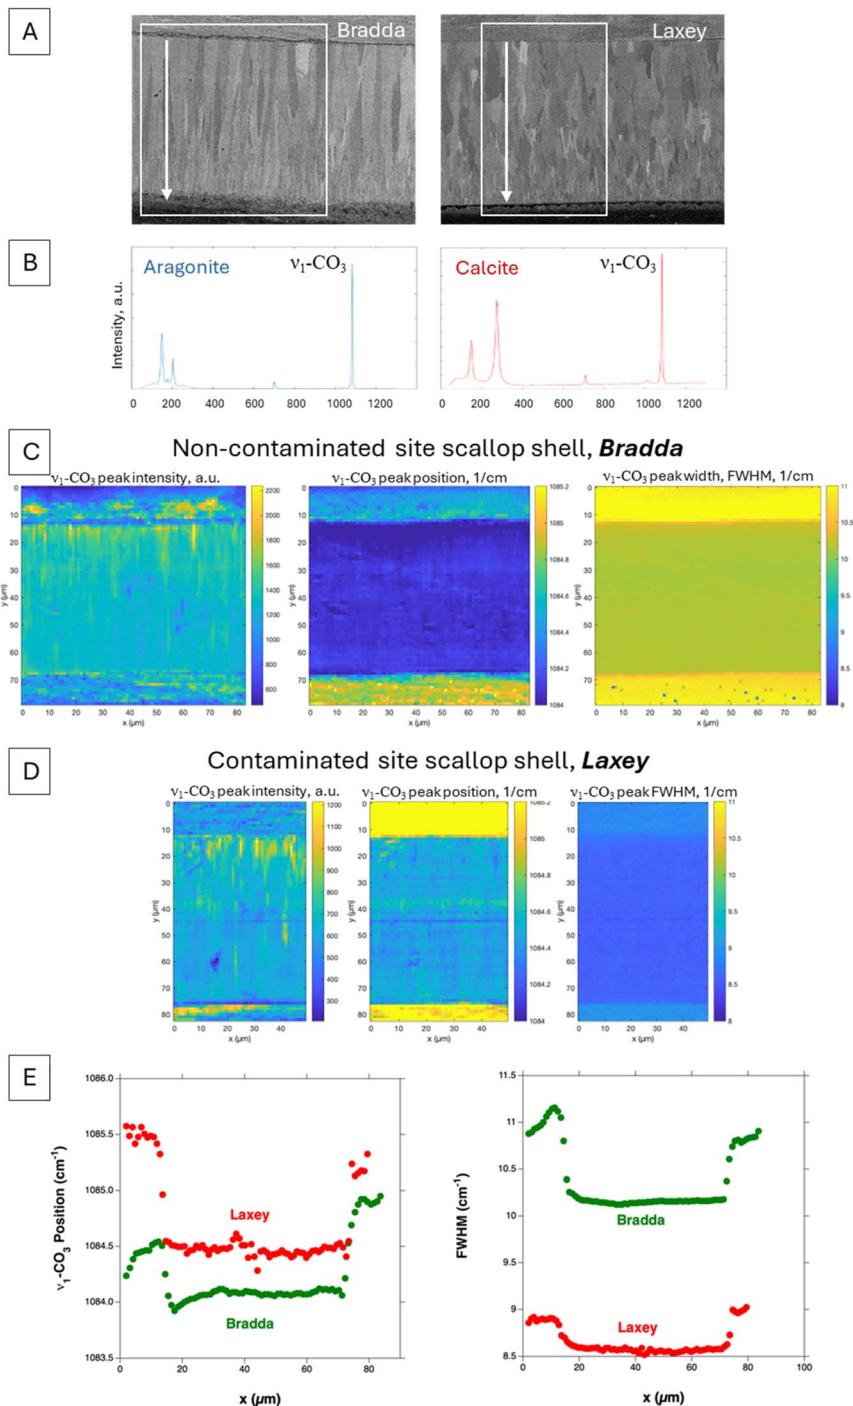
**Fig. 8** (A) BSE images of a sample from non-contaminated (Bradda) and contaminated (Laxey) sites; (B) Raman spectra taken from the myostracum and foliated regions of the Bradda sample, (C)  $\nu_1$ -CO<sub>3</sub> Raman maps evaluating peak intensity, position and full width at half maximum of the Bradda and (D) and Laxey samples, (E) comparison of line profiles from top to bottom of the  $\nu_1$ -CO<sub>3</sub> Raman position and full width at half maximum for Bradda and Laxey samples.

The parallel Raman study also revealed differences in response between the regions at the upper and lower boundaries of the myostracum. The results are presented in Fig. 8. Using the  $\nu_1$ -CO<sub>3</sub> symmetric stretching mode for Raman

mapping, we observed, for all analysed samples, systematic shifts in the peak position above, below and across the myostracum, with a difference of  $0.5\text{ cm}^{-1}$  between each. In comparison to the aragonitic myostracum, the top calcite domain is  $0.5\text{ cm}^{-1}$  higher, while the lower domain differs by  $1\text{ cm}^{-1}$ . The peak position in samples from the non-contaminated site is overall shifted to smaller wavelengths. Moreover, the  $\nu_1\text{-CO}_3$  peak width is marginally higher for the non-contaminated site shells than in its contaminated counterpart. This variation in peak position and width may indicate intrinsic crystallite strain or be related to smaller grain sizes. It remains to be determined whether the crystallite size or intrinsic strain contribute to the peak shift and broadening. However, small and pre-strained crystallites have been identified in other mineralized tissues such as dental enamel, dentin, bone, and other bivalve shells indicating that it could be a “toughening” feature, rather than a random occurrence.<sup>21–23</sup>
