## Ongoing legacy contamination from a military radar station in Iceland: a case study

Contamination in and around military radar stations in the Arctic has been an ongoing concern since first identified in the 1980s. This study reports on the environmental impact from a DEW line US military station that was operated on Heiðarfjall mountain in northeast Iceland from 1957 to 1970. This review is conducted as a part of work of the POPs Expert Group of the Arctic Monitoring and Assessment Program (AMAP) for an assessment report on local sources vs. long-range transport of Persistent Organic Pollutants (POPs) in the Arctic. The main resource for this summary is an evaluation of results from several reports on Heiðarfjall Langanes, one from an Icelandic Environmental Authority in 1993 and another from the Canadian Environmental Science Group (ESG) at the Royal Military College of Canada, which was commissioned in 2017 by the owners of the land that was used for the station. The results are compared to findings in scientific papers and reports for contamination at other military radar stations in Canada and Alaska. This review shows considerable contamination on Heiðarfjall over 50 year

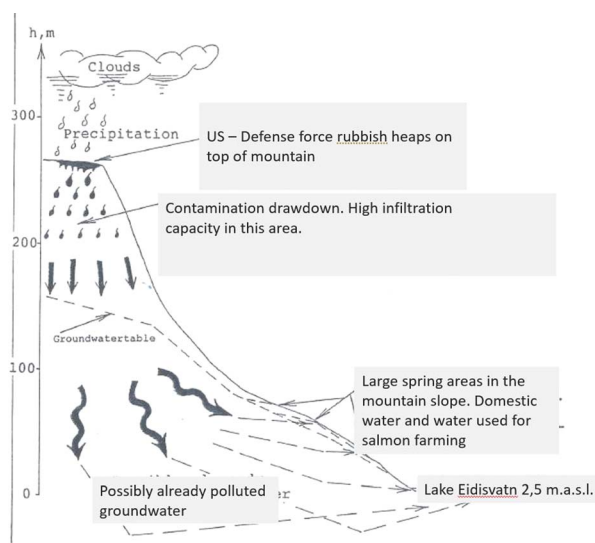
Fig. 2 Transport model of pollution spread at Heiðarfjall.<sup>42</sup>

The engineering consultant's conclusion was that groundwater pollution would mostly spread southwards towards the farm, the estuary lake Eiðisvatn and the sea as shown in Fig. 2. Calculations of the pollution infiltration flow from the top of the mountain indicate that it would take at least 30 years to reach the springs on the south side of the mountain flowing to Eiðisvatn.

and it would take at least another 70 years until it had disappeared, but some dilution could be expected.<sup>42</sup>

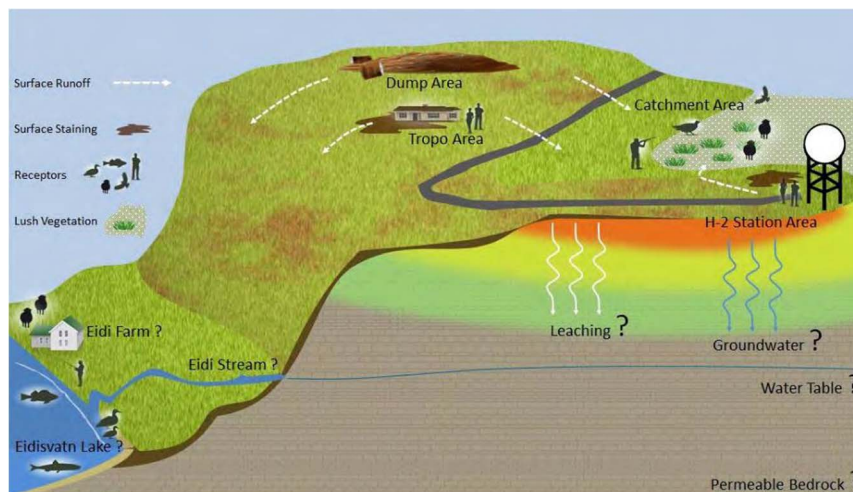
Fig. 3 Schematic picture of Heiðarfjall and the sites investigated by the ESG in 2017.<sup>10</sup> Water source for Eidi farm is at the Eidi stream.

The sites chosen for sampling by the ESG, see Fig. 3, were: (1) the Dump area (*ca.*  $18.000 \text{ m}^2$ ) where debris, both during operating and later during clean-up, had been buried; (2) the Tropo area, with a communication building (still standing), and where two tropospheric communication dishes once stood; (3) the Sewage Outfall area; (4) the POL (petroleum oil and lubricant) Tank area, where a large fuel storage tank used to be situated. Sites 3 and 4 were on the southern edge of the summit area, directly above the Eiði farm; (5) the Garage area; (6) the Barracks area; (7) the Powerhouse area, and (8) Radome area (sites 5, 6, 7, and 8 are all situated at the Station area); (9) the lower-lying Catchment area, where a concrete drainage pipe was observed leading to a small pond; and (10) the Eiði stream area. Fig. 4 shows a recent picture of the Station area.

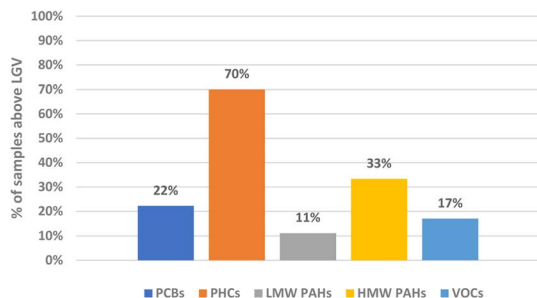
Fig. 5 Non-compliance of POPs with the LGV (lowest guideline value) in samples.<sup>10</sup>

POPs are non-compliant to the lowest guideline value, as shown in Fig. 5, from 11% for low molecular weight PAHs to

70% for PHCs. However, this is not representative as sampling is not evenly distributed and several sites are not tested for some POPs as shown in Table 1.

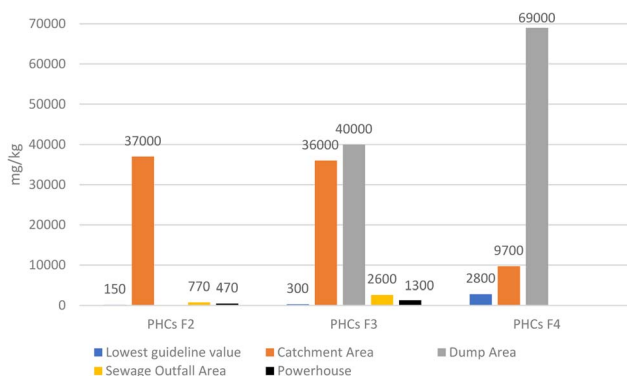
Fig. 6 PHCs (mg kg<sup>-1</sup>) detected above the lowest guideline value for F2, F3 and F4 (150, 300, and 2800, respectively) at four areas. The highest value in each area of the four is shown in the figure.

PHCs, used as fuels and lubricants, consist of a large number of hydrocarbon compounds, some of which can cause severe health issues. The ESG observed considerable remains of oil barrels, some of which were stained black, and some black tar like chunks around the Dump area and around the Powerhouse area. Oil barrels were also observed by the MHR in 1993, as mentioned previously.<sup>43</sup> PHCs are arranged into four categories (F1, F2, F3, F4) depending on the number of carbons, and their volatility decreases and persistence increases in the environment with a rising number of carbons. PHCs in F1 were not detected over the lowest guideline values whereas this was the case with the other three, to varying degrees. PHCs were tested at six areas and detected over the lowest standard at four areas: the Dump, Sewage outfall, Powerhouse and Catchment areas (Table 2 and Fig. 6). The highest concentration of PHCs ranged from 40 000 mg kg<sup>-1</sup> to 69 000 mg kg<sup>-1</sup> at the Dump area and was 9700 to 37 000 mg kg<sup>-1</sup> at the Catchment area. A similar case was at the DEW line site at Utqiagvik in Alaska where areas around the powerhouse site showed significant petroleum-derived contamination as mentioned earlier.<sup>5</sup>
