Cite this: *Environ. Sci.: Water Res. Technol.*, 2021, 7, 274

This study was conducted to determine if the thermal degradation of various plastic drinking water pipes (i.e., PEX, HDPE, PP, PVC, and CPVC) may be a source of drinking water contamination. Widespread volatile organic compound (VOC) contamination was found in water distribution systems following three wildfires in California. A potential source of this contamination was thought to be due to the degradation of plastic components in drinking water distribution systems. Eleven plastic drinking water pipes, across eight brands, were exposed to elevated temperatures (200 °C to 400 °C), and subsequently submerged in water or in *n*-hexane to observe the extent of VOC leaching. Results indicated that thermally damaged drinking water pipes can be sources of VOC leaching, with ten of the eleven materials leaching benzene, a carcinogen, into water. As exposure temperature increased, an increase in VOC leaching was observed in the polyethylene materials. Conversely, in the vinyl materials the significant mass loss associated with high exposure temperature was inversely proportional to the amount of BTEX leaching that was observed

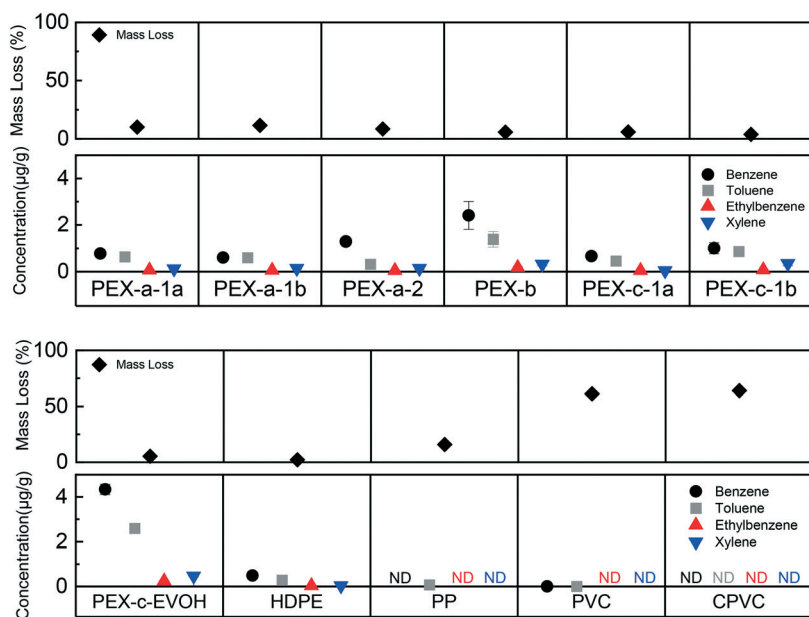
Fig. 2 Average amount of benzene, toluene, ethylbenzene, and xylene leaching observed after burning each material at 400 °C and extracting in water for 7 days. The error bars reflect the standard deviation of the measurements ( $n = 3$ ). If no error bars are visible, this indicates the error bars are smaller than the symbol size. ND indicates the compound was not detected above the MDL.

Results showed that plastic pipe thermal exposure can generate BTEX, which can then leach from cooled plastics into water. BTEX was not found from new and non-thermally degraded plastics in water, while 10 of 11 thermally degraded plastic pipes leached at least one BTEX component (Fig. 2). The chemical leaching differences between products is likely attributed to differences between plastic characteristics and experimental conditions. PE materials lost less mass due to isothermal heating (5 wt% to 10 wt%) compared to the PVC and CPVC samples (61 wt% and 64 wt%, respectively) (Fig. 2). A detectable, but significantly lower amount of benzene and toluene was observed for the PVC pipe, and no BTEX was found for the CPVC pipe (Fig. 2). Additionally, there was a general trend of compound concentration leaching across the plastics where benzene > toluene > ethylbenzene ≈ xylene (Fig. 2). This trend could be attributed to several factors including compound production, water solubility, air volatilization, polymer solubility parameters, and/or partitioning into the aqueous phase. Octanol-water coefficients and solubility values mirror the trend of concentrations observed (Table S4†), indicating that benzene would most readily partition into the aqueous phase.

Little to no BTEX was found for the PP pipe, which has a similar structure to HDPE. The onset degradation temperature of the PP pipe (416 °C) was lower than that of the HDPE and PEX materials (Table 1), and unsurprisingly, the PP had more mass loss (~15 wt%) (Fig. 2) at the same temperature. In previous PP studies, benzene has been found in the air after pyrolysis between 300 °C to 600 °C.<sup>53,54</sup> No prior studies were found that examined BTEX release into water from thermally damaged PP materials.
