Cite this: *Environ. Sci.: Water Res. Technol.*, 2021, 7, 274

This study was conducted to determine if the thermal degradation of various plastic drinking water pipes (i.e., PEX, HDPE, PP, PVC, and CPVC) may be a source of drinking water contamination. Widespread volatile organic compound (VOC) contamination was found in water distribution systems following three wildfires in California. A potential source of this contamination was thought to be due to the degradation of plastic components in drinking water distribution systems. Eleven plastic drinking water pipes, across eight brands, were exposed to elevated temperatures (200 °C to 400 °C), and subsequently submerged in water or in *n*-hexane to observe the extent of VOC leaching. Results indicated that thermally damaged drinking water pipes can be sources of VOC leaching, with ten of the eleven materials leaching benzene, a carcinogen, into water. As exposure temperature increased, an increase in VOC leaching was observed in the polyethylene materials. Conversely, in the vinyl materials the significant mass loss associated with high exposure temperature was inversely proportional to the amount of BTEX leaching that was observed

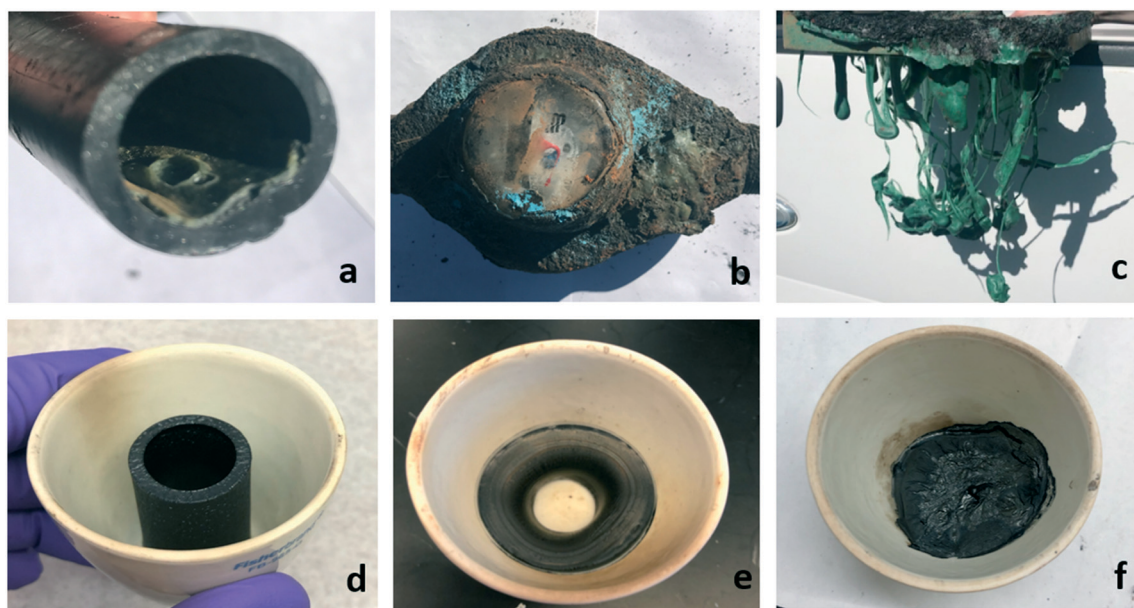
**Fig. 1** Images of fire-damaged water system components including (a) a HDPE plastic pipe, (b) a water meter, and (c) a water meter cover following the Camp Fire. Thermally degraded pipe samples in laboratory experiments include the (d) PEX-c pipe degraded at 300 °C, (e) HDPE pipe degraded at 300 °C, and (f) HDPE pipe degraded at 400 °C.

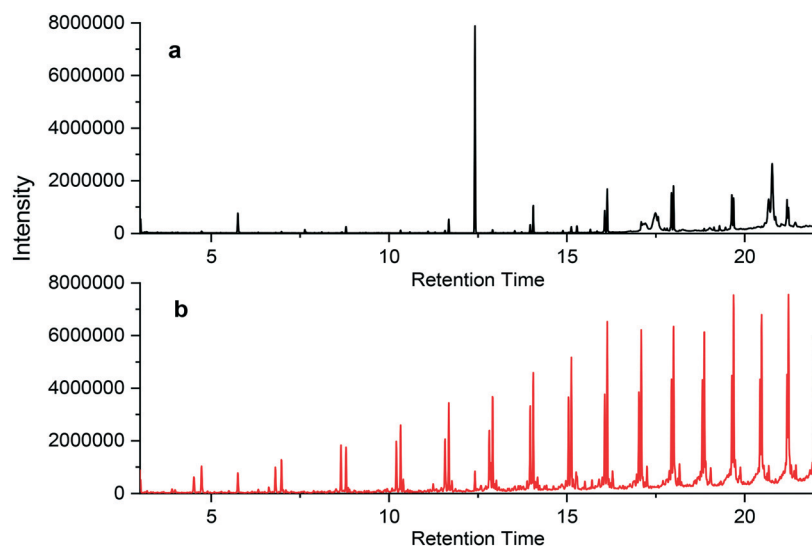
Fig. 4 Chromatographs of PEX-c-1a when (a) unburned and (b) burned at 400 °C, where samples were extracted in *n*-hexane. The internal standard is the peak at 5.8 minutes.

**Leaching promoted by hexane extraction.** As expected, a greater number of peaks were observed in the *n*-hexane extracts (32 to 134) compared to the water extracts (3 to 22) for all plastics (see example for PEX-c-1a in Fig. 4 and all other pipe types in Fig. S17–S26†). For the degraded PEX, HDPE, and PP pipes, between 100 to 134 unique compounds were leached into *n*-hexane, whereas for the degraded PVC and CPVC pipes between 30 to 41 compounds were leached (Fig. 4 and S17–S26†). While most compounds extracted from the new pipes were either straight chain or branched alkanes of varying lengths (Table S3†), thermal exposure led alkenes to represent the majority of compounds detected in the leachate (Table S5†). These aliphatic hydrocarbons are products of alkane hydrocarbon chain scission and are not typical drinking water contaminants. They have low aqueous solubility, which is why they were only detected in the hexane extracts and are generally less toxic than their cyclical or aromatic counterparts.<sup>56,57</sup>

Generally, both the magnitude of the peak and the number of compounds increased after burning the materials. However, one notable exception occurred for the PEX-c pipes; one peak (retention time of 12.5 min) for the unburned pipe was significantly larger than that of any of the burned peaks (Fig. 4 and S21†). This peak likely represented the compound, di-*tert*-butylbenzene, which has been shown to be an ultraviolet light or radiolysis degradation product of the antioxidant Irgafos 168®.<sup>58,59</sup> This compound was only observed in the leachate of the PEX-c materials, in which the crosslinking occurs using beta irradiation. This may explain why the magnitude of this degradation product was so large.<sup>60</sup> This peak decreased substantially in the burned plastic extract (Fig. 4 and S21†), indicating it may have been thermally decomposed.
