# Environmental and private property contamination following the Norfolk Southern chemical spill and chemical fires in Ohio†

In February 2023, a train derailment in Ohio caused a chemical spill and fires releasing contaminants into the air, soil, waterways, and buildings. The authors conducted a rapid response which included six field investigations and bench-scale experiments to understand the chemical identity, fate, and exposure pathways after the evacuation order was lifted. Multiple buildings were chemically contaminated and silicone wristband products inside a commercial building were found to have adsorbed derailment-related chemicals. The indoor air of this commercial building was found to be contaminated for 4.5 months after the derailment. Derailment chemicals were also found on building exteriors 5 weeks after the incident. Railcar chemicals were detected in the nearby creeks. Cleanup activities (sorbent pads, aerators) as well as creek hydraulic and environmental conditions influenced chemical fate in creeks. Creek mechanical aeration activities prompted VOC emission that contributed to human exposures and vapor intrusion. Atmospheric modeling revealed that the chemica

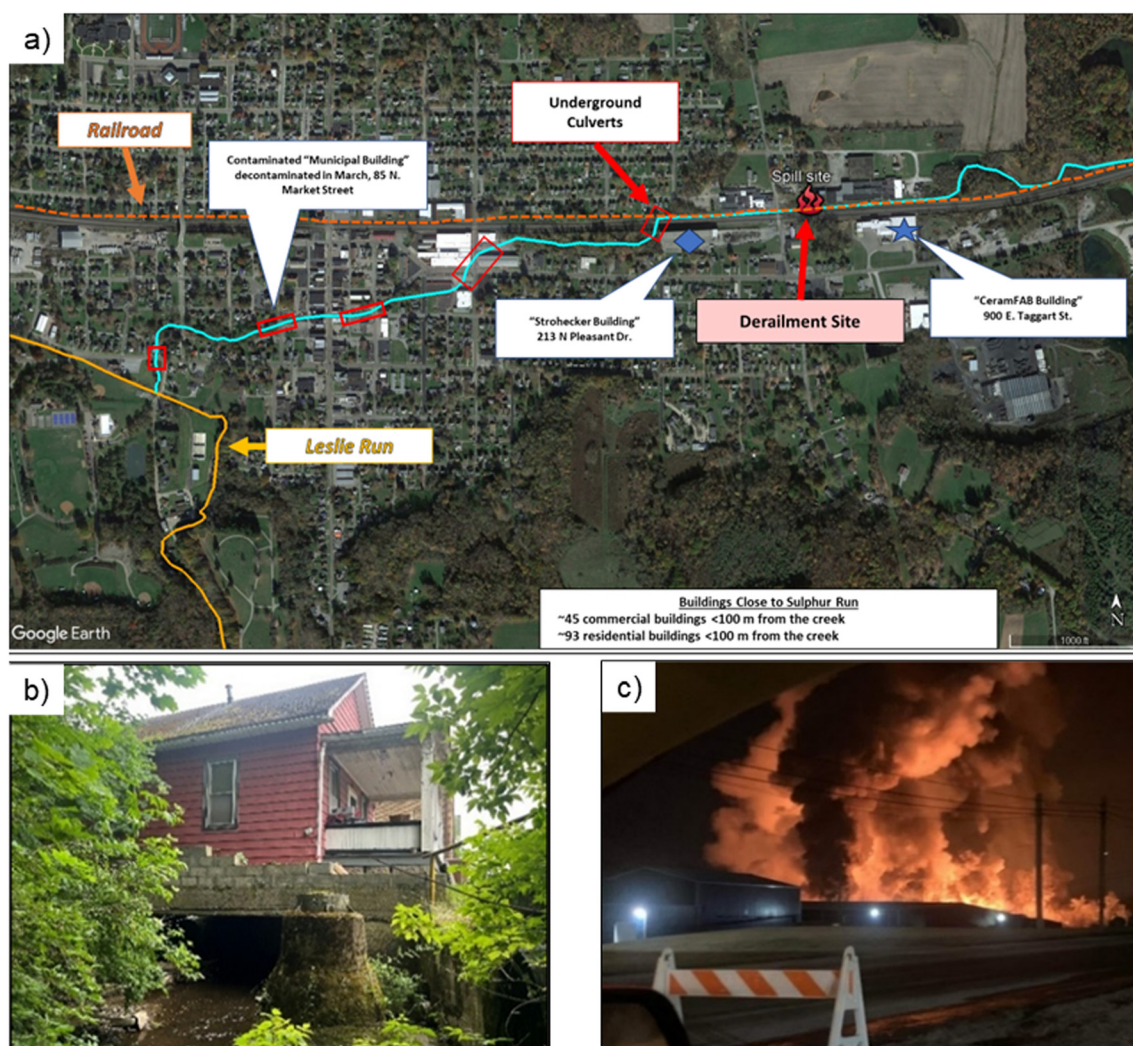
**Fig. 1** a) Map showing the derailment site, culverts, and contaminated buildings near Sulphur Run, b) chemicals released from the derailment entered Sulphur Run and flowed into concrete culverts underneath residential, commercial, and municipal buildings, c) image of the chemical fire visible from East Taggart Street by the CeramFAB Building on February 3, 2023. This image was taken before the open burn was conducted February 6, 2023.

During the following months, concerns were raised about the fate of chemicals released as the derailment occurred on the Eastern side of East Palestine next to Sulphur Run creek (Fig. 1). Sulphur Run received spilled chemicals and runoff from the firefighting operations. Chemicals from the derailment site and roadways reached storm drains and Sulphur Run during the initial response (ESI-Context section†). Chemicals spilled into Sulphur Run flowed through East Palestine, as well as directly by and underneath more than 130 residential, commercial, and municipal buildings through concrete boxed and corrugated metal culverts, and under bridges. Doors and windows of some buildings were less than 5 feet from the creek. At East
