Cite this: *Environ. Sci.: Adv.*, 2024, 3, 972

## Ongoing legacy contamination from a military radar station in Iceland: a case study

Contamination in and around military radar stations in the Arctic has been an ongoing concern since first identified in the 1980s. This study reports on the environmental impact from a DEW line US military station that was operated on Heiðarfjall mountain in northeast Iceland from 1957 to 1970. This review is conducted as a part of work of the POPs Expert Group of the Arctic Monitoring and Assessment Program (AMAP) for an assessment report on local sources vs. long-range transport of Persistent Organic Pollutants (POPs) in the Arctic. The main resource for this summary is an evaluation of results from several reports on Heiðarfjall Langanes, one from an Icelandic Environmental Authority in 1993 and another from the Canadian Environmental Science Group (ESG) at the Royal Military College of Canada, which was commissioned in 2017 by the owners of the land that was used for the station. The results are compared to findings in scientific papers and reports for contamination at other military radar stations in Canada and Alaska. This review shows consid

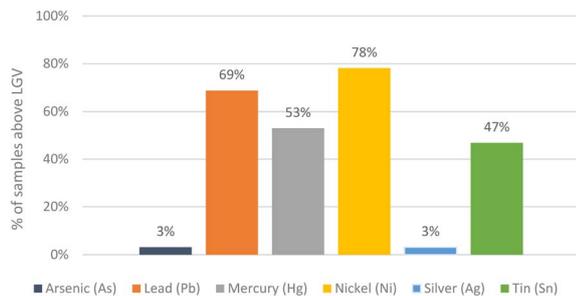
Fig. 8 Non-compliance with the lowest guideline value in samples of 6 primary trace elements, measured in 32 samples from the 10 areas chosen by the ESG for investigation at the H-2 area.<sup>10</sup>

aluminium, antimony, cobalt, copper, iron, manganese, vanadium, and zinc were frequently above the guideline values. None of the six primary inorganic elements were above the guideline values at the Eiði farm area. However, ten other inorganic elements (not shown here) exceeded the lowest guidelines at the Eiði farm area, especially vanadium and antimony which were 50 and 20-fold higher than the lowest guideline values. Others were aluminium, chromium, cobalt, copper, iron, manganese, sulphur, and zinc, ranging from 2 to 7-fold higher (Fig. 8).
