Cite this: *J. Mater. Chem. A*, 2020, 8, 17399

DOI: 10.1039/d0ta06985j

Characterization of mechanical degradation in an all-solid-state battery cathode†

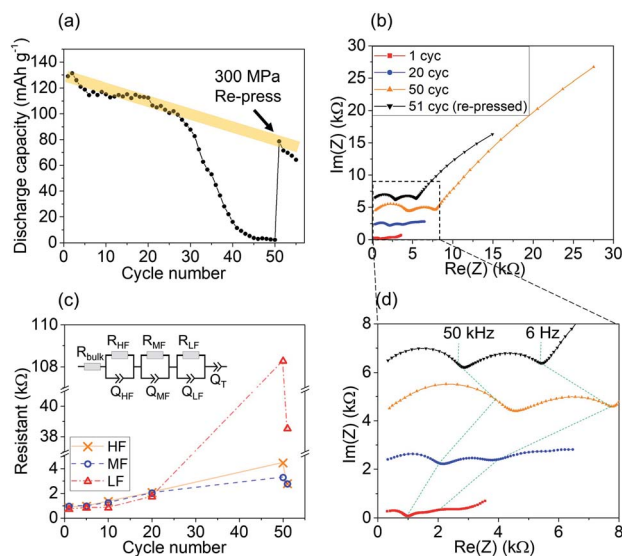
Fig. 1(a) presents the discharge capacity retention of the SSB. The first cycle shows a discharge capacity of 129 mA h g^{-1} . Over the next 26 cycles, the discharge capacity gradually decreased to 102 mA h g^{-1} , corresponding to a loss rate of approximately 1 mA h g^{-1} per cycle, as represented by the yellow line in Fig. 1(a). However, a rapid capacity decline occurred between the 30th and 40th cycle, with the cell capacity ending at less than 20 mA h g^{-1} . Similar cycling behavior was consistently observed in other cells, although the sudden drop in capacity could be found earlier or later. The cycling performance of an additional

To investigate the mechanical contribution to this rapid capacity degradation, 300 MPa pressure was reapplied to the cell after 50 cycles to restore the mechanical contact. Remarkably, after re-pressing the cell at this pressure, the discharge capacity of the SSB recovered to $\sim 80 \text{ mA h g}^{-1}$. This result unambiguously confirms that mechanical degradation significantly contributes to capacity loss during SSB cycling. In addition, the discharge capacity of 80 mA h g^{-1} after the re-pressing corresponds to an average capacity decay rate of 1 mA h g^{-1} per cycle, which is consistent with the initial decay rate for the first 25 cycles. This finding suggests that there are likely two distinct degradation modes during SSB cycling: one that leads to gradual capacity decay at a relatively constant rate, which may be related to the chemical degradation, and another that leads to rapid capacity decay over several cycles, which can be attributed to the mechanical degradation.

Any contact loss in the composite cathode would lead to an increase in the interfacial resistance, which can be probed by electrochemical impedance spectroscopy (EIS). Fig. 1(b) and (c) present the EIS measurements of the cell after 1, 20, 50, and 51 (after re-pressing) cycles. Each spectrum consists of three distinct semicircles in the high-, mid-, and low-frequency regions. The different frequency regions originate from the different time constants for the charged species transport at various interfaces. The EIS results were fitted with the equivalent circuit model, and the cell resistances at different frequencies are summarized in Fig. 1(d). During the first 50 cycles, the resistance in all the frequency regions increased. After re-pressing the cell (51st cycle), a significant decrease of all the resistances was observed. This general trend suggests that mechanical degradation is not limited to the cathode/solid electrolyte interface but may also occur at other interfaces such as the anode/solid electrolyte interface and solid electrolyte grain boundaries. Although it is not possible to precisely assign a single frequency region to the cathode/solid electrolyte interface because of the overlapping time constants of different transport processes, previous studies have argued that the mid-frequency region is most sensitive to changes at the cathode/solid electrolyte interface.⁷ Interestingly, the resistance corresponding to the mid-frequency region (R_{MF}) only increased from 954 to 1241Ω in the first 10 cycles, a 30% increase. After 50 cycles, it further increased to 3283Ω , a 244% increase. This finding again demonstrates that interfacial degradation is accelerated in the later cycles, which is consistent with the observed faster capacity decay. After re-pressing, R_{MF} decreased to 2755Ω , suggesting that the application of large external pressure results in the recovery of some contact area between the cathode and solid electrolyte and reduces the cell resistance. However, this value is still much larger than the original R_{MF} after the first cycle, suggesting that other factors, such as chemical degradation at the interfaces, also play a role in the resistance growth, or that not all contact can be restored. We note that it has become clear recently that LZO does not fully protect NMC at the charging voltage required for NMC²⁷ and the

Fig. 1 Electrochemical tests of SSB before and after re-pressing. (a) Discharge capacity of the cell. Pressure of 300 MPa was applied after 50 cycles. (b) and (d) EIS measurement after 1, 20, 50, and 51 cycles. (c) Summary of cell resistances determined through EIS measurements. The equivalent circuit is shown in the inset.

It should be noted that the observed cathode/solid electrolyte delamination is likely only part of the overall mechanical degradation during SSB operation. Contact loss during cycling is also likely to occur at the anode side. The low-frequency region in the EIS data (Fig. 1), which is often attributed to the anode/solid electrolyte interface,⁷ sees a significant increase during cycling and decreases after pressing. This suggests some anode delamination could also exist and requires further study of the anode morphology. Moreover, although significant cathode particle cracking is not observed in the current study (Fig. 4(d)), it has often been observed in liquid cells,^{28,29} and could occur in SSBs with longer cycling and larger depth of charge and discharge.

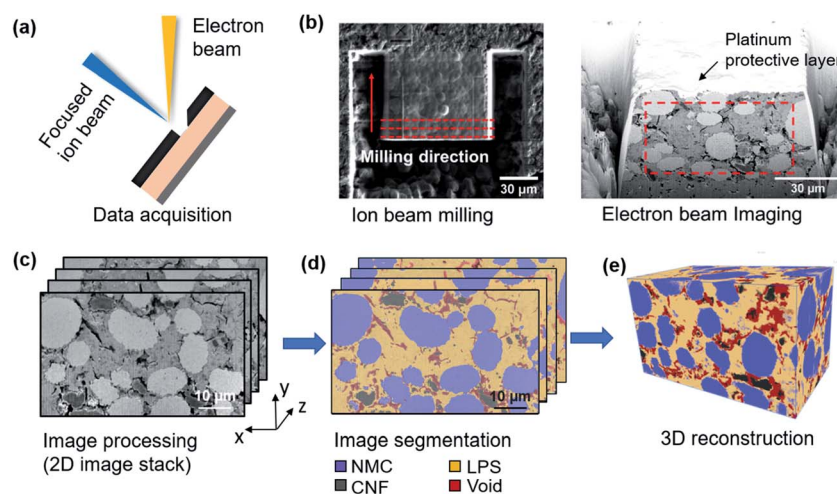
To directly observe and verify the possible contact loss between the cathode and solid electrolyte, FIB-SEM tomography was used to characterize the microstructural evolution in the composite cathode during cycling. Three SSB cells (before cycling, after 10 cycles, and after 50 cycles) were extracted in the discharged state and evaluated using FIB-SEM tomography. The workflow for the FIB-SEM tomography experiment is presented in Fig. 2. The SSB full cell was tilted at a 52° angle with the cathode composite perpendicular to the ion beam. The ion beam was first used to mill trenches surrounding the area of interest, exposing the cross-section to the top-mounted electron beam at a 52° angle. A backscattered electron (BSE) image was acquired to provide 2D morphology information on the cathode composite. Then, a thin slice (50 nm) was milled away from the cross-section with the ion beam, and another BSE image was taken. After repeating this process several hundred times, the image stack was aligned, cropped, and combined into a 2D image stack (Fig. 2(c)) (see ESI Fig. S2 and S3† for the detailed image process procedures). The 2D image stack and corresponding four-phase segmentation image are presented in Fig. 2(c) and (d), respectively, whereby the NMC cathode (blue), LPS solid electrolyte (yellow), carbon (black), and void (red) can be accurately distinguished. The segmented image stacks were then reconstructed into a 3D volume. The reconstructed structures of the composite cathodes before and after electrochemical cycling are presented in Fig. 3.

Fig. 2 Workflow for FIB-SEM tomography. (a) Schematic illustration of data acquisition set-up in FIB-SEM. (b) Ion-beam milling and BSE electron beam imaging were performed iteratively during serial sectioning. (c) 2D image stack obtained after image processing. (d) Corresponding four-phase segmentation results and (e) reconstructed 3D volume of the cathode composite (the final 3D volumes were slightly different for the three samples but were all $\sim 60 \times 40 \times 30\ \mu\text{m}^3$).

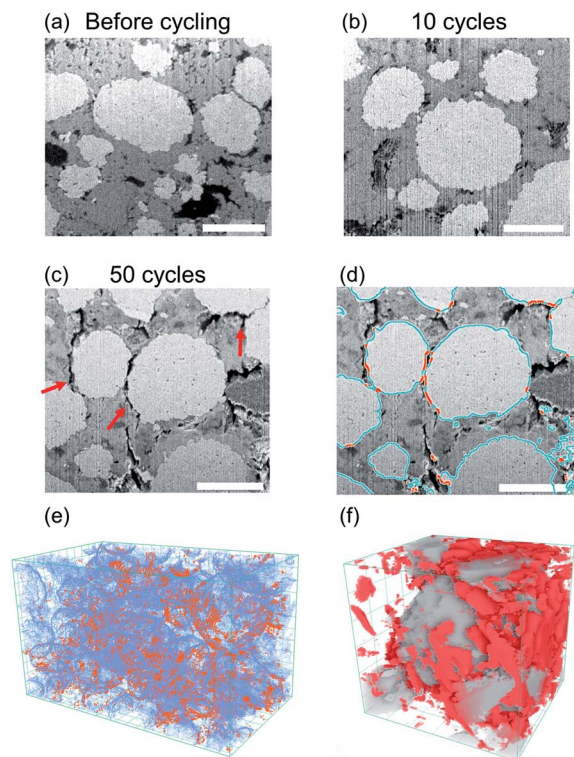
To better quantify the degree of contact loss at the cathode/solid electrolyte interface in the sample that was cycled 50 times, we divided the cathode surface into cathode surface in contact with voids (contact loss) and cathode surface in contact with other components such as other cathode, solid electrolyte, or carbon (with contact), based on the segmentation shown in Fig. 3. Fig. 4(d) demonstrates the labeling of the two categories in a 2D slice of Fig. 4(c) with the contact loss surfaces highlighted in red, and the other cathode surfaces shown in blue. This analysis was performed on all images of the sample, and the reconstructed 3D structure of the cathode surfaces with

contact (blue) and without contact (red) is presented in Fig. 4(e). Contact loss was observed at most of the cathode particle surfaces, demonstrating the severity of the mechanical problems caused by cathode volume change. The estimated contact loss area is 10.4% of the total cathode surface area.

To better visualize the local contact loss distribution around the cathode particles, a single NMC particle and its surrounding voids in the sample cycled 50 times were isolated from the larger volume and are shown in Fig. 4(f). The spherical NMC particle at the center is shown in grey, and the surrounding voids are shown in red. The voids are much more concentrated on the right side of the NMC particle, suggesting that the contact loss areas caused by the cathode particle volume shrinking will mostly be on one side of the particle, rather than uniformly distributed around the particle. This is expected because the presence of voids on one side of the particle is sufficient to release the strain caused by the particle volume change. This concentration of the decohered area in the cathode particle may aggravate its effect on capacity loss as now all the Li ions going in and out of the area under the contact loss have a much larger distance to travel before they reach the solid electrolyte. This is in contrast to if the contact loss area were homogeneously dispersed across the cathode particle. In the latter case, diffusion gradients parallel to the surface, resulting from blocked-out surface area for Li to enter or leave the particle, would rapidly fade out in the cathode particle.

Fig. 4 Cross-sectional SEM images of composite cathode (a) before cycling, (b) after 10 cycles, and (c) after 50 cycles. Scale bar: 10 μm (d) NMC surfaces (blue) with void/NMC interfaces highlighted in red and (e) their 3D reconstruction. (f) Part of the 3D reconstruction of the after-50-cycles sample showing an isolated NMC particle (grey) with surrounding voids (red). Other components (LPS and carbon) are not shown. Box sizes for (e) and (f) are $64 \times 38 \times 36 \mu\text{m}^3$ and $18 \times 20 \times 18 \mu\text{m}^3$, respectively.
