Cite this: *Nanoscale Adv.*, 2024, **6**, 2002

The damage mechanism in copper studied using *in situ* TEM nanoindentation[†]

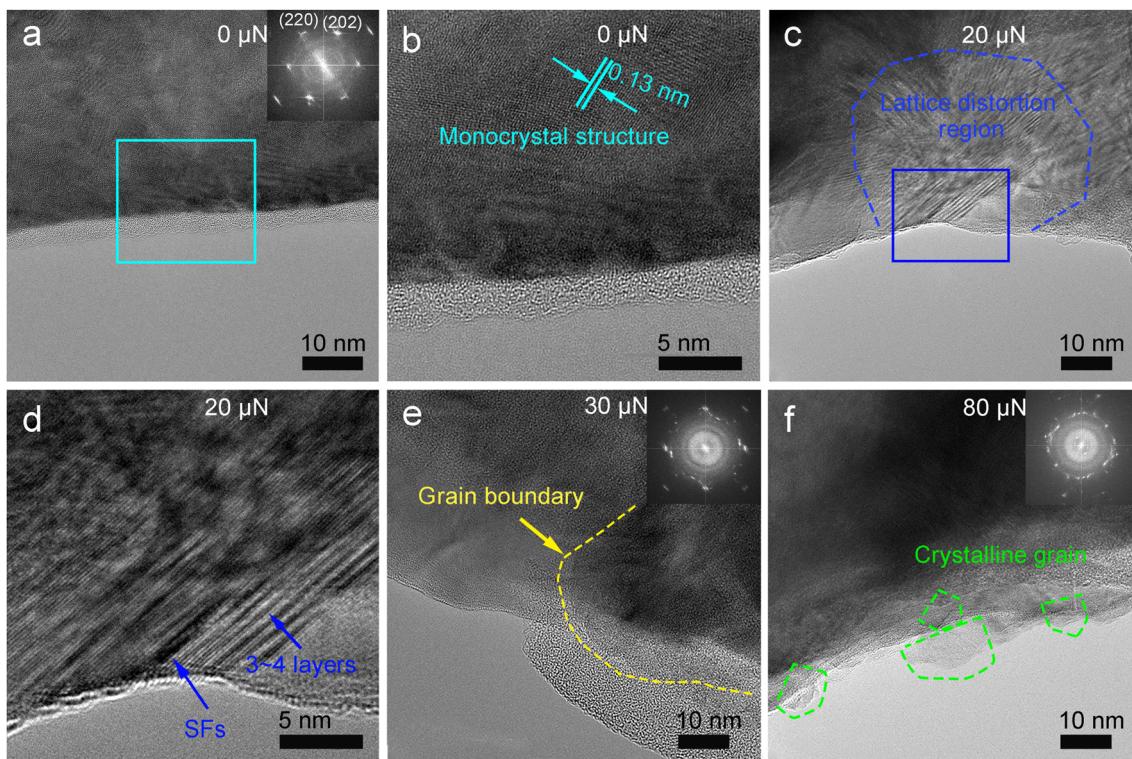
Fig. 2 HRTEM images of the damage evolution process at sequential loads of (a and b) 0, (c and d) 20, (e) 30, and (f) 80 μN . The insets of (a), (e), and (f) show the respective FFT patterns.

To further substantiate the above experimental results, a high-resolution observation of the damaged area was conducted. Fig. 2 presents an analysis of the damage structure of single-crystal copper nanoplates under different loads during

the *in situ* nanoindentation process. As shown in Fig. 2(a), before indentation, the sample surface remained single-crystalline, with a 2 nm amorphous layer originating from the FIB processing damage. Moreover, the inset of Fig. 2 further illustrates that the sample presents a monocrystalline state before indentation. In Fig. 2(b), the crystal plane on the vertical surface is (220), indicating that the loading direction is (220) orientation. In Fig. 2(c), when a load of 20 μN was applied, upon magnification of the indented area, a high density of dislocations can be observed beneath the indentation. These dislocations are distributed within a semi-spherical three-dimensional plastic deformation zone, indicating severe plastic deformation in the region near the center of the indenter. This plastic deformation zone has also been observed in other metals and alloys, consistent with the traditional nanoindentation plasticity theories.^{38–40} Further magnification of the region near the indenter center revealed a significant number of stacking faults with a width of 3 to 4 atomic plane spacings (Fig. 2(d)). As the load increases to 30 μN , high-resolution characterization of the damaged surface, as shown in Fig. 2(e), revealed a larger grain on the upper right side of the indented area, as marked by the yellow dotted line. Further, the fast Fourier transform (FFT) pattern presents multiple sets of diffraction spots (inset of Fig. 2(e)). This suggests that at 30 μN , the damage mechanism in the indented area transitions from stacking faults to grain fragmentation. When the load reaches 80 μN , structural

characterization of the damaged region, as shown in Fig. 2(f), reveals multiple fractured grains at the center of the indentation. The FFT pattern shows polycrystalline characteristics (inset of Fig. 2(f)). This indicates that with increasing stress, larger grains further undergo fragmentation and transform into smaller grains, namely, grain refinement.

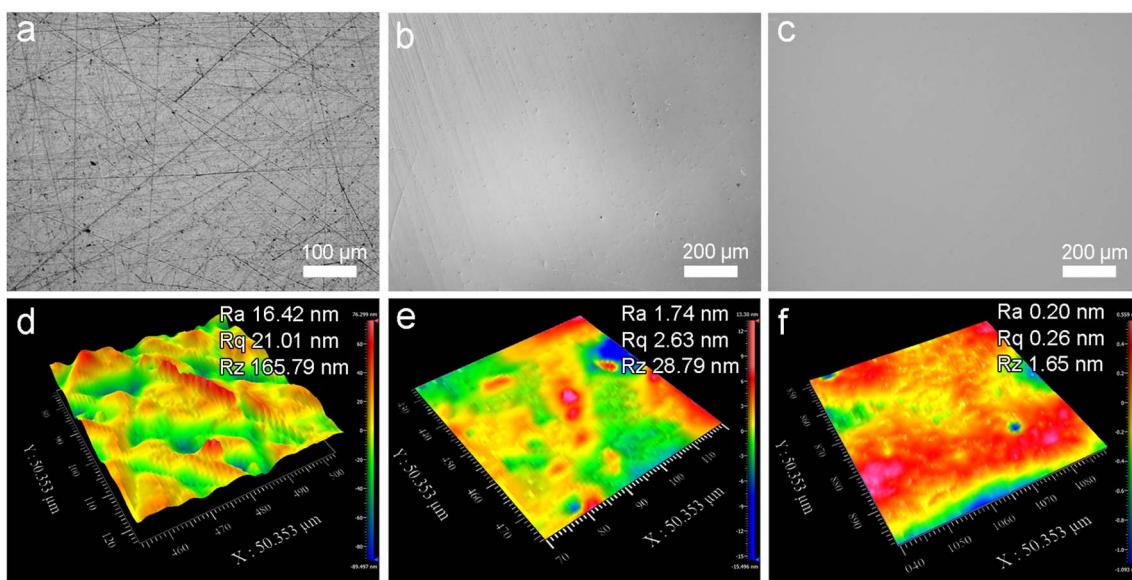
Fig. 3 Optical images of the copper wafer after (a) lapping with consolidated abrasive, (b) mechanical polishing with ceria slurry, and (c) polishing with a novel CMP slurry. Surface roughness and morphologies measured using a ZYGO profilometer after (d) lapping, (e) mechanical polishing, and (f) CMP.

To validate the machining damage mechanism, three typical processing techniques, lapping, mechanical polishing, and chemical mechanical polishing, were conducted. Fig. 3 illustrates the surface quality and topographical characteristics after consolidated abrasive lapping, mechanical polishing, and CMP processes. As depicted in Fig. 3(a), after lapping, numerous intersecting scratches were evident, characterized by a relatively significant depth. Surface roughness measurements were conducted using a 3D optical profilometer. The surface roughness parameters, namely Ra (arithmetic mean height), Rq (root mean square height), and Rz (maximum height) were determined to be 16.42 nm, 21.01 nm, and 165.79 nm, respectively. These measurements were obtained over a scan area of $50 \mu\text{m} \times 50 \mu\text{m}$ (Fig. 3(d)). Upon completion of polishing with ceria slurry, a remarkable reduction in the number and intensity of scratches was observed (Fig. 3(b)). Additionally, an assessment of the surface quality was carried out, revealing surface roughness of Ra , Rq , and Rz of 1.74 nm, 2.63 nm, and 28.79 nm, respectively. Afterward, utilizing an innovative polishing slurry, an exemplarily smooth copper surface was successfully

obtained without scratches. The treated surface displayed an immaculate mirror-like smoothness, devoid of any indications of scratch-induced harm or corrosion marks. The surface roughness parameters for the polished copper, specifically Ra,

Rq, and Rz, were measured to be 0.20 nm, 0.26 nm, and 1.65 nm, respectively, over a scanning area of $50 \mu\text{m} \times 50 \mu\text{m}$.

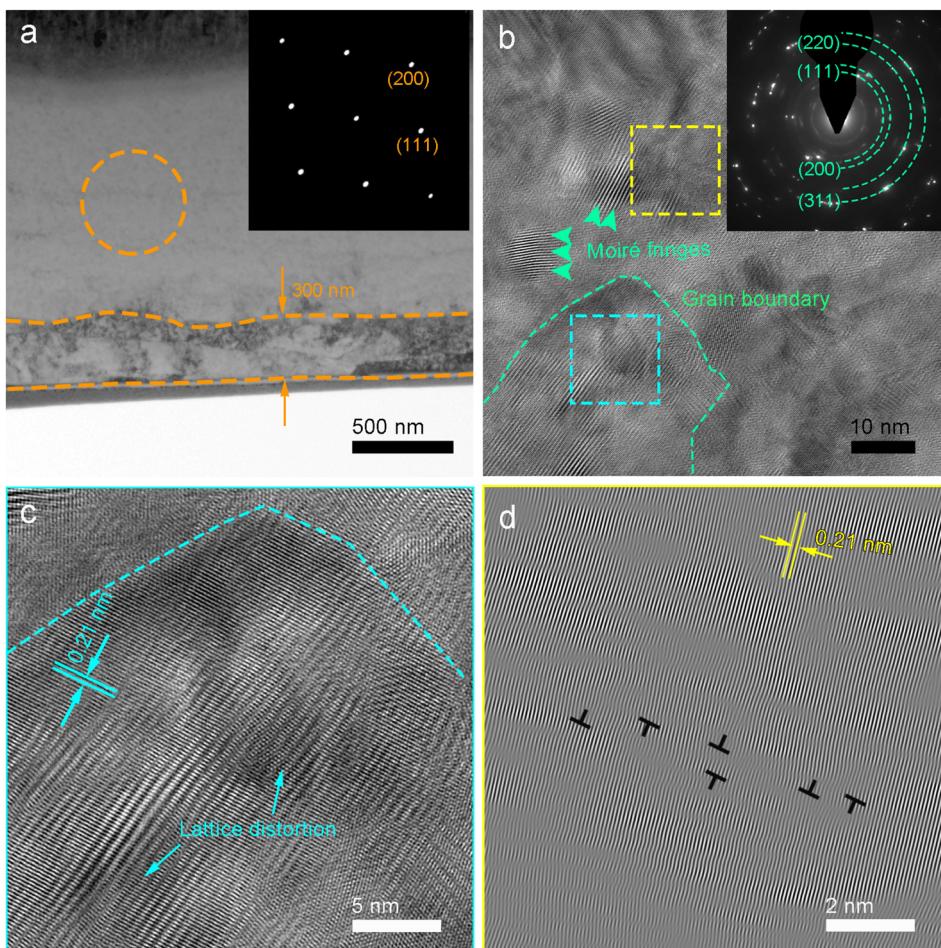
Fig. 4 TEM characterization of copper subsurface after lapping. (a) A low magnification TEM image of subsurface damage, (b) an enlarged TEM image of the damaged area, (c and d) high-resolution TEM images obtained to visualize the damaged area, with distinct damage types corresponding to specific zones marked by cyan (c) and yellow (d) squares. The insets in (a) and (b) are their SAED patterns.

defects.^{41,42} Fig. 4 presents the TEM results for lapping with consolidated abrasive. In Fig. 4(a), the TEM investigation unveiled that the thickness of the lapping-induced damaged layer was 300 nm. Before lapping, the copper sample demonstrated a remarkably monocrystalline state, as visually depicted in the inset of Fig. 4(a). Nevertheless, following the lapping procedure, a transition from a monocrystalline pattern to a polycrystalline state was observed in Fig. 4(b), which indicates grain breakage happening during lapping. The damaged area was further analyzed to gain deeper insights into the damage types that arose from the lapping process. In the lower leftmost region of the damage site, monocrystal structural breakage occurred due to the presence of high abrasive stress. This resulted in the emergence of conspicuous moiré fringes and grain boundaries, as indicated by the green arrows and dotted line in Fig. 4(b). These fringes originate from the overlapping and intersection of two crystalline grains.⁴³ Additionally, within the fractured crystal grains (Fig. 4(c)), regions of severe lattice distortion became apparent. Moving further into the interior of the damaged layer, as the abrasive stress diminishes, a distinct dislocation becomes discernible, clearly delineated by the

yellow square (Fig. 4(d)). The inverse fast Fourier transform (IFFT) image, focusing on the region indicated by the yellow square in Fig. 4(b), unveils the presence of edge dislocations within the inner zone of the damaged layer.

In short, the damaged layer encompasses a variety of components, namely moiré fringes, grain boundaries, and edge dislocations. Within the outermost portion of the damage layer, the predominant form of damage consists of fractured grains. Nevertheless, by delving deeper into the damaged layer, defects assume a more significant role.

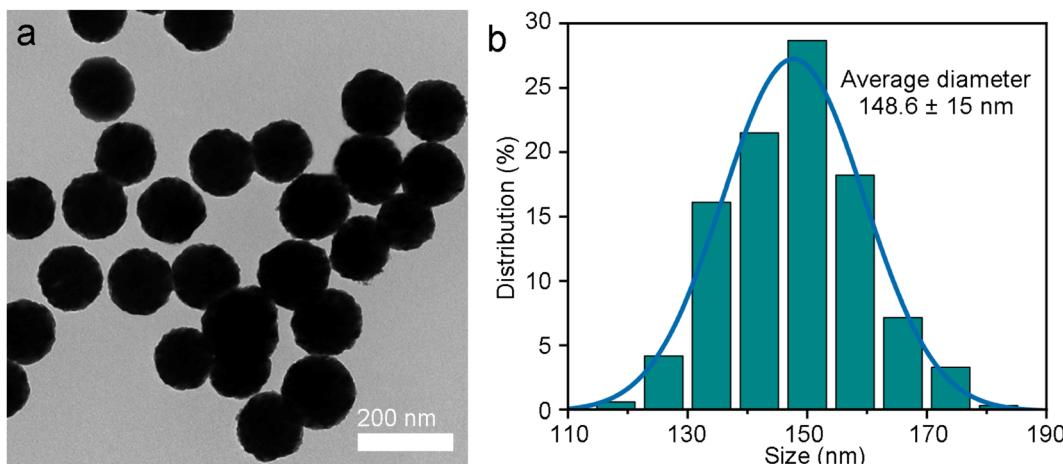
Fig. 5 (a) TEM image and (b) particle size distribution of CeO_2 abrasives.

Mechanical polishing is a precision polishing technology, that mainly relies on very fine polishing powder or polishing slurry lapping, rolling action, removing a layer of extremely thin material on the surface of the sample until the required smoothness is reached.⁴⁴ Fig. 5(a) shows the TEM image of ceria abrasive particles, indicating uniform dispersion of ceria. Particle size statistics revealed a normal distribution for ceria particles, with an average abrasive diameter of 148 nm (Fig. 5(b)).

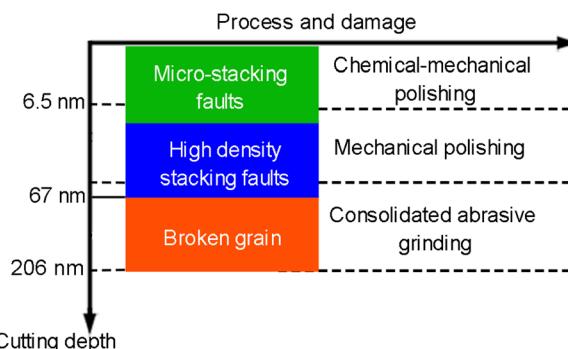
Fig. 8 Diagram of damage evolution under different process conditions.

Cutting depth is a crucial parameter that affects the quality of machining surfaces and the structure of the damage layer. According to the above experimental results, a relationship between the cutting depth and the damage generated during precision machining is established. The cutting depth for different processes was calculated, with specific details explained in the ESI.† The surface damage layer produced by the lapping process contains defects such as lattice distortions, broken grains, and edge dislocations. The surface of the sample was subjected to higher lapping stress, resulting in more severe damage, with a large number of broken grains in the damaged layer. The subsurface, on the other hand, experiences lower lapping stress, leading to relatively lower damage, characterized

by the presence of numerous crystal defects such as high-density stacking faults in the damaged layer (Fig. 8). During the mechanical polishing process, the stress on the copper surface exceeds the MPa level.¹⁹ The damaged layer contains a significant amount of dislocation structures, and the density of dislocations decreases with increasing depth of the damaged layer. Moreover, in chemical mechanical polishing, copper atoms are collectively removed under mechanical and chemical action, forming micro-stacking faults composed of only a few atomic layers on the surface (Fig. 8). In high-precision machining, severe damage caused by broken grains significantly affects the surface quality and material mechanical
