Nanoscale Advances

The damage mechanism in copper studied using *in situ* TEM nanoindentation†

Copper (Cu) has a soft-plastic nature, which makes it susceptible to damages from scratching or abrasive machining, such as lapping and polishing. It is a challenge to control these damages as the damage mechanism is elusive. Nonetheless, controlling damages is essential, especially on the atomic surfaces of Cu. To interpret the damage mechanism, *in situ* transmission electron microscopy (TEM) nanoindentation was performed using a cube-corner indenter with a radius of 57 nm at a loading speed of 5 nm s⁻¹. Experimental results showed that damages originate from dislocations, evolve to stack faults, and then form broken crystallites. When the indentation depth was 45 nm at a load of 20 μN, damages comprised dislocations and stacking faults. After increasing the depth to 67 nm and load to 30 μN, the formation of broken crystallites initiated; and the critical depth was 67 nm. To validate the damage mechanism, fixed-abrasive lapping, mechanical polishing, and chemical mechanical polishing (CMP) were conducted. Firstly, a novel green CMP slurry containing silica, hydrogen peroxide, and aspa

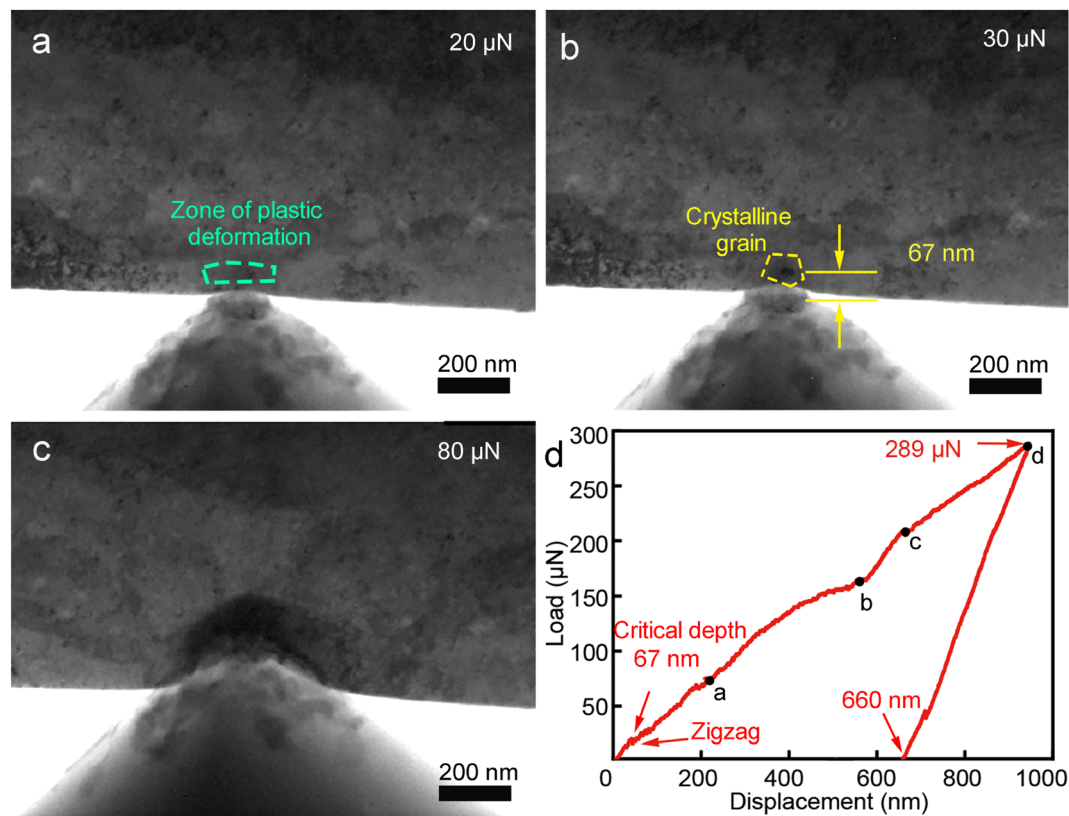
Fig. 1 Snapshots of TEM images of the nanoindentation area at sequential loads of (a) 20, (b) 30, and (c) 80 μN ; (d) load–displacement curve of nanoindentation.

In situ TEM nanoindentation was performed to interpret the damage mechanism of the copper surface during machining. Fig. 1 shows a series of video snapshots during *in situ* nanoindentation of single-crystal copper nanoplates under a range of

applied loads. Prior to indentation, the sample surface remained flat. As depicted in Fig. 1(a), upon applying a load of 20 μN with a depth of 45 nm, slight irreversible plastic deformation occurred on the sample surface, along with the appearance of a minor zigzag in the load–displacement curve (Fig. 1(d)). These features are attributed to dislocation and stacking fault formation, sudden stress release, and instantaneous load drop.³⁵ TEM imaging confirmed that plastic deformation occurred in the indentation area without the formation of new grains at 20 μN, as shown in Fig. 1(a). Continuing to increase the load to 30 μN, Fig. 1(b) marks the onset of small grain formation within the single crystal, observed at the tip of the diamond indenter. A nano-sized grain is evident within the sample, indicated by the blue dashed line in Fig. 1(b), and a sudden load drop was observed in the load–displacement curve, indicating grain breakage in the single-crystal nanoplate at a depth of 67 nm under 30 μN. Further increasing the load to 80 μN, corresponding to a displacement of 219 nm, as shown in Fig. 1(c), the nanoplate experienced severe plastic deformation accompanied by the generation of new grains. Moreover, the serrated features observed on the load–displacement curve are a result of significant grain fragmentation. With further increases in the load, plastic deformation primarily occurred during the ‘ab’ stage, accompanied by grain fracture. In the ‘bc’ stage, due to excessive loading, the entire nanoplate sample undergoes overall elastic deformation, along with plastic deformation. The stiffness during the ‘bc’ stage is greater than that during the ‘ab’ stage. Finally, during the ‘cd’ stage, the plastic deformation of the sample further increases, and severe irreversible plastic deformation occurs in the indentation area. Loading was concluded when the displacement reached 900 nm.

As stress levels escalated, the damaged area witnessed an initial onset of dislocation motion and the emergence of stacking faults. Subsequently, grain fracture took place. Stress during the sample loading process was meticulously calculated. As illustrated in Fig. 1(d), grain fracture occurred in monocrystalline nanoplate when the load reached 30 μN, corresponding to a displacement of 67 nm. In the realm of nanoindentation experiments, the equation employed to calculate the stress is as follows³⁶

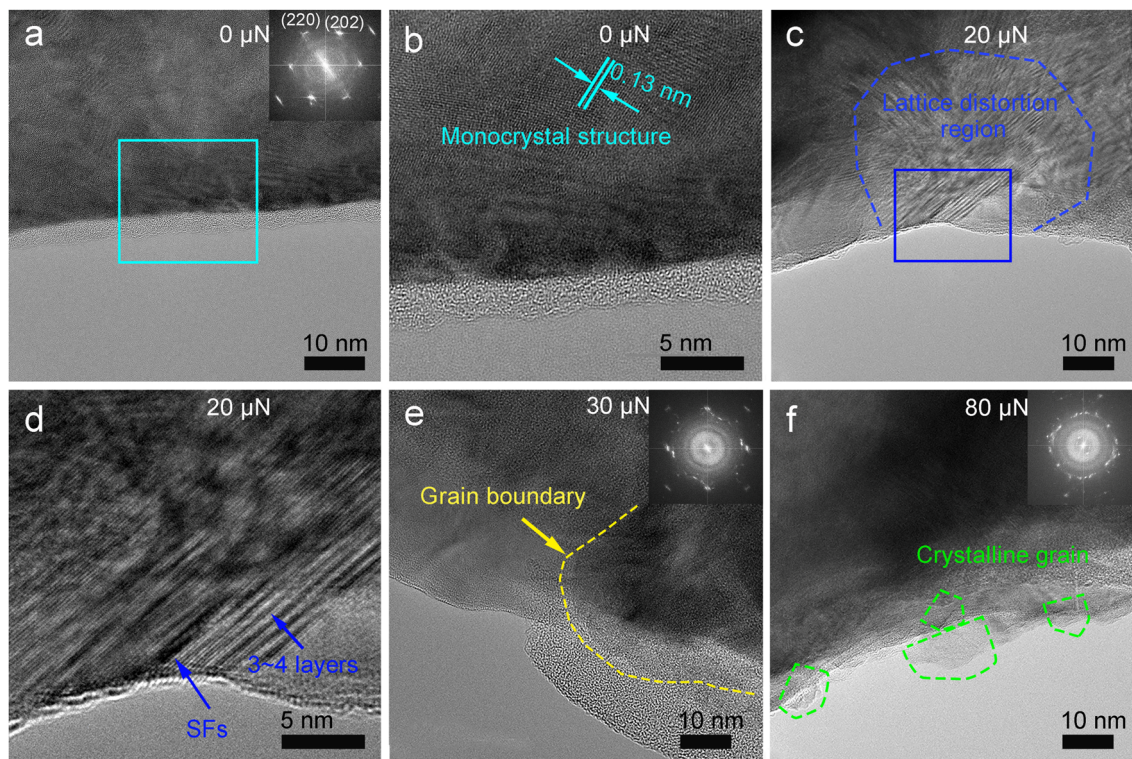
Fig. 2 HRTEM images of the damage evolution process at sequential loads of (a and b) 0, (c and d) 20, (e) 30, and (f) 80 μN . The insets of (a), (e), and (f) show the respective FFT patterns.

To further substantiate the above experimental results, a high-resolution observation of the damaged area was conducted. Fig. 2 presents an analysis of the damage structure of single-crystal copper nanoplates under different loads during

the *in situ* nanoindentation process. As shown in Fig. 2(a), before indentation, the sample surface remained single-crystalline, with a 2 nm amorphous layer originating from the FIB processing damage. Moreover, the inset of Fig. 2 further illustrates that the sample presents a monocrystalline state before indentation. In Fig. 2(b), the crystal plane on the vertical surface is (220), indicating that the loading direction is $\langle 220 \rangle$ orientation. In Fig. 2(c), when a load of 20 μN was applied, upon magnification of the indented area, a high density of dislocations can be observed beneath the indentation. These dislocations are distributed within a semi-spherical three-dimensional plastic deformation zone, indicating severe plastic deformation in the region near the center of the indenter. This plastic deformation zone has also been observed in other metals and alloys, consistent with the traditional nanoindentation plasticity theories.^{38–40} Further magnification of the region near the indenter center revealed a significant number of stacking faults with a width of 3 to 4 atomic plane spacings (Fig. 2(d)). As the load increases to 30 μN , high-resolution characterization of the damaged surface, as shown in Fig. 2(e), revealed a larger grain on the upper right side of the indented area, as marked by the yellow dotted line. Further, the fast Fourier transform (FFT) pattern presents multiple sets of diffraction spots (inset of Fig. 2(e)). This suggests that at 30 μN , the damage mechanism in the indented area transitions from stacking faults to grain fragmentation. When the load reaches 80 μN , structural

characterization of the damaged region, as shown in Fig. 2(f), reveals multiple fractured grains at the center of the indentation. The FFT pattern shows polycrystalline characteristics (inset of Fig. 2(f)). This indicates that with increasing stress, larger grains further undergo fragmentation and transform into smaller grains, namely, grain refinement.

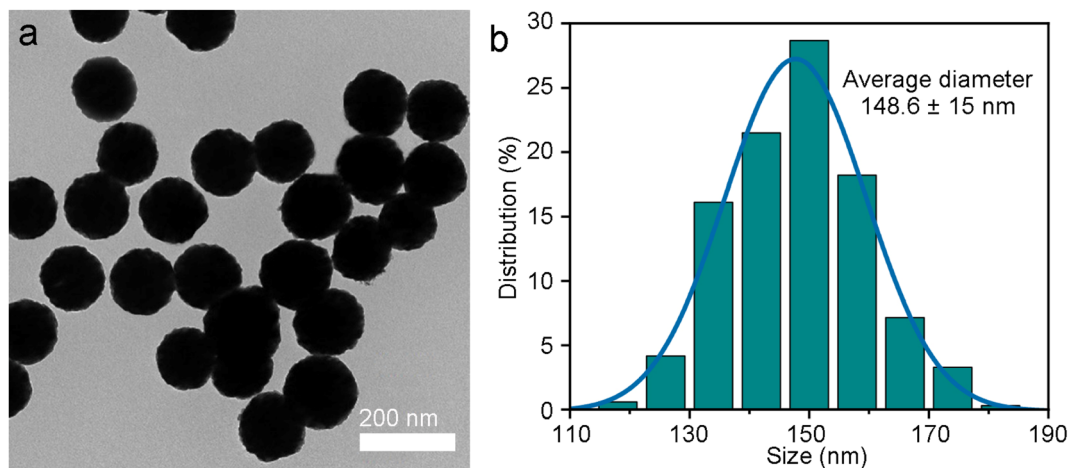
Fig. 5 (a) TEM image and (b) particle size distribution of CeO₂ abrasives.

Mechanical polishing is a precision polishing technology, that mainly relies on very fine polishing powder or polishing slurry lapping, rolling action, removing a layer of extremely thin material on the surface of the sample until the required smoothness is reached.⁴⁴ Fig. 5(a) shows the TEM image of ceria abrasive particles, indicating uniform dispersion of ceria. Particle size statistics revealed a normal distribution for ceria particles, with an average abrasive diameter of 148 nm (Fig. 5(b)).
