Cite this: *Nanoscale Adv.*, 2024, 6, 2002

## The damage mechanism in copper studied using *in situ* TEM nanoindentation†

Copper (Cu) has a soft-plastic nature, which makes it susceptible to damages from scratching or abrasive machining, such as lapping and polishing. It is a challenge to control these damages as the damage mechanism is elusive. Nonetheless, controlling damages is essential, especially on the atomic surfaces of Cu. To interpret the damage mechanism, *in situ* transmission electron microscopy (TEM) nanoindentation was performed using a cube-corner indenter with a radius of 57 nm at a loading speed of 5 nm s<sup>-1</sup>. Experimental results showed that damages originate from dislocations, evolve to stack faults, and then form broken crystallites. When the indentation depth was 45 nm at a load of 20 μN, damages comprised dislocations and stacking faults. After increasing the depth to 67 nm and load to 30 μN, the formation of broken crystallites initiated; and the critical depth was 67 nm. To validate the damage mechanism, fixed-abrasive lapping, mechanical polishing, and chemical mechanical polishing (CMP) were conducted. Firstly, a novel green CMP slurry containi

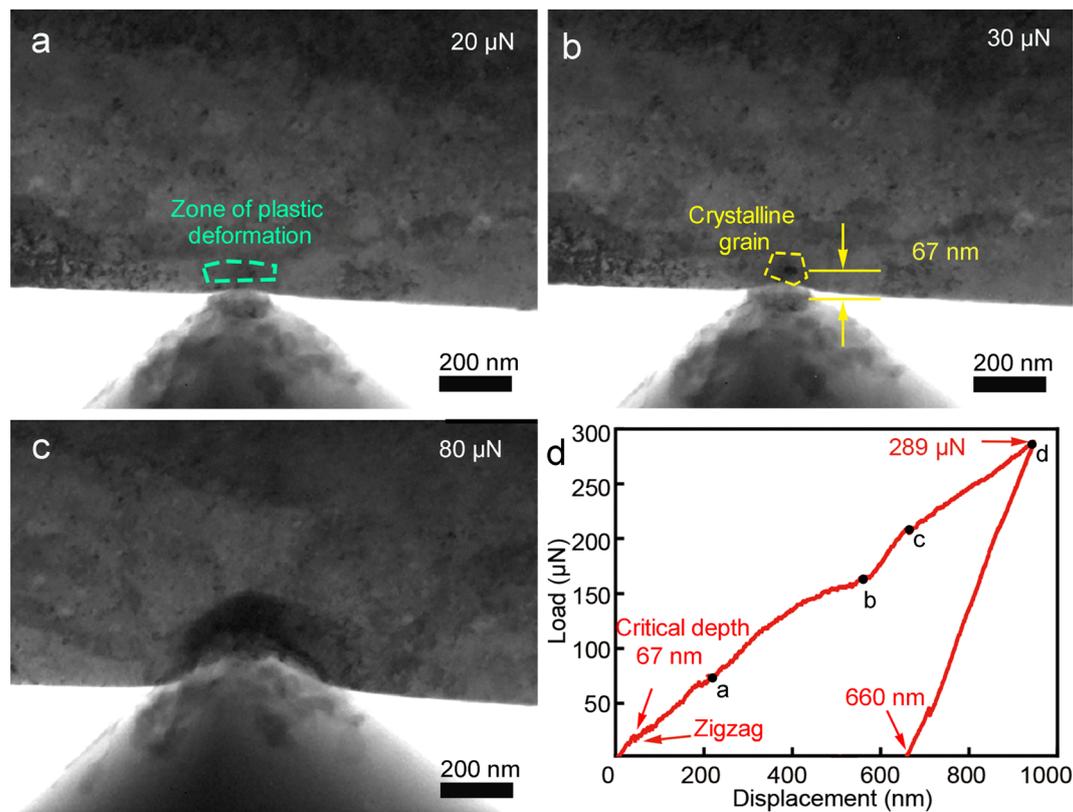
Fig. 1 Snapshots of TEM images of the nanoindentation area at sequential loads of (a) 20, (b) 30, and (c) 80  $\mu\text{N}$ ; (d) load–displacement curve of nanoindentation.

*In situ* TEM nanoindentation was performed to interpret the damage mechanism of the copper surface during machining. Fig. 1 shows a series of video snapshots during *in situ* nanoindentation of single-crystal copper nanoplates under a range of

applied loads. Prior to indentation, the sample surface remained flat. As depicted in Fig. 1(a), upon applying a load of 20 μN with a depth of 45 nm, slight irreversible plastic deformation occurred on the sample surface, along with the appearance of a minor zigzag in the load–displacement curve (Fig. 1(d)). These features are attributed to dislocation and stacking fault formation, sudden stress release, and instantaneous load drop.<sup>35</sup> TEM imaging confirmed that plastic deformation occurred in the indentation area without the formation of new grains at 20 μN, as shown in Fig. 1(a). Continuing to increase the load to 30 μN, Fig. 1(b) marks the onset of small grain formation within the single crystal, observed at the tip of the diamond indenter. A nano-sized grain is evident within the sample, indicated by the blue dashed line in Fig. 1(b), and a sudden load drop was observed in the load–displacement curve, indicating grain breakage in the single-crystal nanoplate at a depth of 67 nm under 30 μN. Further increasing the load to 80 μN, corresponding to a displacement of 219 nm, as shown in Fig. 1(c), the nanoplate experienced severe plastic deformation accompanied by the generation of new grains. Moreover, the serrated features observed on the load–displacement curve are a result of significant grain fragmentation. With further increases in the load, plastic deformation primarily occurred during the ‘ab’ stage, accompanied by grain fracture. In the ‘bc’ stage, due to excessive loading, the entire nanoplate sample undergoes overall elastic deformation, along with plastic deformation. The stiffness during the ‘bc’ stage is greater than that during the ‘ab’ stage. Finally, during the ‘cd’ stage, the plastic deformation of the sample further increases, and severe irreversible plastic deformation occurs in the indentation area. Loading was concluded when the displacement reached 900 nm.

As stress levels escalated, the damaged area witnessed an initial onset of dislocation motion and the emergence of stacking faults. Subsequently, grain fracture took place. Stress during the sample loading process was meticulously calculated. As illustrated in Fig. 1(d), grain fracture occurred in mono-crystalline nanoplate when the load reached 30 μN, corresponding to a displacement of 67 nm. In the realm of nanoindentation experiments, the equation employed to calculate the stress is as follows<sup>36</sup>

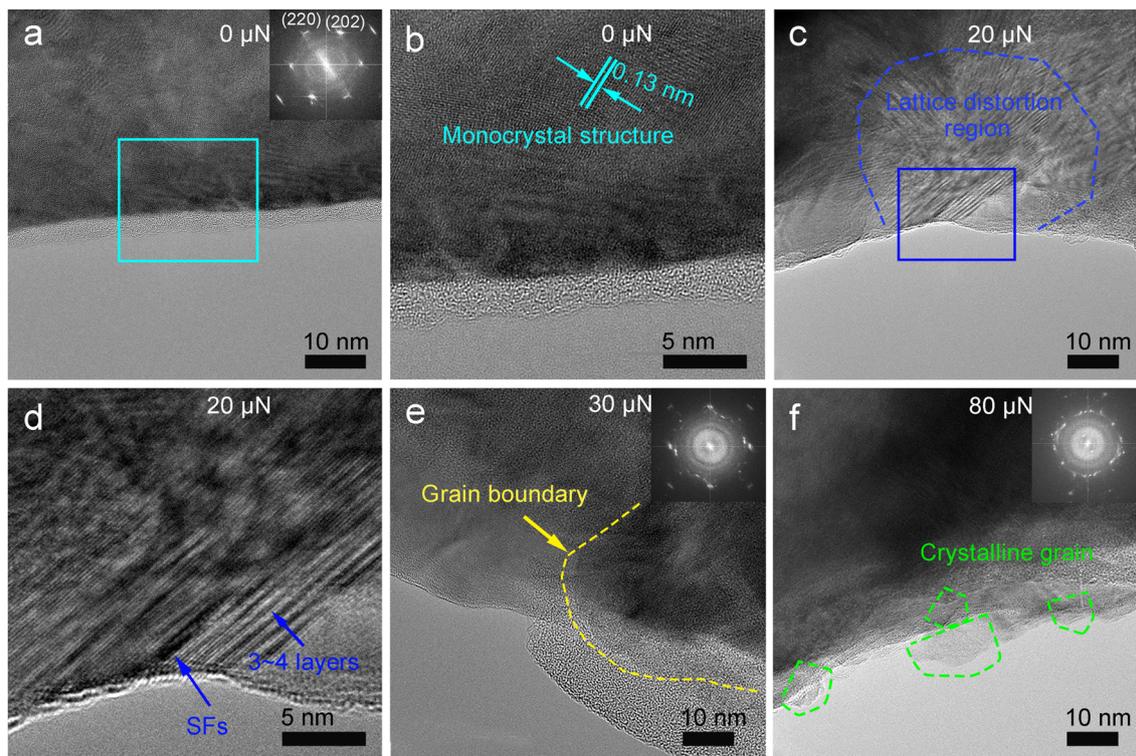
Fig. 2 HRTEM images of the damage evolution process at sequential loads of (a and b) 0, (c and d) 20, (e) 30, and (f) 80  $\mu\text{N}$ . The insets of (a), (e), and (f) show the respective FFT patterns.

To further substantiate the above experimental results, a high-resolution observation of the damaged area was conducted. Fig. 2 presents an analysis of the damage structure of single-crystal copper nanoplates under different loads during

the *in situ* nanoindentation process. As shown in Fig. 2(a), before indentation, the sample surface remained single-crystalline, with a 2 nm amorphous layer originating from the FIB processing damage. Moreover, the inset of Fig. 2 further illustrates that the sample presents a monocrystalline state before indentation. In Fig. 2(b), the crystal plane on the vertical surface is (220), indicating that the loading direction is  $\langle 220 \rangle$  orientation. In Fig. 2(c), when a load of 20  $\mu\text{N}$  was applied, upon magnification of the indented area, a high density of dislocations can be observed beneath the indentation. These dislocations are distributed within a semi-spherical three-dimensional plastic deformation zone, indicating severe plastic deformation in the region near the center of the indenter. This plastic deformation zone has also been observed in other metals and alloys, consistent with the traditional nanoindentation plasticity theories.<sup>38–40</sup> Further magnification of the region near the indenter center revealed a significant number of stacking faults with a width of 3 to 4 atomic plane spacings (Fig. 2(d)). As the load increases to 30  $\mu\text{N}$ , high-resolution characterization of the damaged surface, as shown in Fig. 2(e), revealed a larger grain on the upper right side of the indented area, as marked by the yellow dotted line. Further, the fast Fourier transform (FFT) pattern presents multiple sets of diffraction spots (inset of Fig. 2(e)). This suggests that at 30  $\mu\text{N}$ , the damage mechanism in the indented area transitions from stacking faults to grain fragmentation. When the load reaches 80  $\mu\text{N}$ , structural

characterization of the damaged region, as shown in Fig. 2(f), reveals multiple fractured grains at the center of the indentation. The FFT pattern shows polycrystalline characteristics (inset of Fig. 2(f)). This indicates that with increasing stress, larger grains further undergo fragmentation and transform into smaller grains, namely, grain refinement.

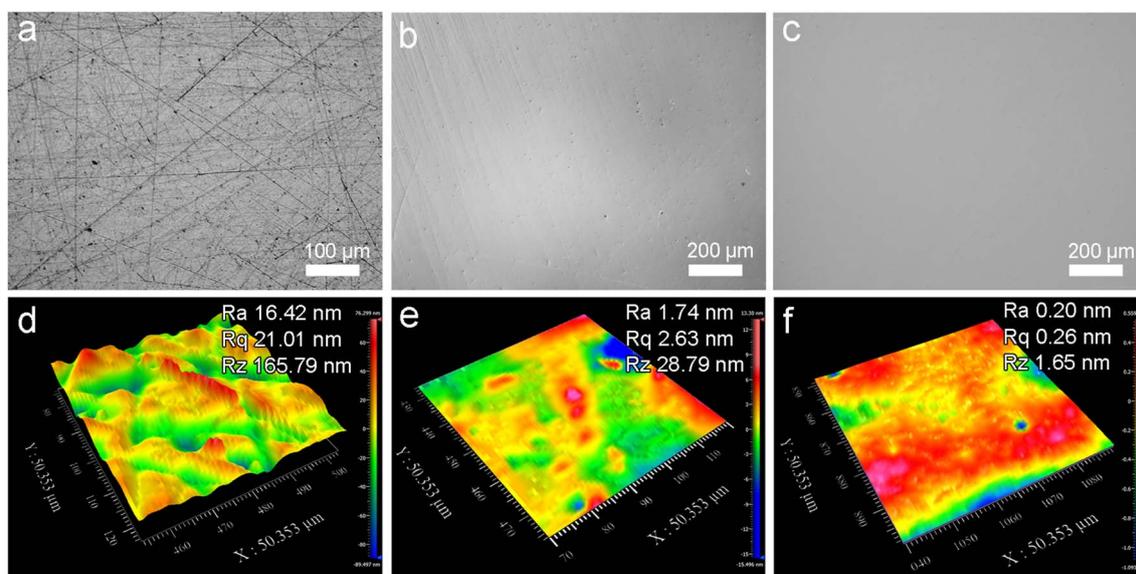
Fig. 3 Optical images of the copper wafer after (a) lapping with consolidated abrasive, (b) mechanical polishing with ceria slurry, and (c) polishing with a novel CMP slurry. Surface roughness and morphologies measured using a ZYGO profilometer after (d) lapping, (e) mechanical polishing, and (f) CMP.

To validate the machining damage mechanism, three typical processing techniques, lapping, mechanical polishing, and chemical mechanical polishing, were conducted. Fig. 3 illustrates the surface quality and topographical characteristics after consolidated abrasive lapping, mechanical polishing, and CMP processes. As depicted in Fig. 3(a), after lapping, numerous intersecting scratches were evident, characterized by a relatively significant depth. Surface roughness measurements were conducted using a 3D optical profilometer. The surface roughness parameters, namely Ra (arithmetic mean height), Rq (root mean square height), and Rz (maximum height) were determined to be 16.42 nm, 21.01 nm, and 165.79 nm, respectively. These measurements were obtained over a scan area of  $50 \mu\text{m} \times 50 \mu\text{m}$  (Fig. 3(d)). Upon completion of polishing with ceria slurry, a remarkable reduction in the number and intensity of scratches was observed (Fig. 3(b)). Additionally, an assessment of the surface quality was carried out, revealing surface roughness of Ra, Rq, and Rz of 1.74 nm, 2.63 nm, and 28.79 nm, respectively. Afterward, utilizing an innovative polishing slurry, an exemplarily smooth copper surface was successfully

obtained without scratches. The treated surface displayed an immaculate mirror-like smoothness, devoid of any indications of scratch-induced harm or corrosion marks. The surface roughness parameters for the polished copper, specifically Ra,

Rq, and Rz, were measured to be 0.20 nm, 0.26 nm, and 1.65 nm, respectively, over a scanning area of  $50\ \mu\text{m} \times 50\ \mu\text{m}$ .

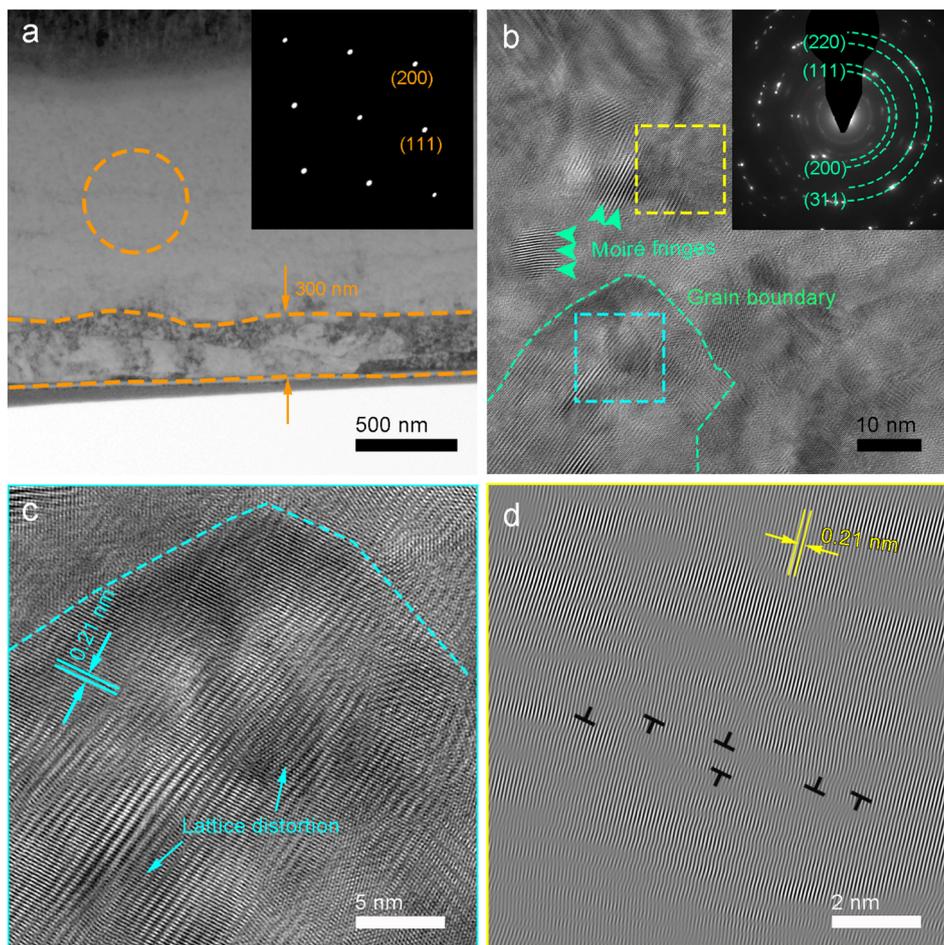
Fig. 4 TEM characterization of copper subsurface after lapping. (a) A low magnification TEM image of subsurface damage, (b) an enlarged TEM image of the damaged area, (c and d) high-resolution TEM images obtained to visualize the damaged area, with distinct damage types corresponding to specific zones marked by cyan (c) and yellow (d) squares. The insets in (a) and (b) are their SAED patterns.

defects.<sup>41,42</sup> Fig. 4 presents the TEM results for lapping with consolidated abrasive. In Fig. 4(a), the TEM investigation unveiled that the thickness of the lapping-induced damaged layer was 300 nm. Before lapping, the copper sample demonstrated a remarkably monocrystalline state, as visually depicted in the inset of Fig. 4(a). Nevertheless, following the lapping procedure, a transition from a monocrystalline pattern to a polycrystalline state was observed in Fig. 4(b), which indicates grain breakage happening during lapping. The damaged area was further analyzed to gain deeper insights into the damage types that arose from the lapping process. In the lower leftmost region of the damage site, monocrystal structural breakage occurred due to the presence of high abrasive stress. This resulted in the emergence of conspicuous moiré fringes and grain boundaries, as indicated by the green arrows and dotted line in Fig. 4(b). These fringes originate from the overlapping and intersection of two crystalline grains.<sup>43</sup> Additionally, within the fractured crystal grains (Fig. 4(c)), regions of severe lattice distortion became apparent. Moving further into the interior of the damaged layer, as the abrasive stress diminishes, a distinct dislocation becomes discernible, clearly delineated by the

yellow square (Fig. 4(d)). The inverse fast Fourier transform (IFFT) image, focusing on the region indicated by the yellow square in Fig. 4(b), unveils the presence of edge dislocations within the inner zone of the damaged layer.

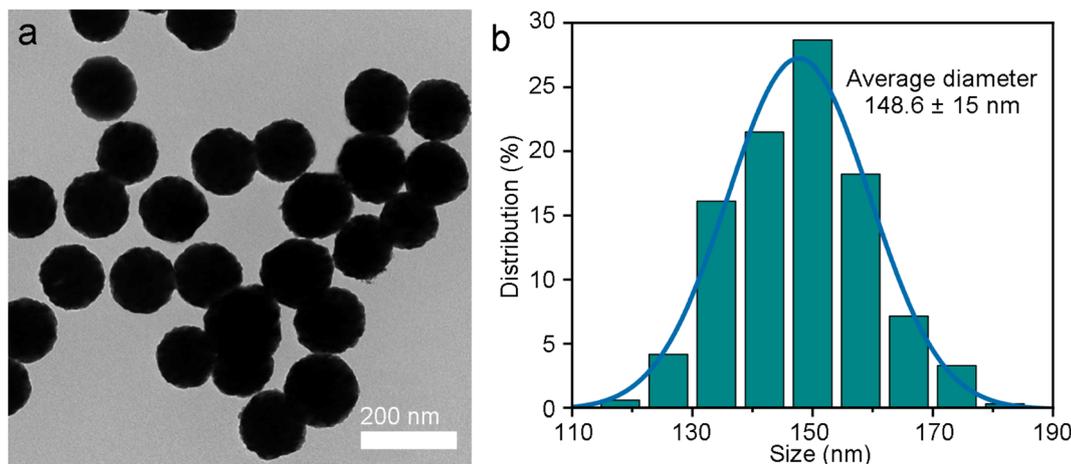
Fig. 5 (a) TEM image and (b) particle size distribution of CeO<sub>2</sub> abrasives.

Mechanical polishing is a precision polishing technology, that mainly relies on very fine polishing powder or polishing slurry lapping, rolling action, removing a layer of extremely thin material on the surface of the sample until the required smoothness is reached.<sup>44</sup> Fig. 5(a) shows the TEM image of ceria abrasive particles, indicating uniform dispersion of ceria. Particle size statistics revealed a normal distribution for ceria particles, with an average abrasive diameter of 148 nm (Fig. 5(b)).

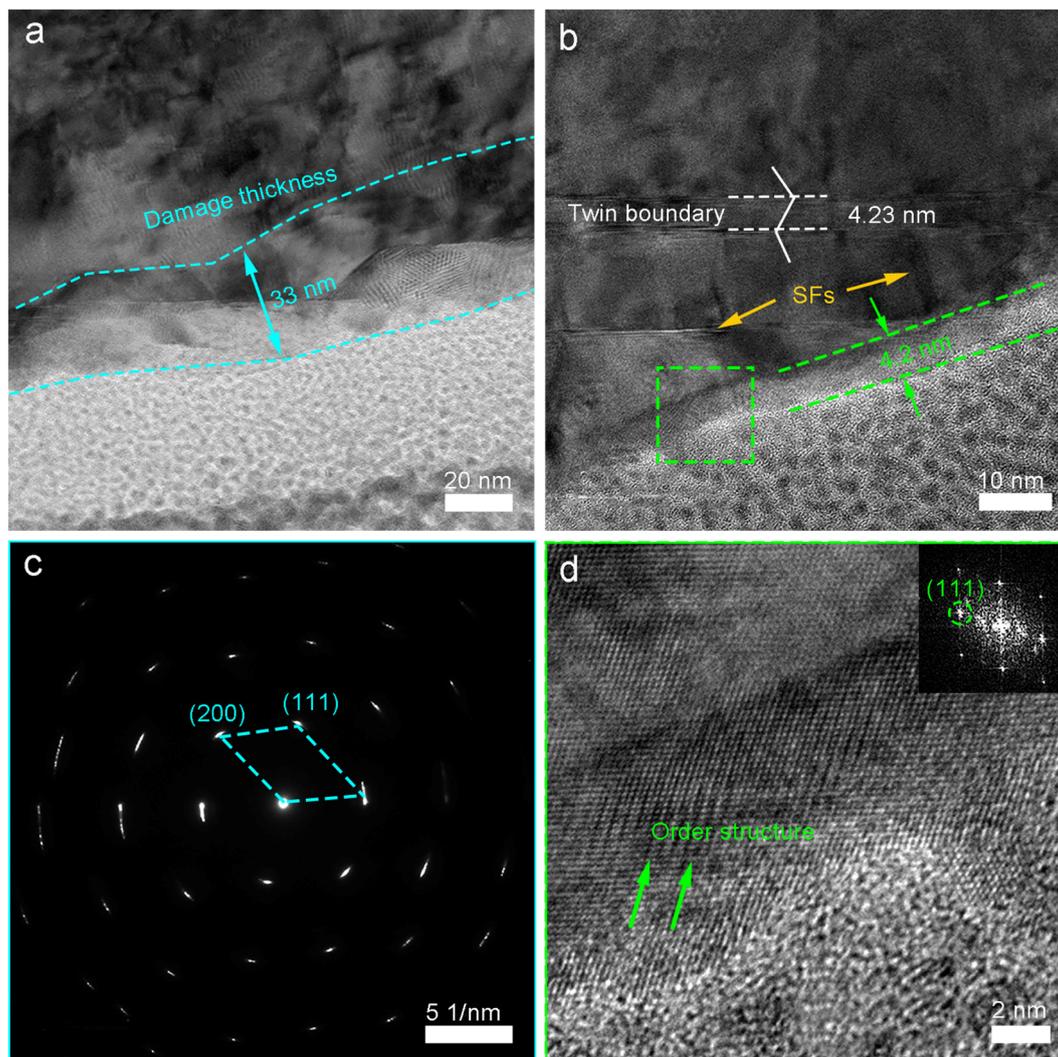
Fig. 6 (a) TEM characterization of the copper subsurface after mechanical polishing. (a) The low magnification TEM image of subsurface damage. (b) enlarged TEM image of the damaged area, (c) a SAED pattern of (a), and (d) HRTEM image of the green square in (b).

TEM. A low magnification TEM image presents a cross-sectional perspective of a mechanically polished surface, demonstrating a measured damage layer thickness of 33 nanometers (Fig. 6(a)). Additionally, the polished surface retained its monocrystalline structure (inset in Fig. 6(c)). Furthermore, the structure of the damage layer was observed. As depicted in Fig. 6(b), sporadic defects, including twin structures and stacking faults, were evident in the inner region. Notably, the width of these twin structures was measured at approximately 4.23 nm. The formation of an ordered periodic structure, as demonstrated in Fig. 6(d), was initiated through the alignment of the AB-type structure of two (111) planes within the superficial region, resulting from the vast stacking fault structure. In short, as the depth of the damage layer increases, the stress experienced by the sample gradually decreases, and the defect density also decreases accordingly.

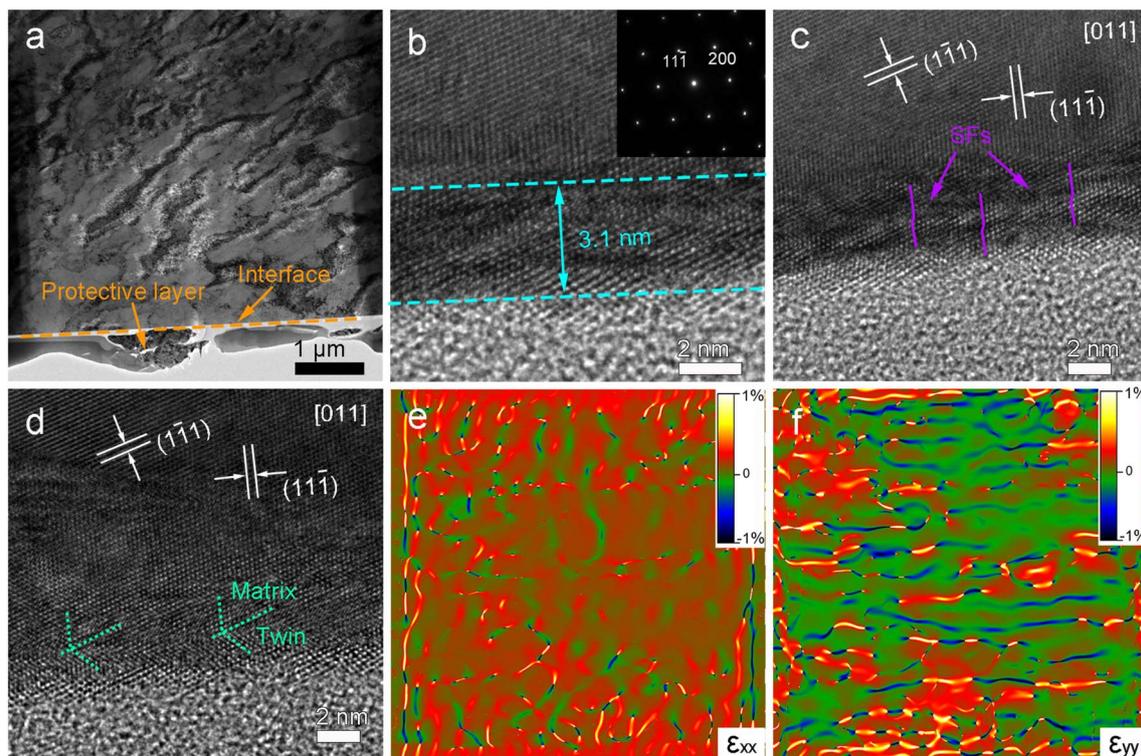
Fig. 7 TEM characterization of the copper subsurface after chemical mechanical polishing. (a) A low-magnification cross-sectional TEM image of subsurface and surface damage, (b) enlarged TEM image of the damaged area, (c) and (d) HRTEM images of different structure defects in different damaged regions, strains maps (e)  $\epsilon_{xx}$  and (f)  $\epsilon_{yy}$  obtained by GPA. The inset in (b) shows the SAED pattern of (b).

After conducting CMP, a TEM cross-section sample was meticulously prepared by employing FIB technology, enabling an in-depth analysis of the damage incurred during the polishing process. As illustrated in Fig. 7(a), a protective layer was strategically employed to shield the damaged layer from the potentially deleterious effects of the ion beam. Within the subsurface realm of the copper sample, a remarkable preservation of its single-crystal state was observed, as vividly presented in the inset of Fig. 7(b). Subsequently, upon scrutinizing the damaged area with precision, it was determined that the thickness of the damaged layer on the polished copper wafer was measured at a mere 3.1 nm, as depicted in Fig. 7(b). Furthermore, diverse damaged areas at distinct locations were meticulously characterized, revealing the presence of stacking faults composed of single-layer atoms, as impeccably exemplified in Fig. 7(c). Fig. 7(d) offers valuable insights into the core structure of twins, each measuring approximately 2 nm in length. To comprehensively assess the stress introduced by the polishing process, a microstrain analysis was conducted on the high-resolution TEM image employing geometric phase analysis (GPA) techniques, as elaborated in prior studies.<sup>45,46</sup> The strain maps meticulously charted the variations along [111] and

[200] directions (Fig. 7(b)). Within these strain maps, regions colored blue denoted compressive strain, whereas red and green regions signified tensile strain and an absence of strain, respectively. Notably, a conspicuous variation in strain was particularly pronounced along the [111] direction, whereas the [200] direction exhibited a notable lack of substantial stress distribution ( $\epsilon_{xx}$  in Fig. 7(e)). It is worth mentioning the presence of a considerable degree of compressive stress between the (111) planes ( $\epsilon_{yy}$  in Fig. 7(f)). The findings highlight that the CMP technology generates processing stress, notably manifesting in a direction parallel to the wafer's surface.

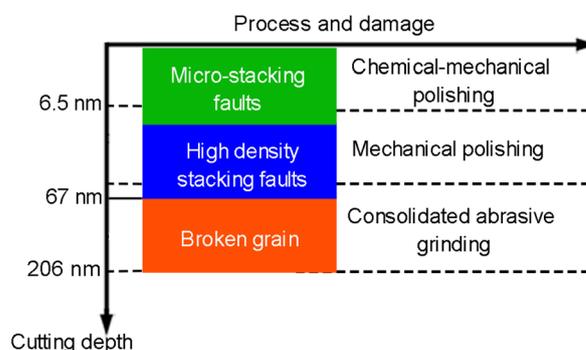
Fig. 8 Diagram of damage evolution under different process conditions.

Cutting depth is a crucial parameter that affects the quality of machining surfaces and the structure of the damage layer. According to the above experimental results, a relationship between the cutting depth and the damage generated during precision machining is established. The cutting depth for different processes was calculated, with specific details explained in the ESI.† The surface damage layer produced by the lapping process contains defects such as lattice distortions, broken grains, and edge dislocations. The surface of the sample was subjected to higher lapping stress, resulting in more severe damage, with a large number of broken grains in the damaged layer. The subsurface, on the other hand, experiences lower lapping stress, leading to relatively lower damage, characterized

by the presence of numerous crystal defects such as high-density stacking faults in the damaged layer (Fig. 8). During the mechanical polishing process, the stress on the copper surface exceeds the MPa level.<sup>19</sup> The damaged layer contains a significant amount of dislocation structures, and the density of dislocations decreases with increasing depth of the damaged layer. Moreover, in chemical mechanical polishing, copper atoms are collectively removed under mechanical and chemical action, forming micro-stacking faults composed of only a few atomic layers on the surface (Fig. 8). In high-precision machining, severe damage caused by broken grains significantly affects the surface quality and material mechanical
