Cite this: *Nanoscale Adv.*, 2024, 6, 2002

The damage mechanism in copper studied using *in situ* TEM nanoindentation†

Dong Wang,^{ab} Zhenyu Zhang,^{ID}*^a Dongdong Liu,^{*a} Xingqiao Deng,^{*c} Chunjing Shi,^d Yang Gu,^e Xiuqing Liu,^e Xiaoyu Liu^e and Wei Wen^f

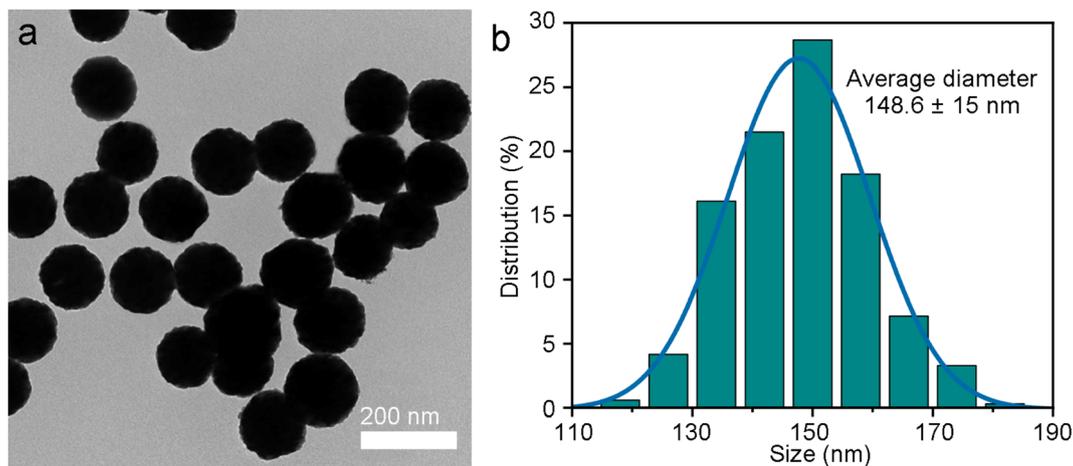
Fig. 5 (a) TEM image and (b) particle size distribution of CeO₂ abrasives.

Mechanical polishing is a precision polishing technology, that mainly relies on very fine polishing powder or polishing slurry lapping, rolling action, removing a layer of extremely thin material on the surface of the sample until the required smoothness is reached.⁴⁴ Fig. 5(a) shows the TEM image of ceria abrasive particles, indicating uniform dispersion of ceria. Particle size statistics revealed a normal distribution for ceria particles, with an average abrasive diameter of 148 nm (Fig. 5(b)).

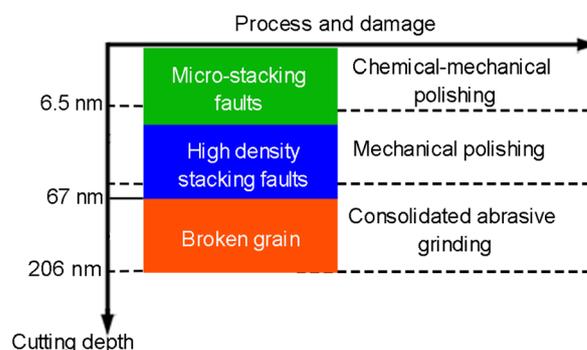
Fig. 8 Diagram of damage evolution under different process conditions.

Cutting depth is a crucial parameter that affects the quality of machining surfaces and the structure of the damage layer. According to the above experimental results, a relationship between the cutting depth and the damage generated during precision machining is established. The cutting depth for different processes was calculated, with specific details explained in the ESI.† The surface damage layer produced by the lapping process contains defects such as lattice distortions, broken grains, and edge dislocations. The surface of the sample was subjected to higher lapping stress, resulting in more severe damage, with a large number of broken grains in the damaged layer. The subsurface, on the other hand, experiences lower lapping stress, leading to relatively lower damage, characterized

by the presence of numerous crystal defects such as high-density stacking faults in the damaged layer (Fig. 8). During the mechanical polishing process, the stress on the copper surface exceeds the MPa level.¹⁹ The damaged layer contains a significant amount of dislocation structures, and the density of dislocations decreases with increasing depth of the damaged layer. Moreover, in chemical mechanical polishing, copper atoms are collectively removed under mechanical and chemical action, forming micro-stacking faults composed of only a few atomic layers on the surface (Fig. 8). In high-precision machining, severe damage caused by broken grains significantly affects the surface quality and material mechanical
