# **RSC Advances**

Cite this: RSC Adv., 2017, 7, 23136

# Effects of the degradation of methane sulfonic acid electrolyte on the collapse failure of Sn–Ag alloy solders for flip-chip interconnections

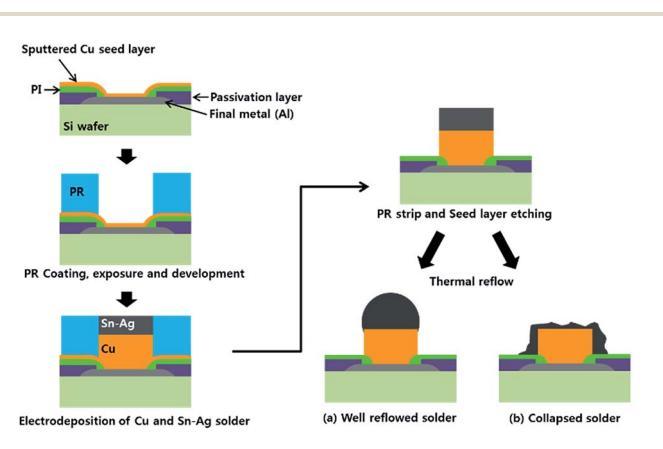
Fig. 1 Schematic illustration of the Cu pillar bump fabrication process; (a) well reflowed solder bump and (b) collapsed solder bump during thermal reflow.

To fabricate Sn-2.3Ag (wt%) alloy solder capped copper pillar bumps, a photo resist (PR) pattern with via hole arrays was fabricated using a conventional industrial photolithography process and mass production tools.1 The electrodeposition of the Sn-Ag alloy was carried out on the Cu stud substrate at a current density of  $-20 \text{ mA cm}^{-2}$  for 600 s in a bath containing 2.0 mol  $L^{-1}$  MSA (CH<sub>3</sub>SO<sub>3</sub>H, Sigma-Aldrich), 0.192 mol  $L^{-1}$  tin methanesulfonate ((CH<sub>3</sub>SO<sub>3</sub>)<sub>2</sub>Sn, Sigma-Aldrich) and 0.008 mol  $L^{-1}$  silver methanesulfonate ((CH<sub>3</sub>SO<sub>3</sub>)Ag, Sigma-Aldrich). In addition to the basic MSA bath, 120 mL L<sup>-1</sup> TS-SLG and 0.005 mol  $L^{-1}$  catechol (C<sub>6</sub>H<sub>6</sub>O<sub>2</sub>) were added as an Ag complexing agent and anti-oxidant, respectively. The electrodeposition of the Sn-Ag alloy solder was conducted using a twoelectrode cell: a Sn plate was used as the anode and a silicon wafer covered with Cu seed and PR via hole patterns (illustrated in Fig. 1) was used as the cathode. All the electrodepositions were conducted at room temperature, 296 K.

After the electrodeposition of the Sn–Ag alloy on the Cu pillar, standard PR stripping and etching of the Cu seed layer were performed.<sup>1</sup> The whole fabrication process for the solder capped Cu pillar bump is schematically illustrated in Fig. 1.

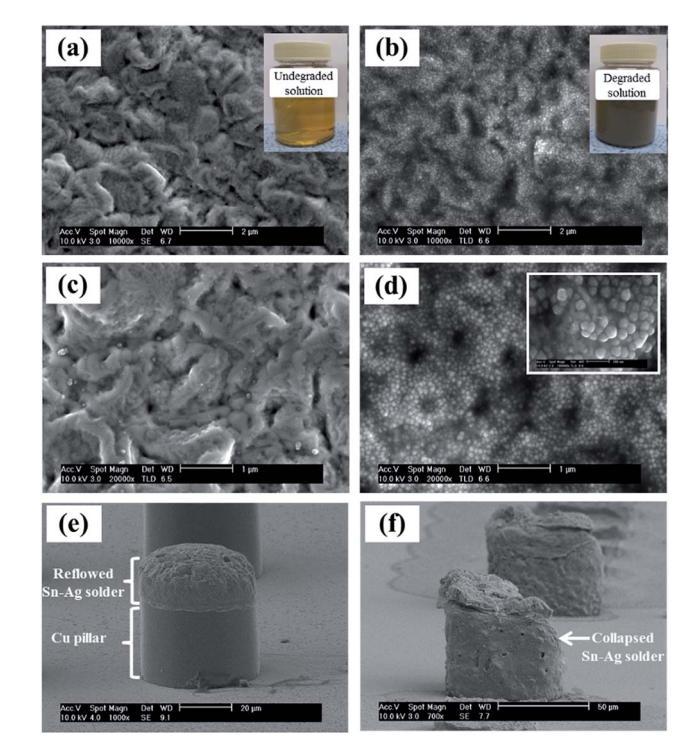
**Fig. 2** The surface morphology of the Sn–Ag alloy bumps electrodeposited from ((a) and (c)) the undegraded bath and ((b) and (d)) the degraded solution. The insets of (a) and (b) are the photos of the undegraded and degraded solution, respectively. Thermal reflowed Sn–Ag solder bumps electrodeposited from (e) the undegraded bath and (f) the degraded solution.

Fig. 2 shows the surface morphologies of the Sn–2.3Ag alloy solder bumps electrodeposited from two different baths, which had been used in the mass-production electroplating process for one week, and three weeks, respectively. The inset images of Fig. 2a and b show the color changes of the solution with time. Typical electroplating baths that contain MSA, tin methanesulfonate, silver methanesulfonate, TS-SLG and catechol are transparent and colorless, but the color of the solution changed to light-yellow after using it for one week, and to muddy gray after using it for three weeks in mass production.

When the Sn–Ag alloy bumps were electrodeposited on Cu pillars from the lite-yellow solution (which had been used for one week), well reflowed Sn–Ag solders could be prepared, as shown in Fig. 2e. The overall morphology of the Sn–Ag alloy bumps electrodeposited from the gray solution (used for three weeks) looked similar to those from the one-week old solution. However, high-magnification SEM images (Fig. 2c and d) reveal

that a Sn–Ag alloy bump electrodeposited from the three-week old solution was fully covered with spherical particles which have diameters ranging between 50 nm and 100 nm, whereas there were no nanoparticles on the bump electrodeposited from the one-week old solution. In particular, the bumps from the three-week old solution completely collapsed and debris was scattered around the Cu pillar bumps after the thermal reflow process (Fig. 2f), which is totally different behavior from that observed in Fig. 2e. Therefore, the results clearly show that the degradation of the electrolyte not only affects the surface morphology of the Sn–Ag bumps, but also leads to the collapse failure of solder bumps during the solder reflow step.

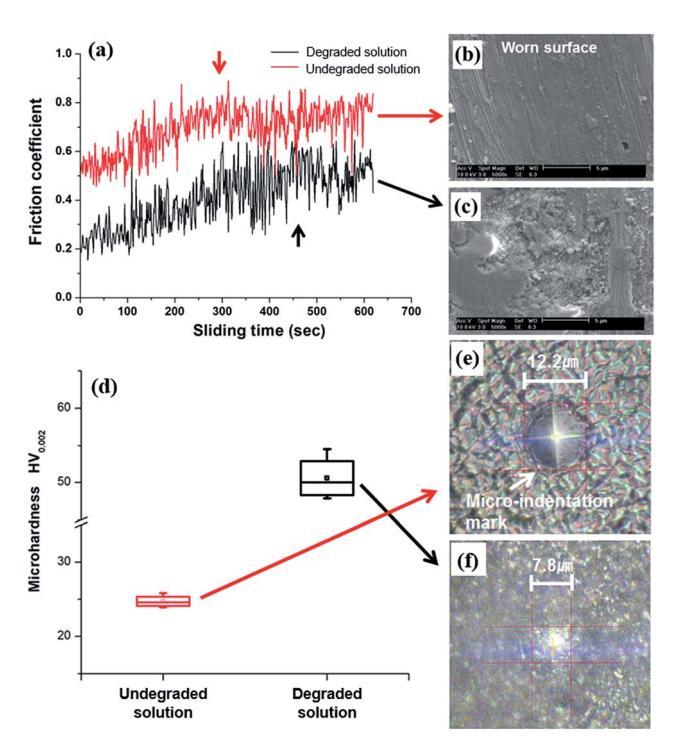
**Fig. 3** (a) Plot of friction coefficient vs. sliding time for two samples slid at a normal load of 20 mN. SEM images of the worn surface of the solders formed from (b) the undegraded bath and (c) degraded bath. (d) The Vickers microhardness values of the samples. Optical micrographs of Vickers indentation (40 mN) on the solders formed from (e) the undegraded bath and (f) degraded bath.

In addition to morphological changes, the mechanical properties of the solder bumps were also significantly affected by the degradation of the bath. Fig. 3 presents the results of the microscale friction, wear and hardness tests for the Sn–Ag alloy bumps prepared from solutions before and after degradation. As the bath was degraded, the coefficients of friction (COF) *vs.* sliding time curves show different tribological behavior (Fig. 3a). The frictional response of the sample formed from the undegraded bath showed an initial COF value of 0.5, and this value settled to 0.75 after 200 s. In contrast, the COF of the sample formed from the degraded bath was 0.2, and this value settled to 0.55 after 450 s. The tribological performance suggests that the degradation of the electrolyte can reduce the friction coefficient of the solder surface by hardening the electrodeposits. As shown in Fig. 3b and c, the wear scar on the surface of

the Sn-Ag electrodeposits prepared from the degraded solution was broader and deeper (0.414 mm<sup>3</sup>) than that of the electrodeposits prepared from the undegraded solution (0.084 mm<sup>3</sup>). Moreover, as shown in Fig. 3d, the hardness of the sample formed from the degraded bath shows the greater hardness value of 50.6 by  $HV_{0.002}$  (Fig. 3f) than the hardness value of the sample formed from the undegraded bath (24.7 by HV<sub>0.002</sub> (Fig. 3e)). These tribological behaviors and the hardening effects are consistent with previous reports<sup>26-28</sup> that discussed the correlation between surface micro-hardness and the surface frictional property. Because the mechanical properties and the melting temperature of solder alloy are highly dependent on the microstructure and the composition of the solder alloy,<sup>29-31</sup> these results suggest that the degradation of the bath has a negative influence on the fabrication of solder bumps. The formation of nanoparticles on the Sn-Ag solder bumps therefore may be one of the major causes of the collapse of the solder bumps during the solder reflow shown in Fig. 2f.

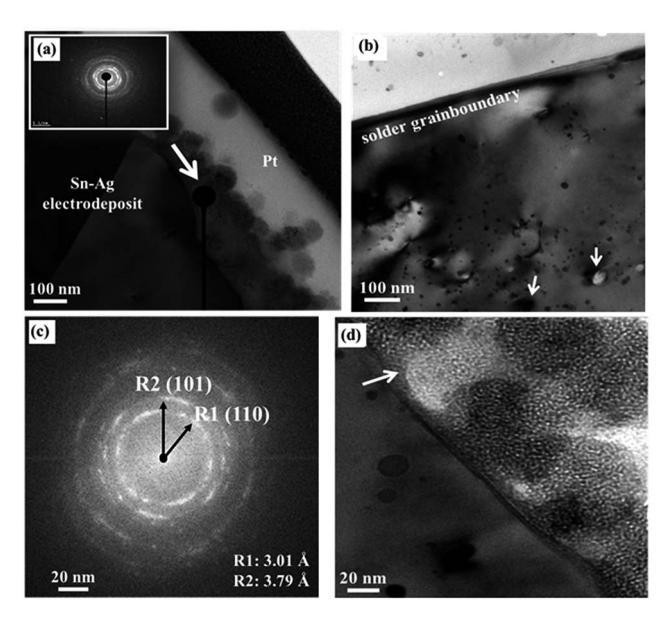
Fig. 4 (a and b) Cross-sectional TEM images and (c) SAED pattern of Sn–Ag alloy solder formed by the degraded electroplating bath showing the deposition of  $SnO_2$  nanoparticles on the surface of the Sn–Ag electrodeposit. (d) The native oxide layer with the meniscus curved shape formed at the interface between  $SnO_2$  nanoparticles and Sn–Ag alloy solder.

To analyze the nanoparticles formed on the surface of the bumps, the Sn–Ag alloy electrodeposits prepared from the degraded solution were further examined using TEM. The crosssectional TEM image confirms the presence of the nanoparticles on the surface of the Sn–Ag alloy solder (Fig. 4a), in accordance with the SEM observation (Fig. 2d). In addition, a number of nanoparticles were also observed embedded in the subsurface layer as well as on the top surface of the solder bump (Fig. 4b). As shown in Fig. 4c, the SAED pattern for these

nanoparticles shows the clear ring patterns of a polycrystalline structure, which are attributed to the (110), (101) and (211) planes of  $SnO_2$ . One notable feature in the HRTEM observation is that a native oxide layer was observed at the interface between the  $SnO_2$  particles and the surface of the Sn-Ag electrodeposits (Fig. 4c). The meniscus shape of the native oxide implies that the  $SnO_2$  particles were probably not acquired during the post electrodeposition process, but rather formed on the surface of the solder layer during the electrodeposition process.

During the electrodeposition of the Sn–Ag alloy, the application of an electric field induces a coulombic force on the SnO<sub>2</sub> particles, and thus positively charged SnO<sub>2</sub> particles approach the negatively charged working electrode. This phenomenon is the well-known phenomenon of electrophoresis.<sup>37</sup> Therefore, it can be assumed that the electrophoretic deposition of SnO<sub>2</sub> nanoparticles occurs simultaneously with the electrodeposition of Sn–Ag alloy, which results in the incorporation of nanoparticles into the subsurface layer as well as the deposition on the top surface of the solder bump (Fig. 4b).

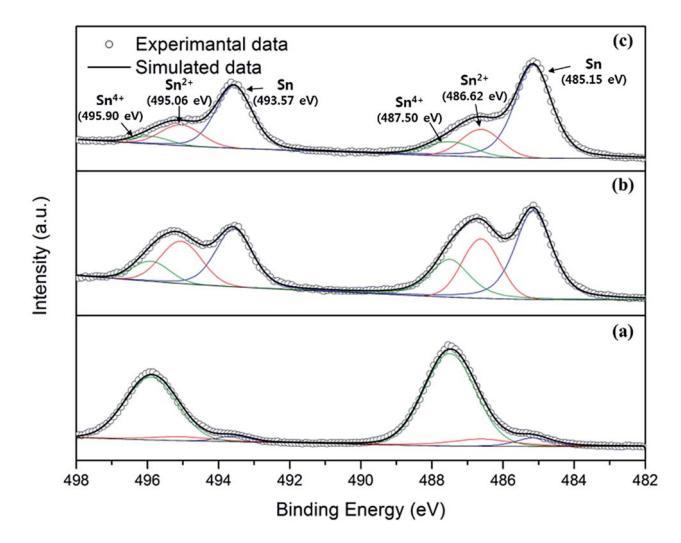
Fig. 5 Sn 3d XPS spectra of the electrodeposited film covered with spherical particles obtained from the degraded bath: (a) w/o ion etching, (b) with ion etching for 300 s and (c) with ion etching for 540 s.

To reveal their exact chemical compositions, XPS analysis was performed on the electrodeposited solder formed by the degraded solution. As shown in Fig. 5, the XPS spectra show the single peak curves of the surface (without ion etching) and double peak curves of the subsurface (after ion etching for 300 s and more). This indicates that Sn<sup>4+</sup> was the dominant species on the top surface, but the subsurface was composed of Sn, Sn<sup>2+</sup> and Sn<sup>4+</sup>. Since the Sn<sup>2+</sup> and Sn<sup>4+</sup> spectra are still substantial at the deep subsurface exposed by ion beam etching for 540 s, it can be deduced that the deep subsurface and the top surface of the solder formed from the degraded bath were substantially composed of stannous and stannic oxide. According to a previous report,32,33 an oxidation layer with a thickness of less than a few tens of nanometers formed on the Sn-based solder surface can significantly affect its solderability due to the non-wetting behavior between the solder bump and solder on the pad substrate. In this respect, the existence of a thick oxide layer mainly composed of SnO<sub>2</sub> nanoparticles (tens of nm) is expected to degrade the solder wetting property18 and lead to failures, such as the collapse of the solder bumps during the solder reflow.

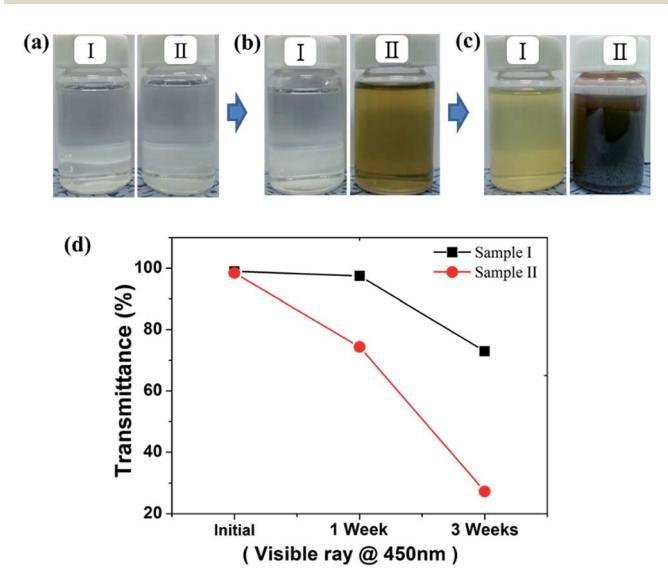
**Fig. 6** The color changes of (I) the Sn–MSA solution and (II) Sn–MSA with Ag cations (a) as prepared, (b) after a week and (c) after 3 weeks. (d) The transmittance of a visible ray at 450 nm wavelength for the solutions with time.

As shown in Fig. 6b and c, when Ag ions coexist in the Sn–MSA bath (solution II), the color changes are more obvious and much faster than in the Ag-free bath (solution I). While the color of solution I changed to a light yellow, the color of sample II changed to dark gray after three weeks, followed by the precipitation of a gray colored sludge. The transmittance of visible light at 450 nm through the degraded solution II decreased to below 30% after 3 weeks, whereas solution I retained ~60% of its transmittance (Fig. 6d).

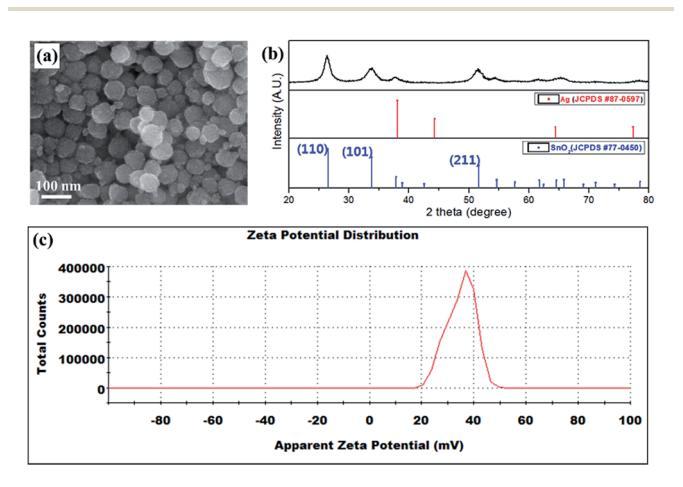
Fig. 7 (a) SEM image and (b) XRD pattern for the precipitated  $SnO_2$  particles extracted from sample II shown in Fig. 6(c). (c) A surface zeta potential graph of  $SnO_2$  particles precipitated from the degraded bath (pH 1.8).

To analyze the species that precipitated after degradation, sludge particles were obtained by centrifugal separation. As shown in Fig. 7, the morphology and size of the particles were similar to the  $SnO_2$  nanoparticles deposited on the surface of the Sn-Ag bumps (Fig. 2d). In addition, all of the peaks in the diffraction pattern of the sludge particles matched that of crystalline  $SnO_2$  (JCPDS no. 77-0450). Therefore, it can be assumed that the  $SnO_2$  nanoparticles observed on the surface of the Sn-Ag bumps are formed in the solution through spontaneous chemical reactions, not during the electrodeposition.

Fig. 7c shows that the zeta potential of the precipitated  $SnO_2$  particles in the degraded bath is about 35.1 mV. The result indicates that the surfaces of the  $SnO_2$  particles are positively charged in the degraded bath (pH 1.8), which is consistent with a previous study that  $SnO_2$  particles have positive zeta potentials in the pH range below 4.3, and
