RSC Advances

Cite this: RSC Adv., 2018, 8, 30155

Corrosion behaviour of welded low-carbon steel in the Arctic marine environment[†]

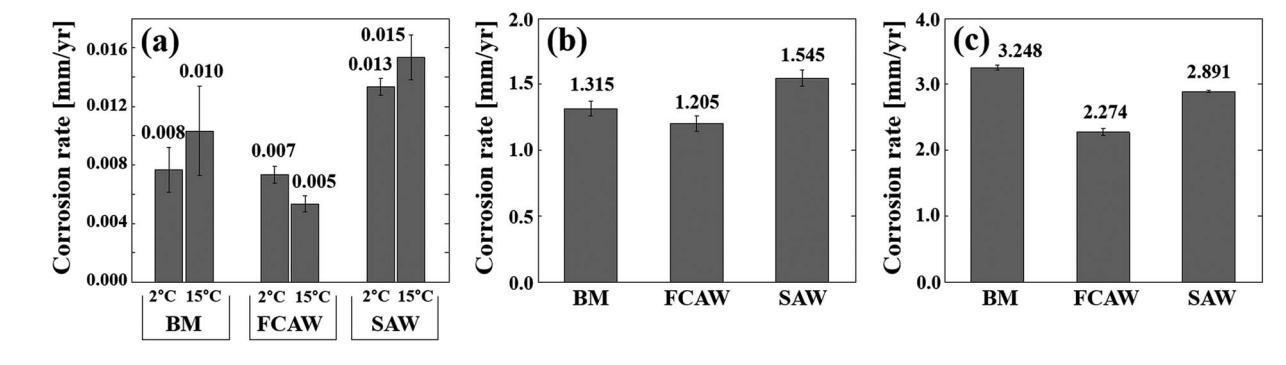
Fig. 1 Corrosion rates of experimental specimens obtained from various corrosion tests. (a) Immersion test, (b) salt-spray test, and (c) cyclic corrosion test.

Concerning the immersion test results (Fig. 1a), the corrosion rate of all specimens showed a satisfactory value of $0.005-0.015 \text{ mm y}^{-1}$. The degree of corrosion was in the order of FCAW < BM < SAW, and the difference between BM and FCAW was very small. The BM specimen showed a slight higher corrosion rate than FCAW but lower than SAW, thus the degree of corrosion was in the order of FCAW < BM < SAW. As the seawater temperature decreased, no noticeable decrease in corrosion was observed. No pitting corrosion was found, and partial red-brown general corrosion was observed.

In the salt spray tests (Fig. 1b), the corrosion rate was 1.205– 1.545 mm y^{-1} , which is 70 times higher than that measured in the seawater immersion tests. This indicates that the base material is very weak in salt spray exposure conditions. The corrosion tendency was similar to the results of immersion test in the order of FCAW < BM < SAW. In general, SST is less relevant to reproduce practical corrosive conditions, but tests were conducted to compare corrosion differences between specimens under constant temperature conditions in saline conditions and for comparison with the CCT test results.

Fig. 1c, serious corrosion rate in the range of 2.274 to 3.248 mm y⁻¹ was confirmed. The degree of corrosion was in the order of FCAW < SAW < BM, and the formation of a significant rust layer was visually observed (ESI†). The corrosion level determined from the CCT was more than 130 times higher than the seawater immersion test, and it was confirmed that the corrosion change of the steel was caused by the repeated wetting and drying, as well as temperature changes. In particular, by comparing the results shown in Fig. 1a and b we confirmed the specific corrosion of the BM is slightly higher than FCAW but much lower than SAW. This is important information for base metals and weld joints in the design of the offshore materials; thus, we identified the causes.

As shown in Fig. 1, the corrosion trends for the BM and the WM under Arctic conditions were confirmed. In the submerged simulated condition test, rust was produced in the form of general corrosion, but it was difficult to visually distinguish the corrosive difference between the BM and the WM specimens because of the small amount of corrosion. However, when comparing the corrosion rates *via* measuring the weight loss, the values for the WM specimens were generally higher than those of the BM specimens. This indicates that the corrosion influence on FZ or HAZ is relatively higher than those of the PM.

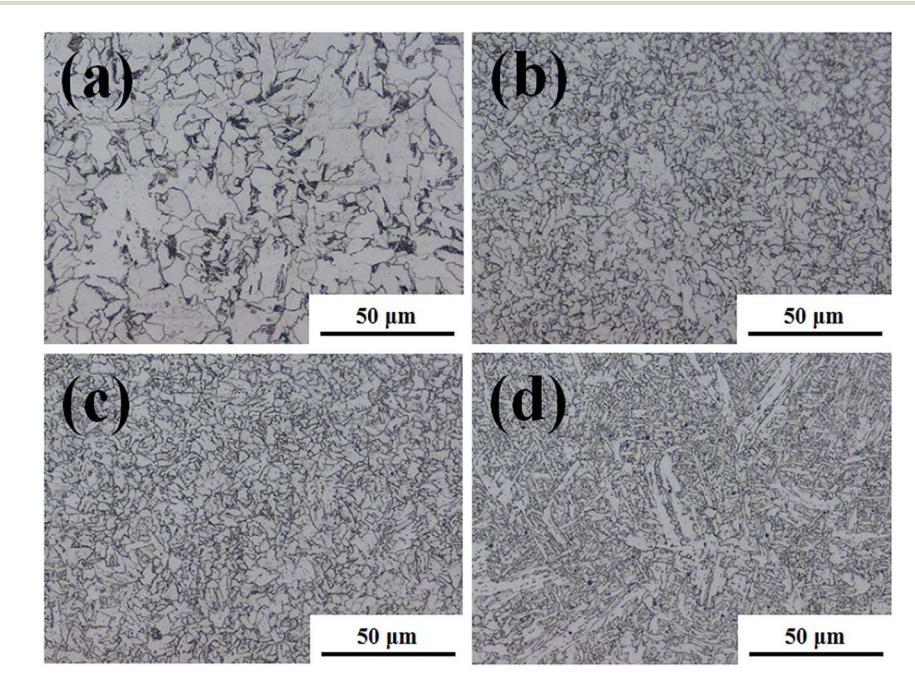
Fig. 2 Microstructural characterisation of the welded joint of FCAW specimen. (a) Parent metal (PM), (b) coarse grain heat affected zone (CGHAZ), (c) fine grain heat affected zone (FGHAZ), and (d) fusion zone (FZ).

The microstructures were analysed to explain the corrosion of the BM. This is because local differences in microstructure, such as grain size and elemental microcomposition, can give rise to different corrosion properties. Therefore, the microstructure can be used to compare the corrosion difference between the FZ and PM in the specimen. Fig. 2 and 3 exhibit the microstructure morphology of FZ, coarse grain heat affected zone (CGHAZ), fine grain heat affected zone (FGHAZ), and PM in the FCAW and SAW test specimens. In the case of the FCAW test specimen, the PM phase was mainly quasi-polygonal ferrite + acicular ferrite + pearlite, FGHAZ was bainitic ferrite + granular bainite + acicular ferrite, CGHAZ was granular bainite +

martensite + acicular ferrite, and FZ was acicular ferrite + martensite. Ralston and Birbilis reported that a finer microstructure gives rise to a more reactive surface as a result of the smaller grains and more grain boundaries, making the surface more prone to corrosion.²¹⁻²³ In addition, bainite is nobler than ferrite; thus, a ferrite-bainite microstructure results in galvanic corrosion.²⁴ In practice, the coexistence of ferrite and bainite phases in the HAZ is expected to result in more corrosion than in the FZ (ferrite + martensite) and PM (ferrite + pearlite). Considering the grain size, HAZ was found to have smaller grains than the PM, and the WM was found to have a dense needle-like structure. Bhagavathi reported that a ferriticmartensitic microstructure shows decreased galvanic effects because of the similarity between BCC and BCT crystal structures.25 However, it has been reported that the corrosion rate of ferrite-martensite is higher than that of the ferrite-pearlite phase;²⁶ thus, the corrosion of the FZ would be higher than that of the PM and lower than that of the HAZ. Therefore, considering the microstructure, it is expected that corrosion progresses in the order of PM < FZ < HAZ in the welding joint of FCAW. In the case of the SAW test specimen, the PM phase was mainly quasi-polygonal ferrite + acicular ferrite + pearlite, FGHAZ was quasi-polygonal ferrite + acicular ferrite + granular bainite, CGHAZ was quasi-polygonal ferrite + acicular ferrite + granular bainite, and FZ was granular bainite + quasi-polygonal ferrite + acicular ferrite. Based on observation, HAZ has the smallest grain size and shows a ferrite-bainite structure with a high ferrite ratio. Therefore, it is expected that the corrosion rate of HAZ and FZ will be higher than that of PM because of the galvanic couple corrosion of ferrite-bainite microstructure. Consequently, if we predict the corrosion tendency of the structures, the corrosion of the HAZ should be the worst, and

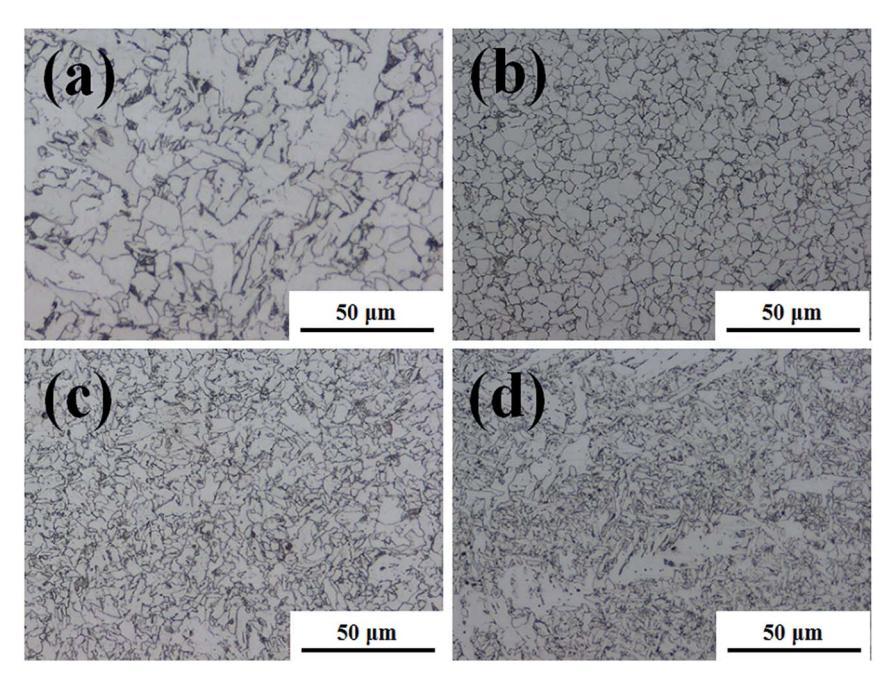
Fig. 3 Microstructural characterisation of the welded joint of SAW specimen. (a) Parent metal (PM), (b) coarse grain heat affected zone (CGHAZ), (c) fine grain heat affected zone (FGHAZ), and (d) fusion zone (FZ).

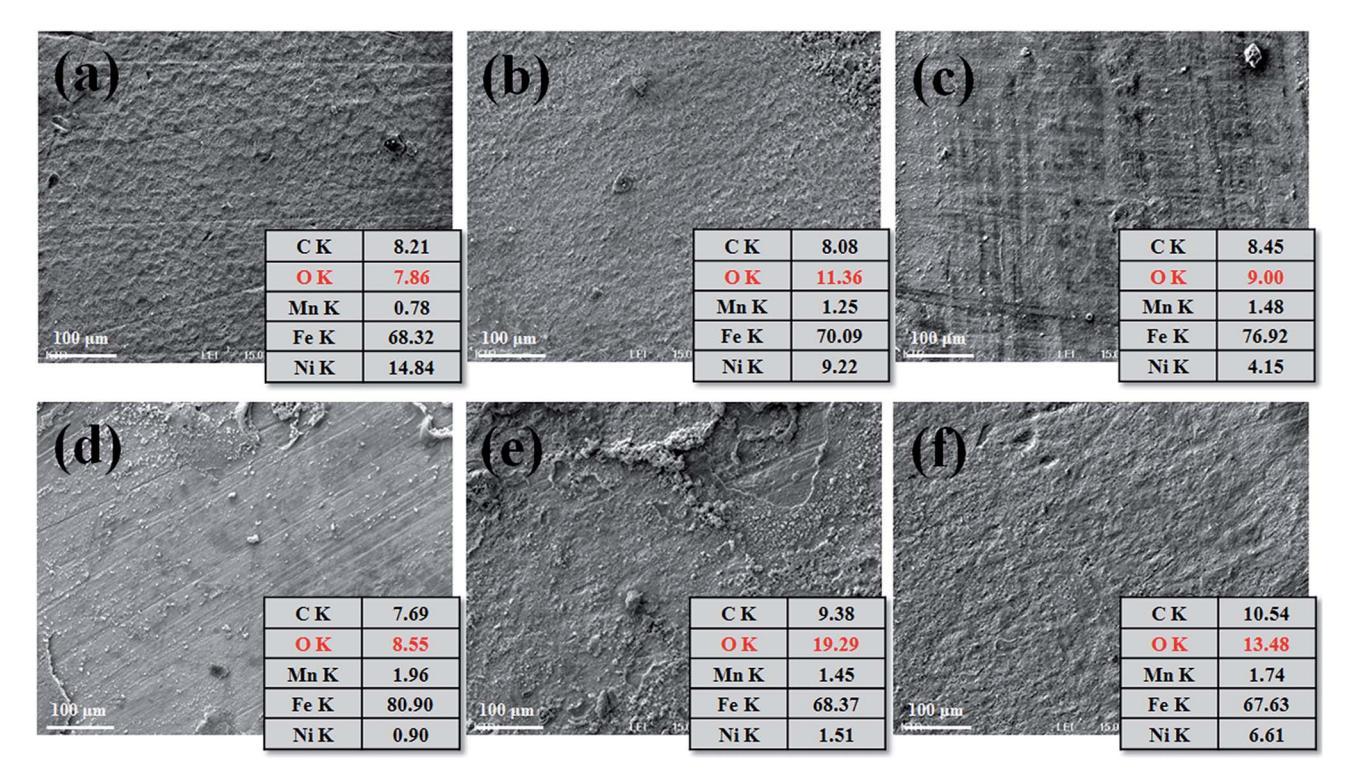
Fig. 4 SEM and EDS characterisation of the corroded surface of (a) FCAW-PM, (b) FCAW-HAZ, (c) FCAW-FZ, (d) SAW-PM, (e) SAW-HAZ and (f) SAW-FZ specimens after one cycle of CCT (wt%). The EDS data were obtained over the entire area shown in each SEM image.

Fig. 4 shows the surface morphology and EDS analysis results of FCAW and SAW specimens. In general, rust is comprised of various types of oxides: hydrated oxides, oxyhydroxides, and miscellaneous crystalline and amorphous substances, but all components are mainly composed of iron and oxide.29 Therefore, measuring the oxygen ratio in the rust layer can provide information about the progression of corrosion under equal exposure conditions. Therefore, to understand the initial corrosion, the chemical composition of the rust layer was analysed at representative positions but excluding the severely corroded region after one cycle of CCT. As shown in Fig. 4, general corrosion occurred over the entire area. In both case of FCAW and SAW, corrosion progressed in the order of PM < FZ < HAZ. Therefore, we confirmed that the corrosion of the PM region progresses the least during the initial corrosion stage.

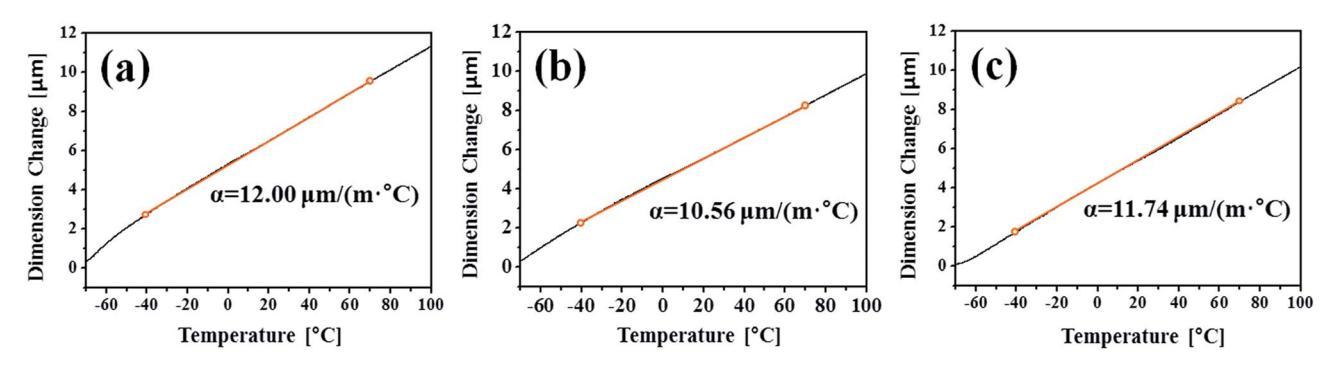
Fig. 5 TMA curves and the coefficient of thermal expansion (CTE) of samples of the (a) base metal (BM) and (b) fusion zone (FZ) of the FCAW specimen and the (c) FZ of the SAW specimen.

The CCT was characterised by adding a temperature change condition to the SST in consideration of the Arctic environment. In fact, comparing the corrosion in the splash and submerged zones, the splash zone condition is more severe considering the repeatability of the wetting/drying conditions arising from wave action and the daily temperature difference depending on the wind speed and seasonal differences. Therefore, thermal expansion measurements were conducted to confirm whether the temperature change affects the corrosion tendencies of the specimens. Fig. 5 shows the CTE measurement data from -50 to 100 °C, where the CTE is calculated based on the practical experiment range. As a result, the values for the BM, FCAW, and

SAW were 12.00, 10.56, and 11.74 μ m (m °C)⁻¹, respectively. Thus, the CTE of BM was highest. Because the CTEs of iron oxides are less than 8.5 µm (m °C)⁻¹ below 100 °C,³⁰ thermal stress occurs between the oxide and metallic layers. Therefore, it is expected that cracks will occur in the iron oxide layer at the locations where the stress is concentrated during corrosion. When the oxide layer on the surface is thick, the layer is damaged by the relatively high thermal deformation of the BM, and continuous corrosion will progress around the damaged locations. Fig. 6 illustrates the schematic corrosion progression pattern in the WM through the CCT. After the initial rust layer is formed, corrosion progresses in the order of PM < FZ < HAZ, depending on the corrosion potential. However, after a certain thickness of rust layer has developed, cracks with relatively high density occur in the PM, which ensures the most stress because of repeated temperature changes. These cracks provide paths for water, oxygen, and other corrosive substances to enter and cause additional corrosion. The protective density and adherence of the rust layer depend on the duration wetness;²⁹ thus, the existence of marine components (chloride) and long relatively long wet/dry cycles may produce unstable rust layers that possess many defects (holes and cracks). The defects inhibit the evaporation of trapped water; therefore, rapid oxidation occurs and reduces the compactness of the rust layer on carbon steel.³¹ Thus, when corrosion progresses in the medium-and long-term, corrosion mostly occurs in the PM as a result of the influence of stress due to the differences in the CTE of each specimen. This means that the importance of impact on the corrosion rate is

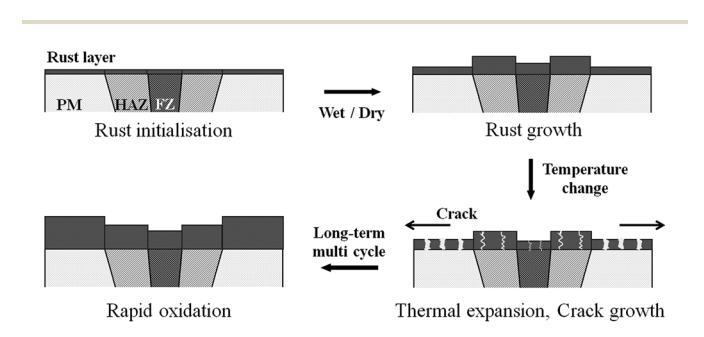
Fig. 6 Schematic of the rapid oxidation of the parent metal (PM), heat affected zone (HAZ), and fusion zone (FZ) under CCT conditions.
