RSC Advances

Characteristics of water quality and bacterial communities in three water supply pipelines[†]

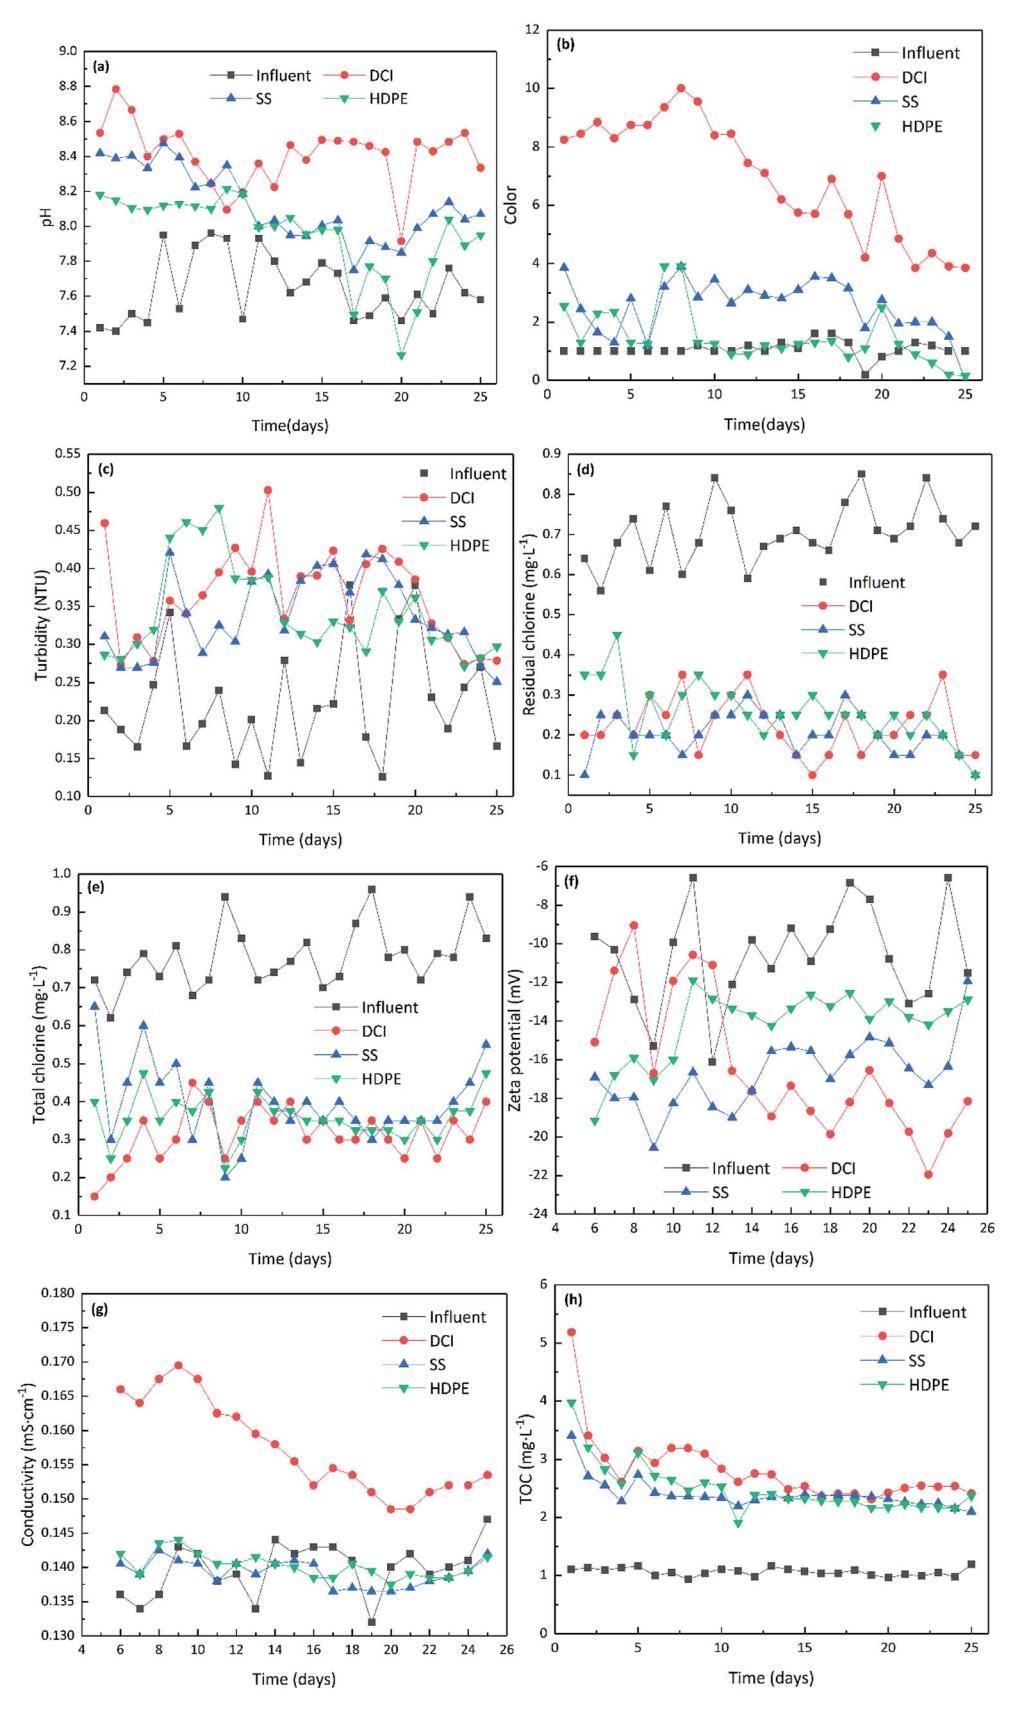
Water quality variations of the influent and effluents are shown in Fig. 1 and S2.† Fig. 1 (line chart) shows the changes in water quality index with the increase in running time within 25 days; moreover, Fig. S2† (box-plot) shows the overall situation of the water quality index over these 25 days.

Fig. 1 Variation of water quality in AR systems.

3.1.1 pH. Due to the different materials, there were significant differences in the effluent pH of the three tubings. As shown in Fig. 1(a) and S2(a),[†] the effluent pH values of the three tubings were always significantly higher than those of the influent, with that of the DCI pipe being the most significant. As shown in Fig. 1(a), when the pH of the influent was between 7.5 and 8.0, the pH of the effluents increased during operation, with the pH of the DCI pipe effluent always higher than 8.0, up to a highest pH of 8.8, while the pH of the SS and HDPE tubes was always less than 8.5. In the later stages of operation, the pH of the SS effluent was maintained at about 8.0, and the pH of HDPE was different from that of the influent. The laboratory simulation results are basically consistent with the actual water sample analysis results (ESI 2[†]). Although the lining of the DCI can protect the iron from corrosion, the dissolution of alkaline substances in the lining cause the pH to rise.28,41,42 Slaats et al. found that the corrosion of the inner walls of cementcontaining pipes involves the leaching of hydroxides, causing pH changes and resulting in scaling in the water mains and domestic installations.43 Bonds et al. reported that cement linings prevent tuberculation by creating a high pH at the pipe wall; moreover leachates from the uncoated cement lining can cause an undesirable rise in the pH of the water, particularly under low flow conditions in small-diameter pipes.44 Due to the long HRT of this test (24 h), the dissolution of the DCI pipe resulted in a significant increase in pH.43

As shown in Fig. 1(b) and S2(b),† during operation, the colour increase of the DCI pipe was significant, always higher

than that of the SS and HDPE pipes, such that the colour reached 10, and the colour of effluent in the SS and HDPE pipes also increased; however, the colour was maintained at within 4, and there was not much difference between the late effluent and the influent. Previous studies have found that the colour of the DCI pipe can significantly increase, mainly due to the dissolution of ferric ions contained in the iron-aluminum tetracalcium $(4CaO \cdot Al_2O_3 \cdot Fe_2O_3)$ in the cement mortar lining.^{41,42} Li *et al.* reported that the elevated pH is accompanied by high alkalinity, whereby CO_3^{2-} in bulk water might react with the iron release to generate poorly settling substances, such as siderite (FeCO₃), resulting in a rise in turbidity and colour.⁸

It can be seen from Fig. 1(c) and S2(c)[†] that, during operation, the turbidity of the effluent from the three tubings increased significantly. Among these, the HDPE pipe increased significantly in the first 10 days, and the effluent turbidity of the DCI pipe was unstable. Only the SS pipe remained at 0.35 NTU, and the turbidity of water from the latter three tubings was less than 0.3 NTU. During operation, the effluent turbidity of the three tubings were generally higher than the influent. The main reason for the turbidity characteristics of this kind of change may be due to the water being renewed every day, whereby the residual chlorine quickly kills the surviving microorganisms, making it difficult for the microorganisms to produce more extracellular secretions that can increase turbidity in the environment,45 and the lining of the DCI pipe provides a haven for a small number of microorganisms. Also, the turbidity in the DCI pipe is more significant than that in the water from the SS and HDPE pipes. Simoes et al. reported that biofilm growth in DWDS contributes to the accumulation of inorganic particles, whereby any inorganic particle passing nearby (e.g. corrosion products, clays, sand) may be incorporated in the biofilms, in the distribution network, which are responsible for discoloured water and are a persistent cause of customer dissatisfaction.³¹

As shown in Fig. 1(d) and S2(d),[†] the trends in the consumption of residual chlorine in the three tubing sample

The zeta potentials were negative during the operation of the three tubing types in this research. Fig. 1(f) and S2(f)[†] show the zeta potential change. The zeta potential of the DCI pipe was gradually reduced from the initial -15.1 mV to -18 mV. The zeta potential of the SS pipe was relatively stable and was maintained at around -15 mV. The initial zeta potential of the HDPE pipe reached -19.1 mV, and this gradually increased and was maintained at -13 mV in the later stage. Previous studies have shown that under alkaline conditions, the zeta potential of the system is lower than that under acidic conditions, and the

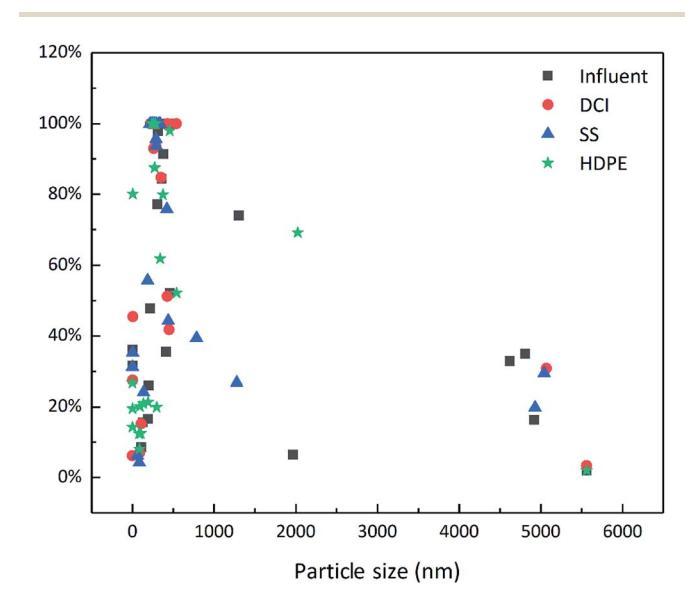
Fig. 2 shows the particle size distribution of the influent and effluents within 25 days. The particle size range (abscissa) of the particulates can be obtained from the particle size frequency distribution map, while the frequency (ordinate) of the particle size of each particulate within the particle size range can be quantified by the content of each particle size fraction present in the water. From Fig. 2, it was found that the soild content of the influent was lower, and the content of small particle sizes was more significant, with particles mainly concentrated in the 0 to 200 nm fraction, while the content of particles in the 400 to 600 nm fraction was relatively small. The large particle sizes in the effluent in the DCI and the SS pipes increased, mainly being concentrated in the 200 to 600 nm fraction, and their distribution at 400 nm was more concentrated. This is consistent with the particle-size distribution of the actual water sample (ESI 2[†]). The particle size of solids in the HDPE pipe samples showed no obvious change compared to the influent. Simoes et al. reported that biofilm growth in DWDS contributes to the accumulation of inorganic particles.31 Slaats et al. reported that when the pH increases, calcium carbonate can precipitate on

Fig. 2 Frequency distribution of particle size in the influent and effluents.

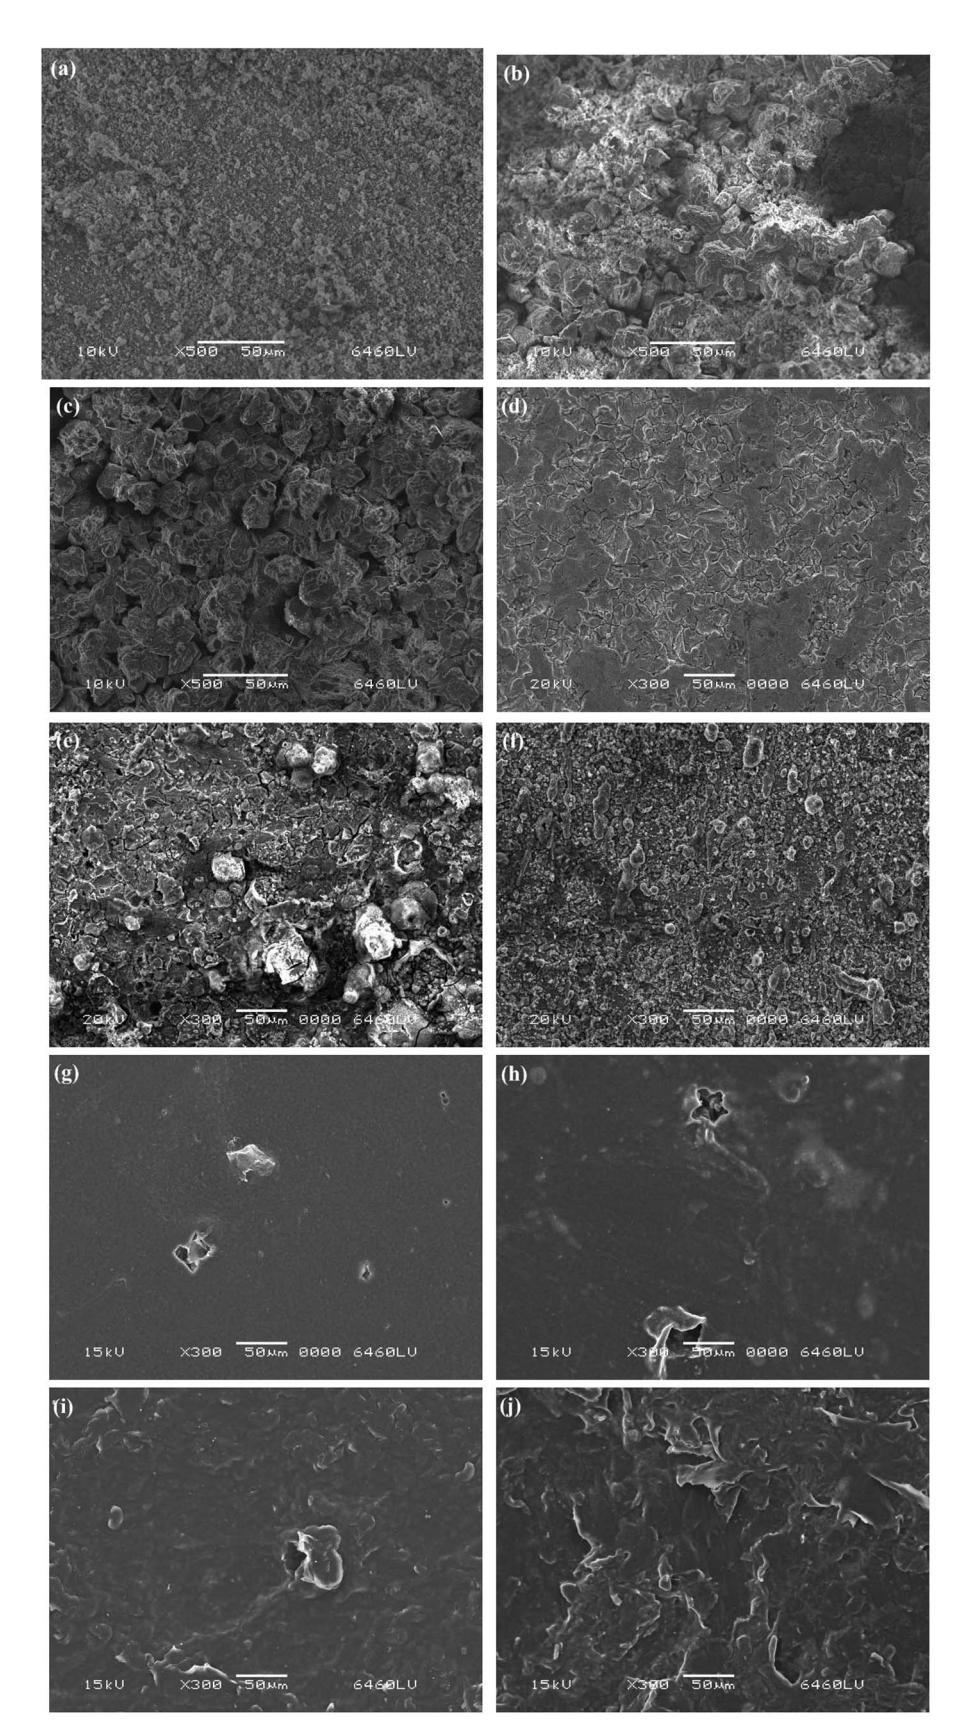
3.2.1 Micromorphology. Representative SEM images of the tubing inner walls during the different running stages are shown in Fig. 3, where it can be seen that the different tubing materials showed significant differences during operation, and even various different microstructural features could be seen in the same tubing samples.

Fig. 3 SEM image of the pipeline inner wall in the three different stages.

As shown in Fig. 3, the microstructure of the DCI pipe inner wall was loose and porous in the form of fine sand before running (Fig. 3(a)); then, relatively dense small grains appeared on the 14^{th} day (Fig. 3(b)), and these became more prominent on the 25^{th} day (Fig. 3(c)). Bonds *et al.* reported that the cement-mortar lining of DCI has cracks that can close and thereby the lining becomes tight after a period of exposure to water, but also the cement will eventually undergo autogenous healing, a phenomenon long recognised by the concrete industry and which occurs due to the formation of calcium carbonate and the continuing hydration of cement grains in the lining.⁴⁴

The SS pipe inner wall had a loose porous texture before running (Fig. 3(d)); then, obvious corrosion scales on the inner wall structure could be seen on the 14th day (Fig. 3(e)), and later the corrosion tubercles became smaller, and the inner walls were denser on the 25th day (Fig. 3(f)). These SEM images of SS are similar with the previous report.^{75,76} However, the corrosion of the SS pipe may not be that easy, as Zhang *et al.* reported that some loose floccus seen on the surface of their sample could represent the metabolites of bacteria.⁴⁰

Before running (Fig. 3(g)), and on the 14th day (Fig. 3(h)), the HDPE pipe inner walls were smooth, with obvious point-like small holes seen before running; the perforations therein increased, and the damage to the inner wall was clealrly intensified on the 14th day, and then inner walls had become rough and compact by the 25th day (Fig. 3(i) and (j)). Leban *et al.* reported that the corrosion products were deposited especially around the perforation, with the shape of the perforations found on the pipe being of irregular shape with sharp angles.⁷⁵ These SEM images of HDPE are similar with the fouled membranes deposits and bacterial cells in the reports of Ayache *et al.*⁷⁷ and Rożej et al.⁶⁸, which imply that it is likely to be a change caused by biofilm formation or particle attachment.

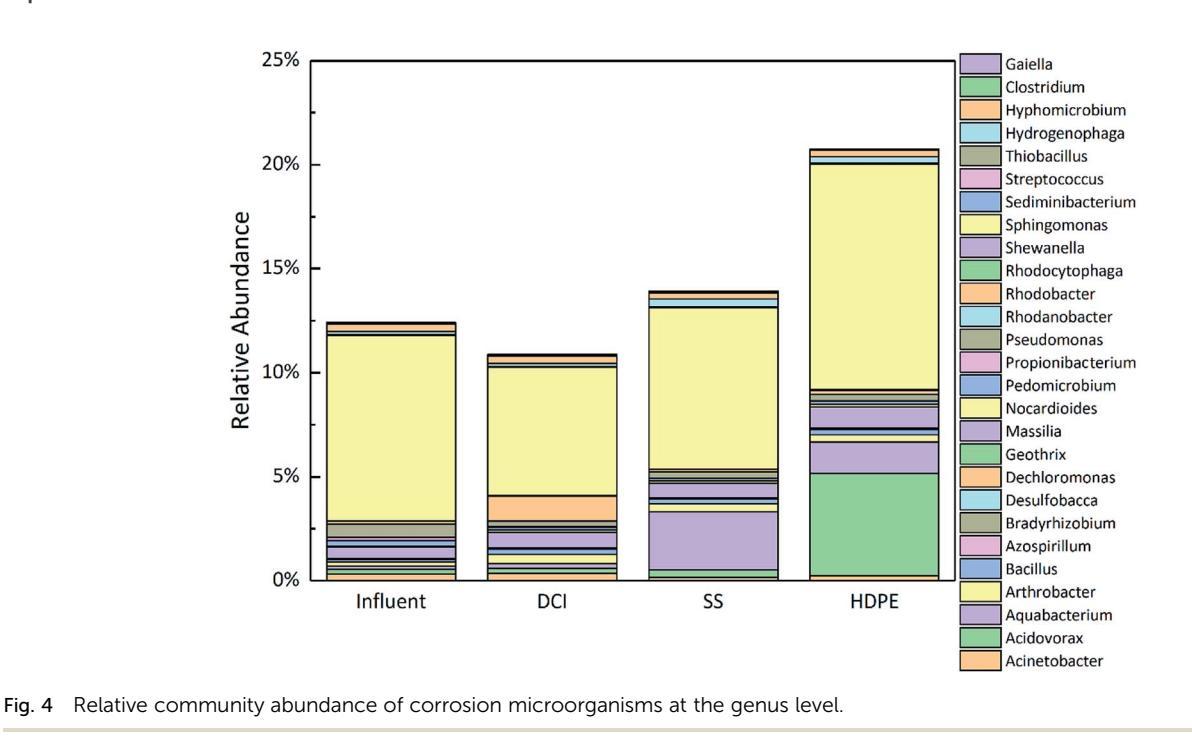
The relative abundance of the various corrosive-related bacteria in the influent and different pipeline effluents are shown in Fig. 4. *Sphingomonas* was dominant in both the influent and effluent of the three tubing material samples (8.9209%, 6.1609%, 7.7781%, and 10.8632%, respectively), followed by *Pseudomonas* (0.6265%) and *Massilia* (0.5473%) in the influent, *Rhodobacter* (1.2033%) and *Massilia* (0.7555%) in the DCI tube effluent, *Aquabacterium* (2.8047%) and *Massilia* (0.6892%) in the SS tube effluent and *Acidovorax* (4.9221%) and *Aquabacterium* (1.5092%) in the HDPE tube effluent. It could thus be seen that the different tubing materials affected the different corrosive bacterial communities.^{28,45,82,84,87,95,96}

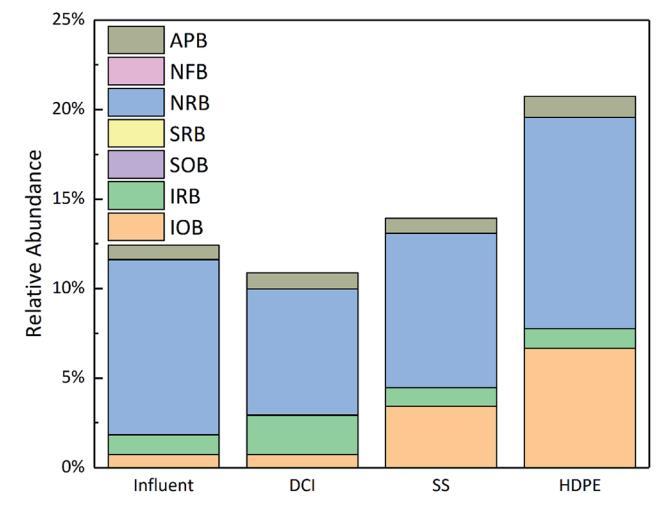
In Fig. 5, the bacterial community was counted according to the different functional types. It was found that NRB was always the most corrosive bacteria in the water from the influent to the effluent. Compared with the pipeline microbial community found in previous research, the relative abundance of the microbial community in this study was relatively low, mainly due to the initial use of new pipelines, and as stable microbial community structures had not yet formed inside the pipeline. Previous researchs has found that Acidovorax (IOB), Aquabacterium (IOB), Sediminibacterium (IOB) and Desulfobacca (SRB) promote corrosion, while Thiobacillus (SOB), Geothrix (IRB), Pseudomonas (IRB) Bacillus (IRB), etc. suppress corrosion.^{24,97–99} Therefore, it can be found from the overall microbial community structure that the microbial community that inhibits corrosion in the pipeline gives the main benefit, whereby the deterioration of the water quality of the pipeline is reduced and the corrosion of the inner wall of the pipeline is reduced.

Fig. 5 Relative abundance of different corrosive functional bacteria at the genus level.
