Failure behavior of nylon products for red phosphorus flame retardant electrical connectors

The failure behavior of red phosphorus flame retardant electrical connectors was investigated by their thermal degradation, changes of surface morphology and elements under an accelerating environmental experiment. The results showed that the nylon electrical connector degraded and cracks were generated on the surface. The temperature of maximum weight loss rate was advanced in the thermogravimetric analysis and the third weight loss peaks appeared after 28 days. The relative atomic content of O and P increased from 0 day to 28 days. The chemical environment of C changed. Partially, C–C bonds broke and became C–O bonds. The release of phosphine increased and this further oxidized to an acid with P=O and P-O groups in a warm and humid environment.

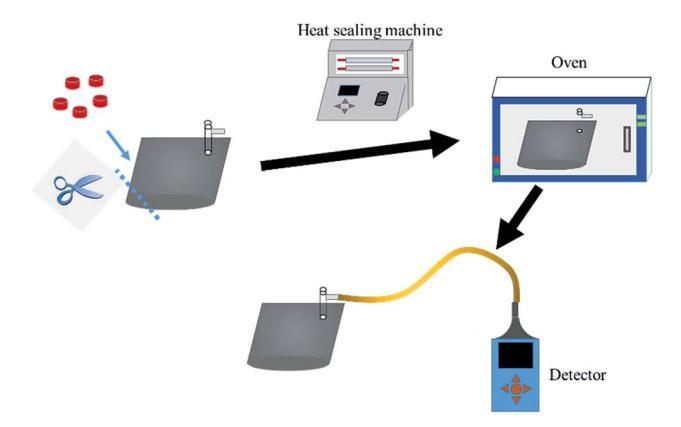
Fig. 2 Schematic diagram of phosphine detection.

Phosphine released by red phosphorus would rapidly reacts with air and water to form an acid under high temperature and humidity. In order to determine phosphine release, 2 g product was deposited in a sealed and dried 500 ml aluminum foil gas collection bag (Fig. 2). After 7 d, 14 d and 21 d, the concentration of phosphine gas in the bag was determined by the BH-90A phosphine detector.

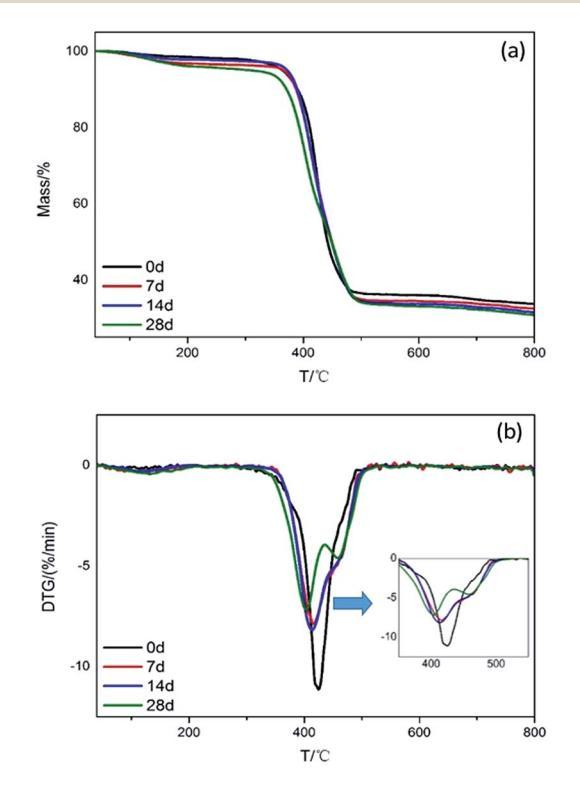
Fig. 3 TGA and DTG curves of connectors in N₂ atmosphere.

Thermal degradation behaviors of the connectors were investigated by TG and DTG, corresponding curves and data are

presented in Fig. 3 and summarized in Table 1. As the environmental test progressing, the initial decomposition temperature ($T_{5\%}$, temperature based on 5% mass loss), the maximum mass loss rate (R_{max}), temperature corresponding to the maximum mass loss rate (T_{max}) and the value of char residues (CR) for connectors at 800 °C all reduced, indicating that the thermal stability of connectors exposed to high temperature and humidity environment diminished. The appearance of the mass loss rate peak for 28 days indicates that the connector produced a new component in the high temperature and humidity environment. Reduced CR indicated that the phosphine released from red phosphorus reacted with water to form various oxygen-containing, phosphorus-based acids, such as phosphoric acid, phosphorous acid, and hypophosphorus acid,

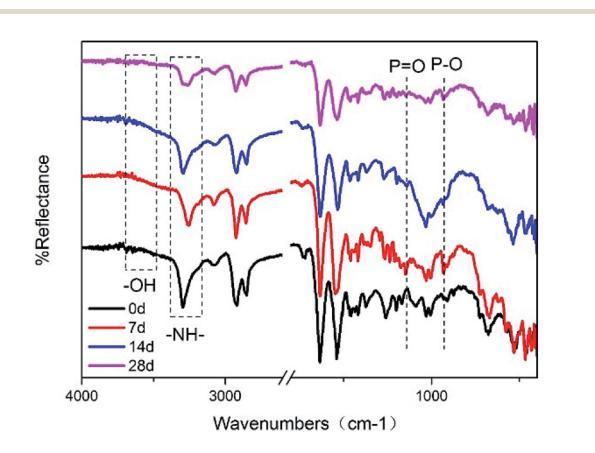
Fig. 4 FTIR spectrum of environment tested connectors after different days.

Fig. 4 is an FTIR spectrum of the connectors after environmental testing. Compared with the initial connectors, the intensity of stretching vibration of –OH for the connectors environmentally tested was enhanced. The peaks representing stretching vibration of P–O and P==O were found at 931 cm⁻¹ and 1143 cm⁻¹,²² illustrated that the red phosphorus in the product released PH₃ and then formed acids. At the same time, the generated phosphoric acid would accelerate the degradation of the polyamide. The peak representing –NH– shows significant changes, transferring to –NH₂,²³ especially for connectors tested by 28 days.

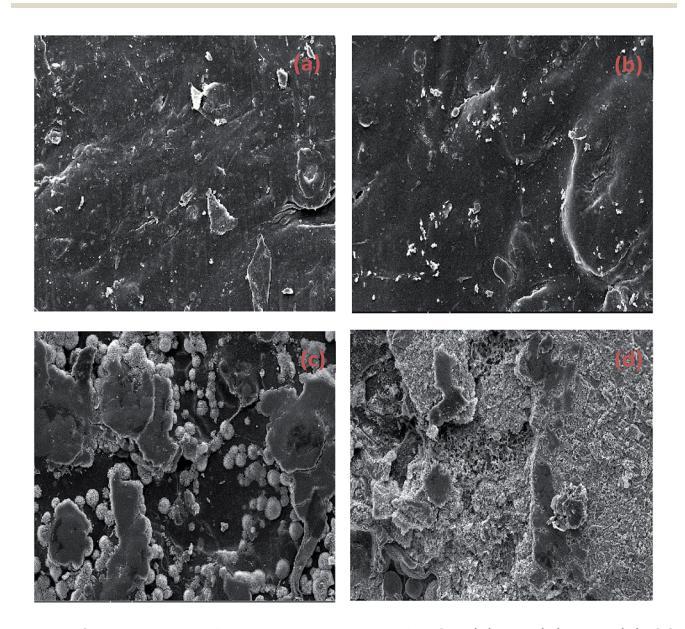
Fig. 5 SEM images of connectors tested for 0 d (a), 7 d (b), 14 d (c), 28 d (d).

Scanning electron microscopy. Fig. 5 is SEM images of connectors and its surface under 80 °C, 75% RH environment for 0 d, 7 d, 14 d and 28 d respectively. The surface of the original sample was relatively smooth. However, with the high temperature and humidity environment test progressing, cracks appeared on the surface, resulting in many flaky layers and increasing the roughness. Green globular substances appeared on the surface and section area of the sample after a period of time. It can be observed that the globular substance dispersed on the edge of the cracks after 14 days. After 28 days,

the globes increased so much that it is too dense to observe a single sphere and the entire surface becomes shattered.

Fig. 6 and Table 2 exhibits the evolution of the elemental dispersion on the surface of connectors. As showed in Fig. 5, the spherical substance was mainly composed of P, O, and Cu elements. The elemental content given in Table 2 indicated that the substance was increasing over time. Phosphorus could not be detected on the surface at the beginning and after 7 days until the globular substance containing phosphorus was formed. With the time increase, the concentration gradient of phosphorus was produced from inside to surface. At the same time, the content of oxygen increased. It proved that phosphorus reacted with water and air to form phosphoric acid through these cracks in the high temperature and humidity environment and the phosphoric acid corroded the copper sheet attached to the connectors to form copper phosphate species on the surface.

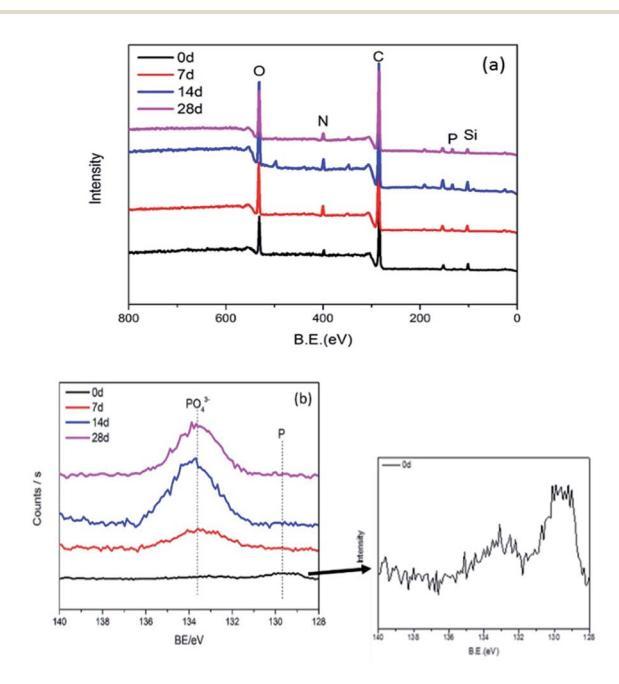
Fig. 7 Wide-scan (a) and P 2p high-resolution (b) XPS spectra for connectors.

X-ray photoelectron energy spectrum analysis. XPS spectrum of survey scan for connectors is exhibited in Fig. 7 and elemental content of connectors tested for different days is showed in Table 3. The intensity of carbon and oxygen is very strong with traces of N and Si existing. Nevertheless, the signal intensity of phosphorus is very low.

The P 2p high-resolution spectra of connectors are exhibited in Fig. 7. There are two main peaks, 129.4 eV corresponding to red phosphorus; 133.4 eV corresponding to phosphate anion.24 The presence of these peaks affirms that red phosphorus was

oxidized to phosphate. The intensities of peaks increases gradually and reaches a stable state, confirming that phosphate concentration increased with test prolonging, especially in the first 14 days.

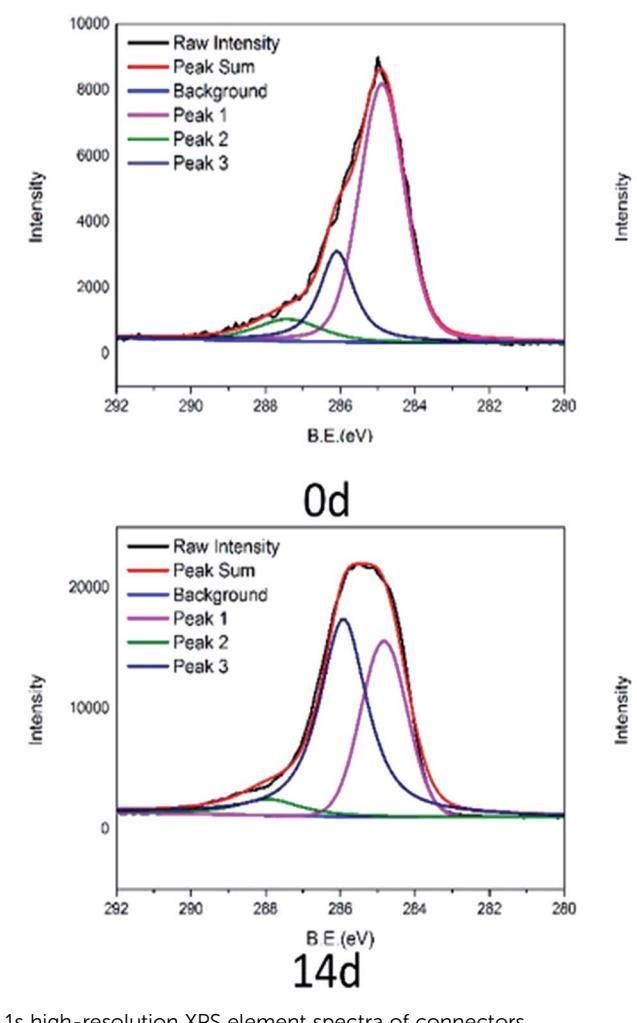
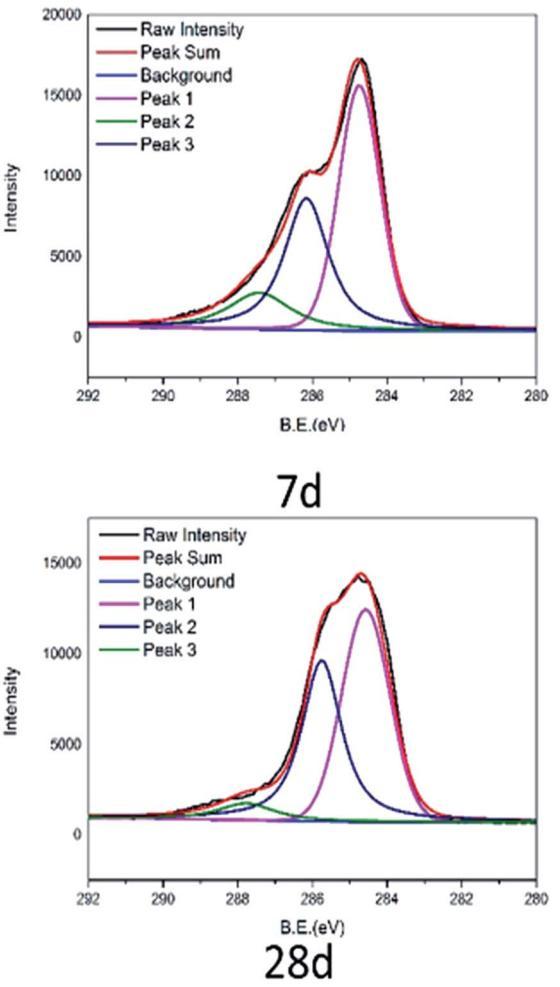
Fig. 8 C 1s high-resolution XPS element spectra of connectors.

The C 1s spectra of tested connectors are fitted into three peaks to know the types of functional groups of PA66 from connectors in Fig. 8. The three peaks centered at 284.6 eV corresponding to C-C; 286.0-286.3 eV corresponding to C-O; 287.5-287.7 eV corresponding to C=O.25 While compared with the C 1s of the initial product, the intensity of the carbonoxygen bond significantly increased. It is expected that PA66 was degraded and carbon-carbon bonds partially were broken,

oxidized to carbon-oxygen bonds. The degradation of PA66 is a complicated process, mainly involving not only the hydrolysis of amide bonds, but also the breakage of molecular chains, accompanied by the formation of various small molecular compounds. The carbon-carbon bond is broken further, accelerating oxidization to cause the rise of the carbon-oxygen bond. This would generate cracks and further reduce the thermal stability of the connector, making it flammability.²⁶

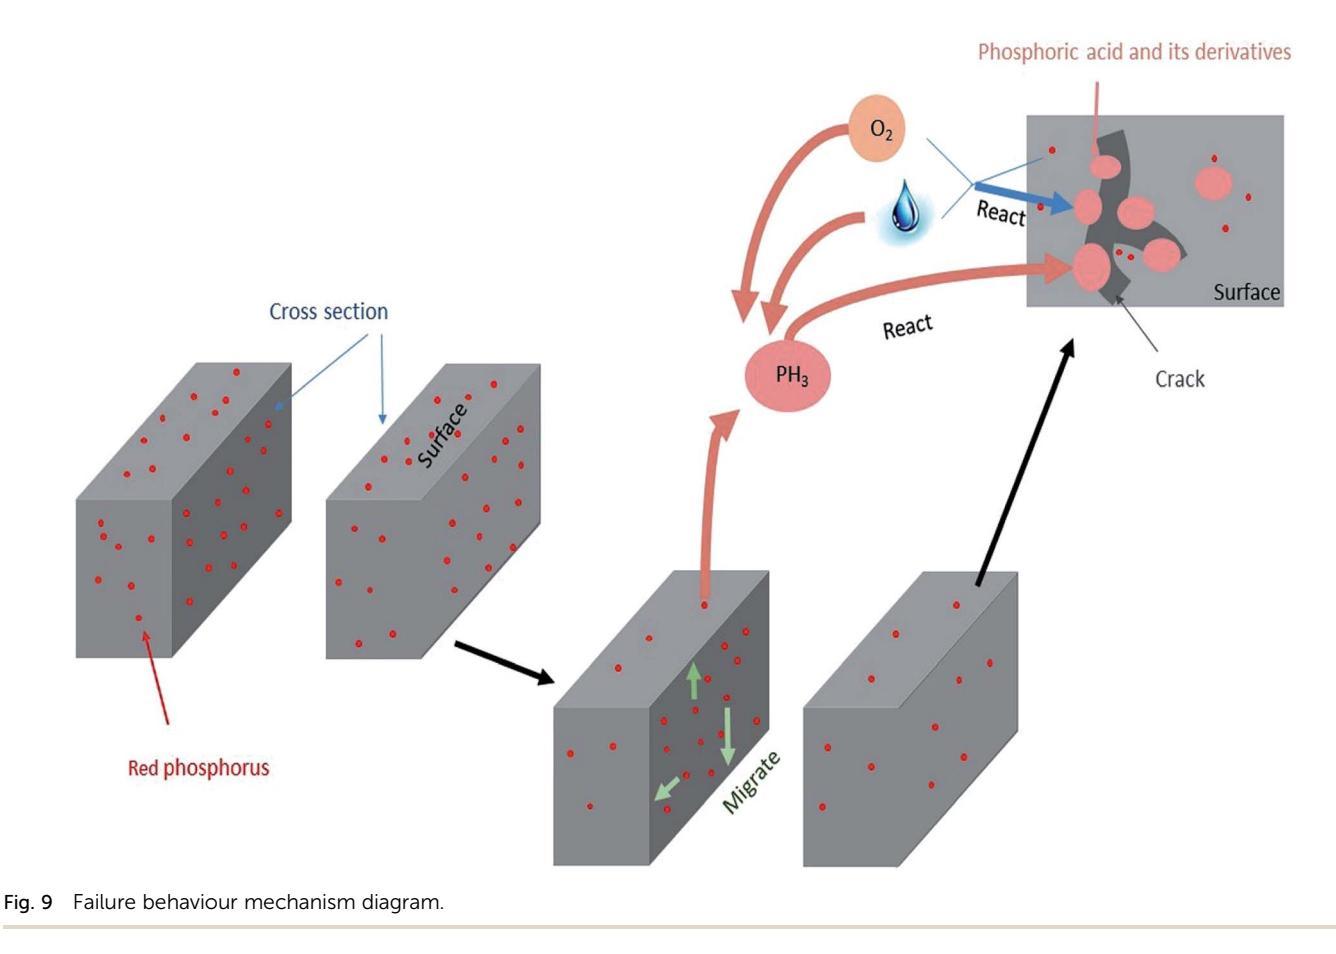
The mechanism of failure behaviour is revealed in Fig. 9. After connectors had undergone high temperature and humidity environmental testing, red phosphorus migrated to the surface and accumulated into several areas. At the same time, significant degradation occurred, the decomposition temperature was advanced and -OH and phosphorus oxides were formed. The surface morphology of connector became rough with cracks increasing and the copper attached to connector formed copper phosphate. The content of phosphorus and oxygen on the surface increased and the chemical environment of phosphorus changed from elemental phosphorus to phosphoric acid derivatives. The amount of phosphine released increased and it reacted with water and oxygen to form acids. Correspondingly, the formation of phosphoric acid derivatives accelerated the degradation process of nylon. Surface cracks caused by degradation resulted in red phosphorus to be further oxidized to an acid. The mutual promotion caused the failure behavior of the red phosphorus flame retardant PA66 electrical connector.
