Zhenyu Zhang, Dongdong Liu, Xingqiao Deng *et al.* The damage mechanism in copper studied using *in situ* TEM nanoindentation

Cite this: Nanoscale Adv., 2024, 6, 2002

The damage mechanism in copper studied using *in situ* TEM nanoindentation[†]

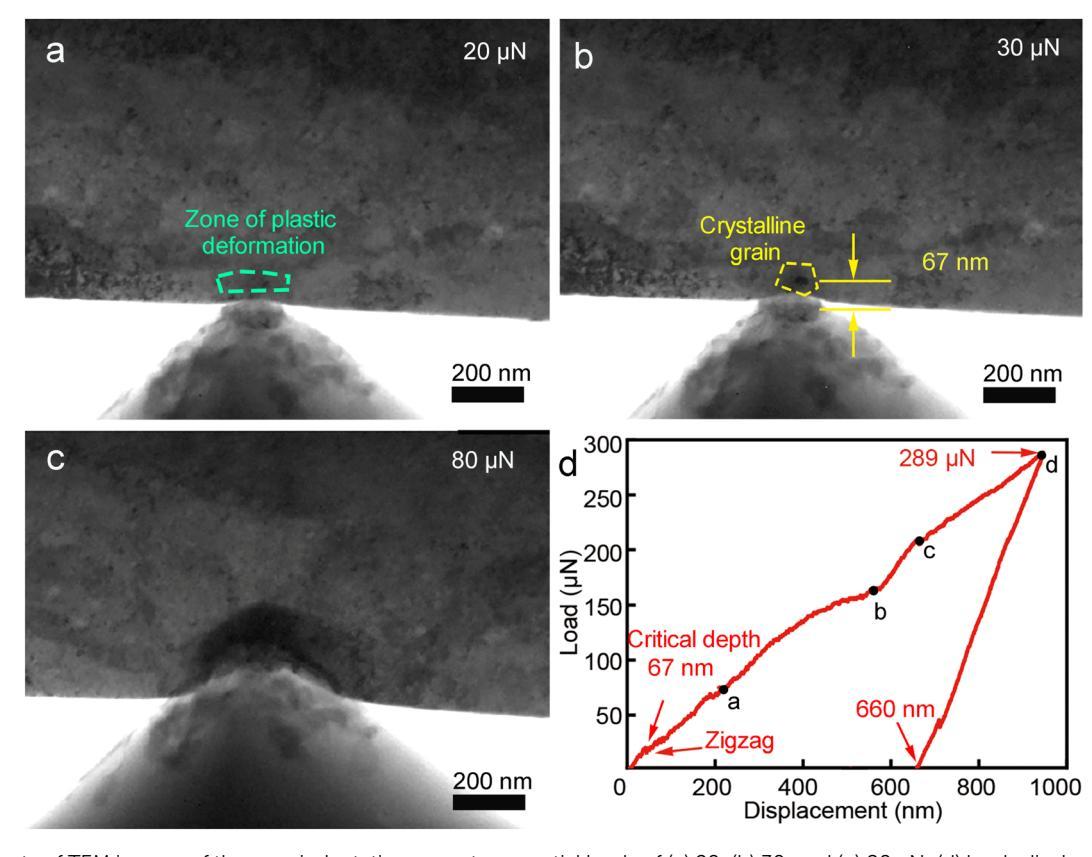
Fig. 1 Snapshots of TEM images of the nanoindentation area at sequential loads of (a) 20, (b) 30, and (c) 80 μN; (d) load-displacement curve of nanoindentation.

In situ TEM nanoindentation was performed to interpret the damage mechanism of the copper surface during machining. Fig. 1 shows a series of video snapshots during *in situ* nano-indentation of single-crystal copper nanoplates under a range of

applied loads. Prior to indentation, the sample surface remained flat. As depicted in Fig. 1(a), upon applying a load of 20 µN with a depth of 45 nm, slight irreversible plastic deformation occurred on the sample surface, along with the appearance of a minor zigzag in the load-displacement curve (Fig. 1(d)). These features are attributed to dislocation and stacking fault formation, sudden stress release, and instantaneous load drop.35 TEM imaging confirmed that plastic deformation occurred in the indentation area without the formation of new grains at 20 µN, as shown in Fig. 1(a). Continuing to increase the load to 30 μ N, Fig. 1(b) marks the onset of small grain formation within the single crystal, observed at the tip of the diamond indenter. A nano-sized grain is evident within the sample, indicated by the blue dashed line in Fig. 1(b), and a sudden load drop was observed in the load-displacement curve, indicating grain breakage in the single-crystal nanoplate at a depth of 67 nm under 30 µN. Further increasing the load to 80 μN, corresponding to a displacement of 219 nm, as shown in Fig. 1(c), the nanoplate experienced severe plastic deformation accompanied by the generation of new grains. Moreover, the serrated features observed on the load-displacement curve are a result of significant grain fragmentation. With further increases in the load, plastic deformation primarily occurred during the 'ab' stage, accompanied by grain fracture. In the 'bc' stage, due to excessive loading, the entire nanoplate sample undergoes overall elastic deformation, along with plastic deformation. The stiffness during the 'bc' stage is greater than that during the 'ab' stage. Finally, during the 'cd' stage, the plastic deformation of the sample further increases, and severe irreversible plastic deformation occurs in the indentation area. Loading was concluded when the displacement reached 900 nm.

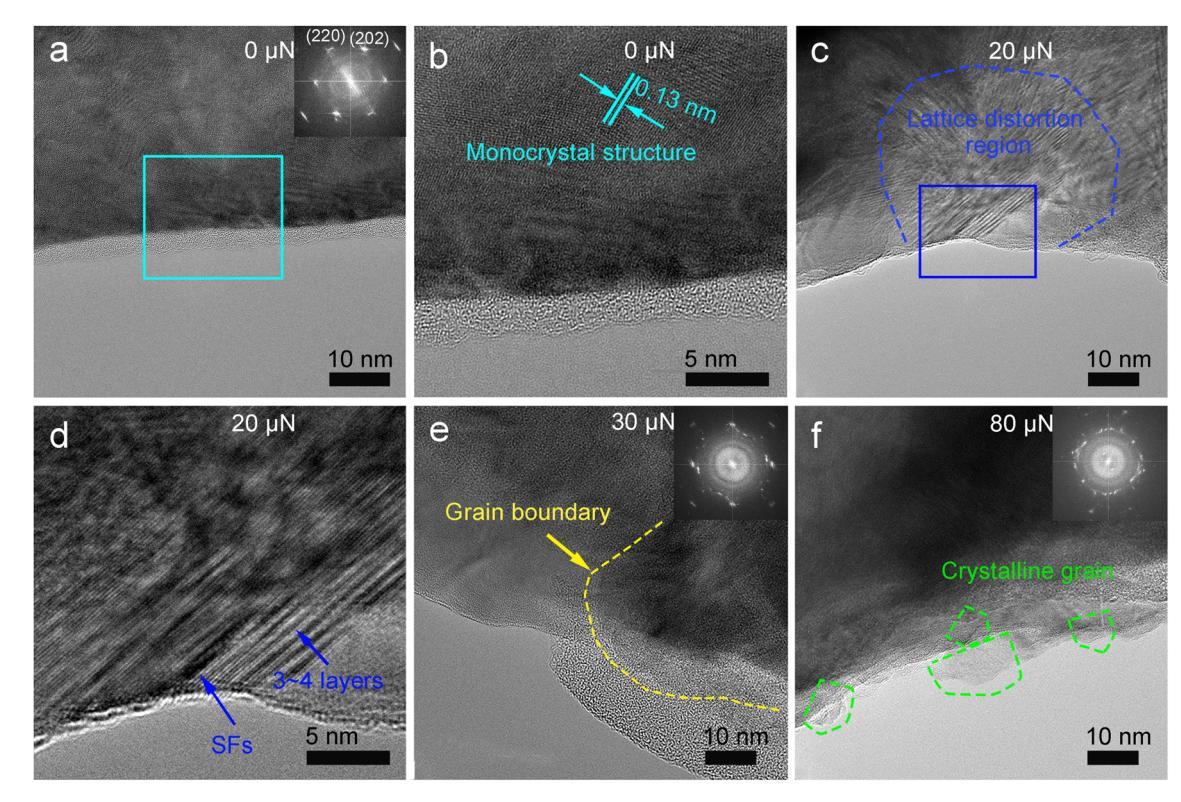
Fig. 2 HRTEM images of the damage evolution process at sequential loads of (a and b) 0, (c and d) 20, (e) 30, and (f) 80 μN. The insets of (a), (e), and (f) show the respective FFT patterns.

To further substantiate the above experimental results, a high-resolution observation of the damaged area was conducted. Fig. 2 presents an analysis of the damage structure of single-crystal copper nanoplates under different loads during

the in situ nanoindentation process. As shown in Fig. 2(a), before indentation, the sample surface remained singlecrystalline, with a 2 nm amorphous layer originating from the FIB processing damage. Moreover, the inset of Fig. 2 further illustrates that the sample presents a monocrystalline state before indentation. In Fig. 2(b), the crystal plane on the vertical surface is (220), indicating that the loading direction is $\langle 220 \rangle$ orientation. In Fig. 2(c), when a load of 20 μ N was applied, upon magnification of the indented area, a high density of dislocations can be observed beneath the indentation. These dislocations are distributed within a semi-spherical three-dimensional plastic deformation zone, indicating severe plastic deformation in the region near the center of the indenter. This plastic deformation zone has also been observed in other metals and alloys, consistent with the traditional nanoindentation plasticity theories.³⁸⁻⁴⁰ Further magnification of the region near the indenter center revealed a significant number of stacking faults with a width of 3 to 4 atomic plane spacings (Fig. 2(d)). As the load increases to 30 µN, high-resolution characterization of the damaged surface, as shown in Fig. 2(e), revealed a larger grain on the upper right side of the indented area, as marked by the yellow dotted line. Further, the fast Fourier transform (FFT) pattern presents multiple sets of diffraction spots (inset of Fig. 2(e)). This suggests that at 30 μ N, the damage mechanism in the indented area transitions from stacking faults to grain fragmentation. When the load reaches 80 $\mu N,$ structural

characterization of the damaged region, as shown in Fig. 2(f), reveals multiple fractured grains at the center of the indentation. The FFT pattern shows polycrystalline characteristics (inset of Fig. 2(f)). This indicates that with increasing stress, larger grains further undergo fragmentation and transform into smaller grains, namely, grain refinement.

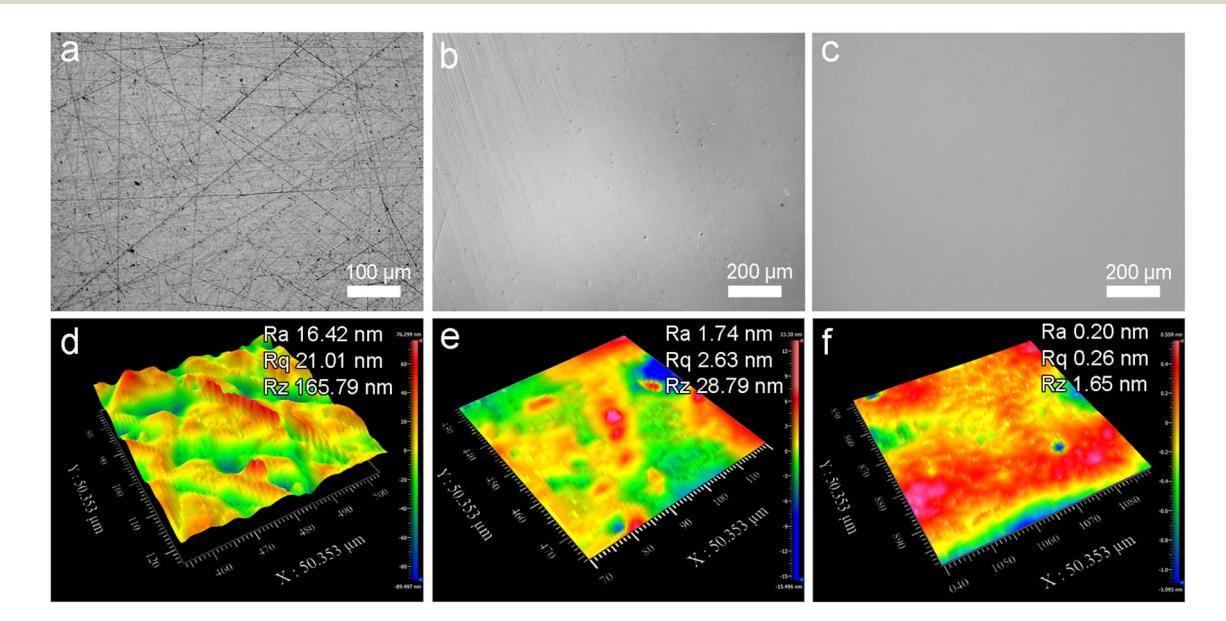
Fig. 3 Optical images of the copper wafer after (a) lapping with consolidated abrasive, (b) mechanical polishing with ceria slurry, and (c) polishing with a novel CMP slurry. Surface roughness and morphologies measured using a ZYGO profilometer after (d) lapping, (e) mechanical polishing, and (f) CMP.

To validate the machining damage mechanism, three typical processing techniques, lapping, mechanical polishing, and chemical mechanical polishing, were conducted. Fig. 3 illustrates the surface quality and topographical characteristics after consolidated abrasive lapping, mechanical polishing, and CMP processes. As depicted in Fig. 3(a), after lapping, numerous intersecting scratches were evident, characterized by a relatively significant depth. Surface roughness measurements were conducted using a 3D optical profilometer. The surface roughness parameters, namely Ra (arithmetic mean height), Rq (root mean square height), and Rz (maximum height) were determined to be 16.42 nm, 21.01 nm, and 165.79 nm, respectively. These measurements were obtained over a scan area of 50 μ m \times 50 μ m (Fig. 3(d)). Upon completion of polishing with ceria slurry, a remarkable reduction in the number and intensity of scratches was observed (Fig. 3(b)). Additionally, an assessment of the surface quality was carried out, revealing surface roughness of Ra, Rq, and Rz of 1.74 nm, 2.63 nm, and 28.79 nm, respectively. Afterward, utilizing an innovative polishing slurry, an exemplarily smooth copper surface was successfully

obtained without scratches. The treated surface displayed an immaculate mirror-like smoothness, devoid of any indications of scratch-induced harm or corrosion marks. The surface roughness parameters for the polished copper, specifically Ra, Rq, and Rz, were measured to be 0.20 nm, 0.26 nm, and 1.65 nm, respectively, over a scanning area of 50 $\mu m \times$ 50 $\mu m.$

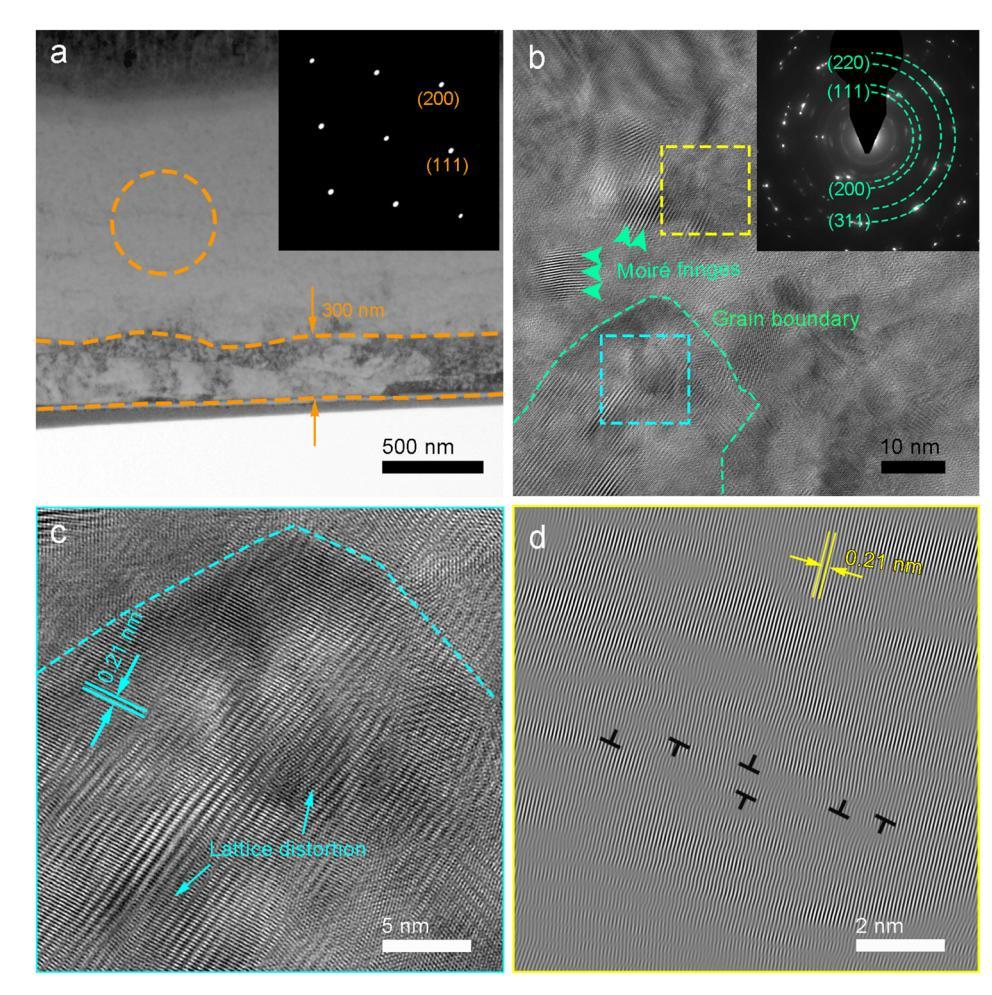
Fig. 4 TEM characterization of copper subsurface after lapping. (a) A low magnification TEM image of subsurface damage, (b) an enlarged TEM image of the damaged area, (c and d) high-resolution TEM images obtained to visualize the damaged area, with distinct damage types corresponding to specific zones marked by cyan (c) and yellow (d) squares. The insets in (a) and (b) are their SAED patterns.

defects.41,42 Fig. 4 presents the TEM results for lapping with consolidated abrasive. In Fig. 4(a), the TEM investigation unveiled that the thickness of the lapping-induced damaged layer was 300 nm. Before lapping, the copper sample demonstrated a remarkably monocrystalline state, as visually depicted in the inset of Fig. 4(a). Nevertheless, following the lapping procedure, a transition from a monocrystalline pattern to a polycrystalline state was observed in Fig. 4(b), which indicates grain breakage happening during lapping. The damaged area was further analyzed to gain deeper insights into the damage types that arose from the lapping process. In the lower leftmost region of the damage site, monocrystal structural breakage occurred due to the presence of high abrasive stress. This resulted in the emergence of conspicuous moiré fringes and grain boundaries, as indicated by the green arrows and dotted line in Fig. 4(b). These fringes originate from the overlapping and intersection of two crystalline grains.43 Additionally, within the fractured crystal grains (Fig. 4(c)), regions of severe lattice distortion became apparent. Moving further into the interior of the damaged layer, as the abrasive stress diminishes, a distinct dislocation becomes discernible, clearly delineated by the yellow square (Fig. 4(d)). The inverse fast Fourier transform (IFFT) image, focusing on the region indicated by the yellow square in Fig. 4(b), unveils the presence of edge dislocations within the inner zone of the damaged layer.

In short, the damaged layer encompasses a variety of components, namely moiré fringes, grain boundaries, and edge dislocations. Within the outermost portion of the damage layer, the predominant form of damage consists of fractured grains. Nevertheless, by delving deeper into the damaged layer, defects assume a more significant role.

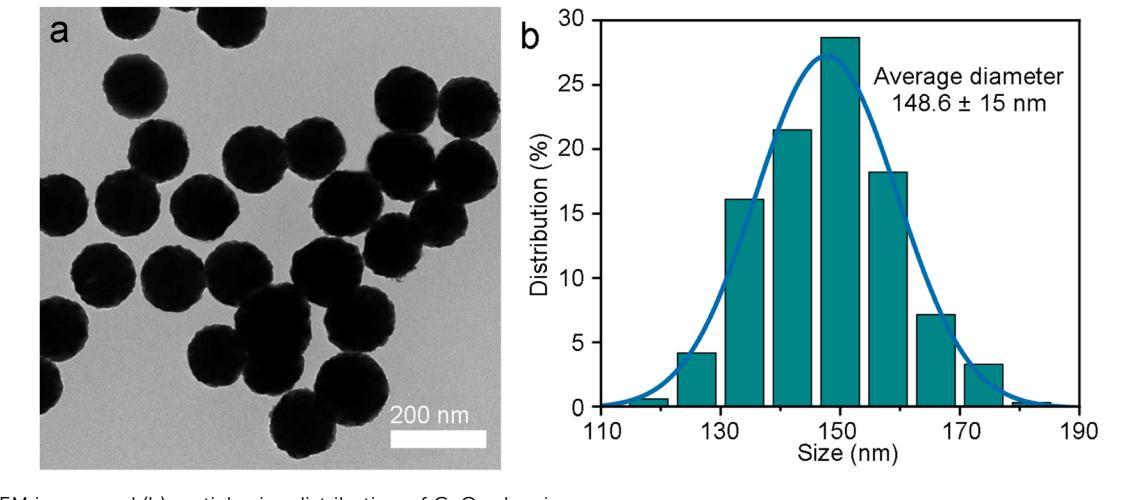
Fig. 5 (a) TEM image and (b) particle size distribution of CeO₂ abrasives.

Mechanical polishing is a precision polishing technology, that mainly relies on very fine polishing powder or polishing slurry lapping, rolling action, removing a layer of extremely thin material on the surface of the sample until the required smoothness is reached.⁴⁴ Fig. 5(a) shows the TEM image of ceria abrasive particles, indicating uniform dispersion of ceria. Particle size statistics revealed a normal distribution for ceria particles, with an average abrasive diameter of 148 nm (Fig. 5(b)).

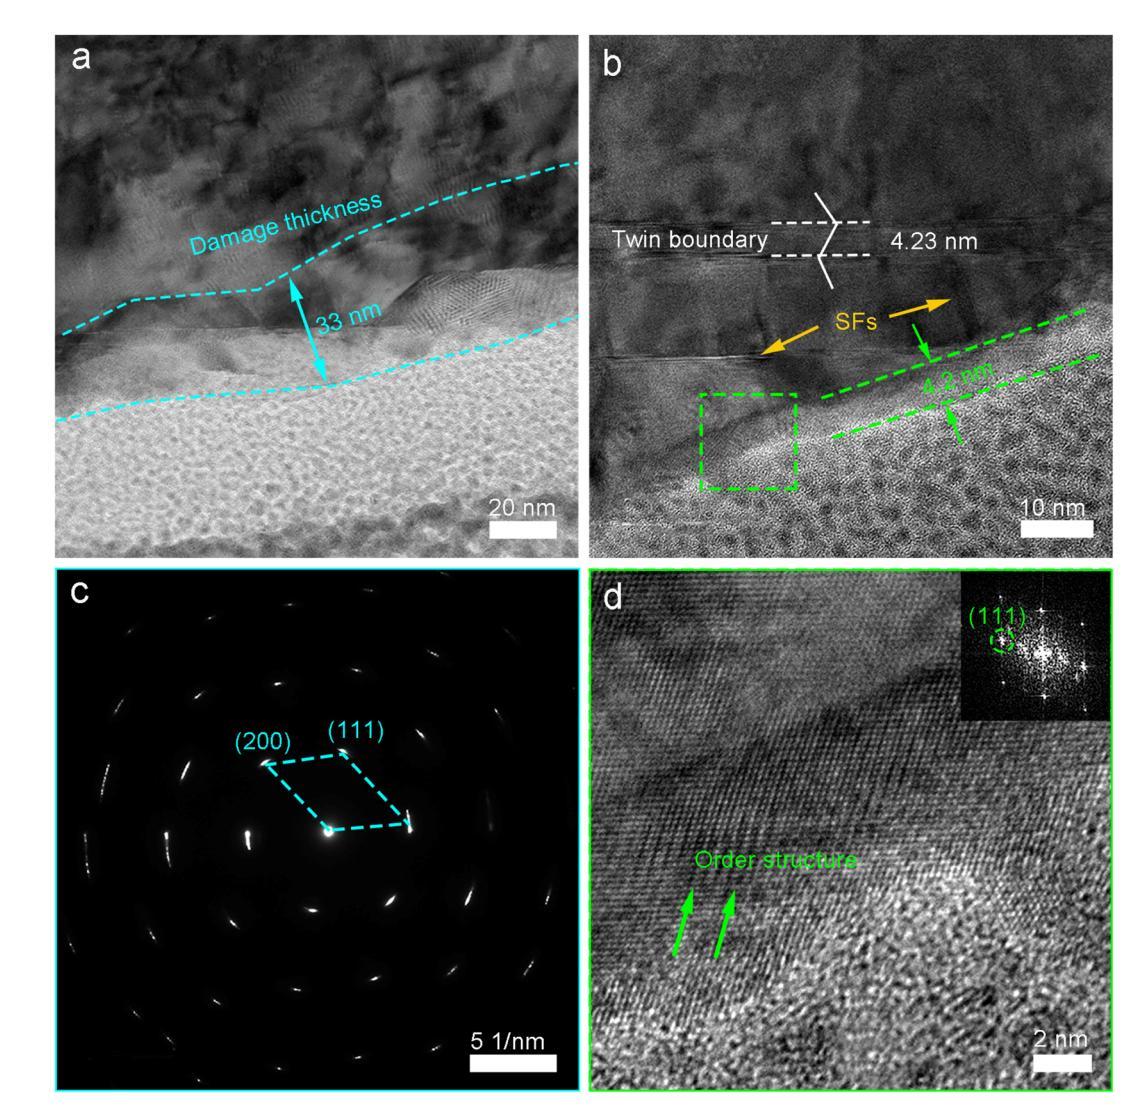
Fig. 6 (a) TEM characterization of the copper subsurface after mechanical polishing. (a) The low magnification TEM image of subsurface damage, (b) enlarged TEM image of the damaged area, (c) a SAED pattern of (a), and (d) HRTEM image of the green square in (b).

TEM. A low magnification TEM image presents a cross-sectional perspective of a mechanically polished surface, demonstrating a measured damage layer thickness of 33 nanometers (Fig. 6(a)). Additionally, the polished surface retained its monocrystalline structure (inset in Fig. 6(c)). Furthermore, the structure of the damage layer was observed. As depicted in Fig. 6(b), sporadic defects, including twin structures and stacking faults, were evident in the inner region. Notably, the width of these twin structures was measured at approximately 4.23 nm. The formation of an ordered periodic structure, as demonstrated in Fig. 6(d), was initiated through the alignment of the AB-type structure of two (111) planes within the superficial region, resulting from the vast stacking fault structure. In short, as the depth of the damage layer increases, the stress experienced by the sample gradually decreases, and the defect density also decreases accordingly.

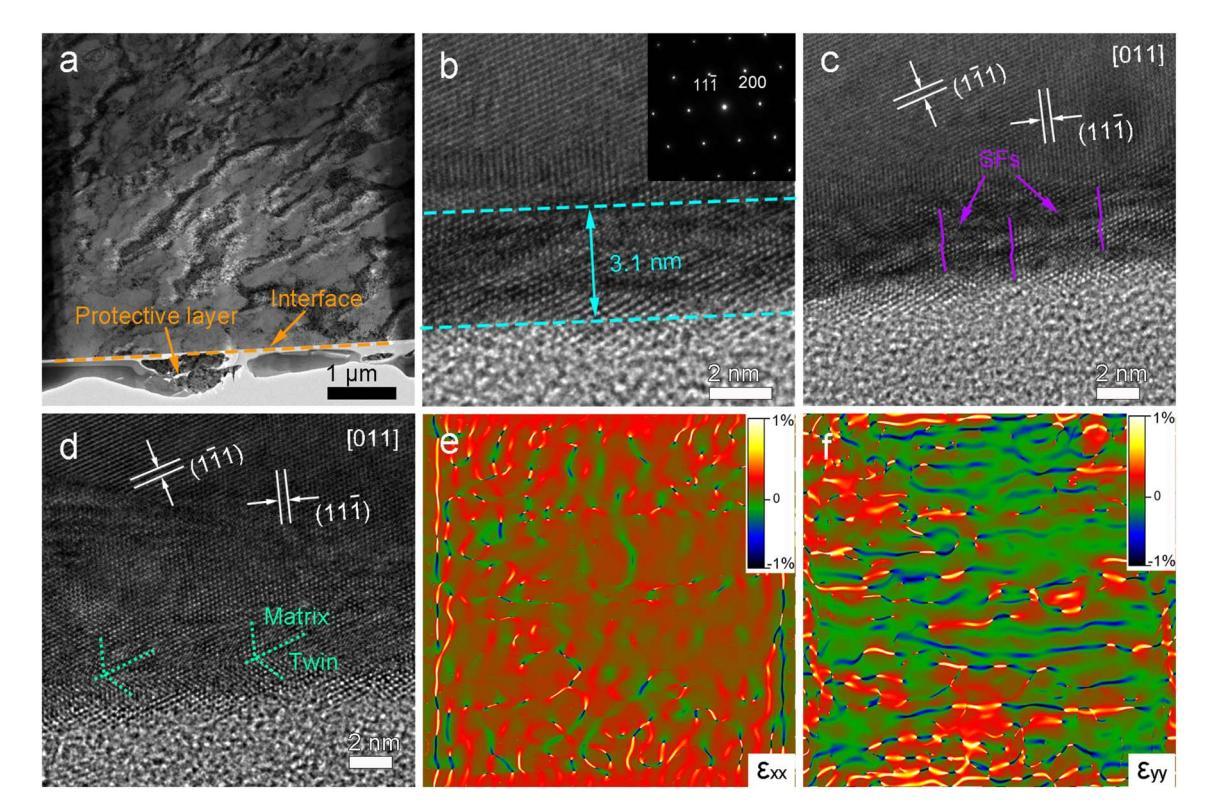
Fig. 7 TEM characterization of the copper subsurface after chemical mechanical polishing. (a) A low-magnification cross-sectional TEM image of subsurface and surface damage, (b) enlarged TEM image of the damaged area, (c and d) HRTEM images of different structure defects in different damaged regions, strains maps (e) ε_{xx} and (f) ε_{yy} obtained by GPA. The inset in (b) shows the SAED pattern of (b).

After conducting CMP, a TEM cross-section sample was meticulously prepared by employing FIB technology, enabling an in-depth analysis of the damage incurred during the polishing process. As illustrated in Fig. 7(a), a protective layer was strategically employed to shield the damaged layer from the potentially deleterious effects of the ion beam. Within the subsurface realm of the copper sample, a remarkable preservation of its single-crystal state was observed, as vividly presented in the inset of Fig. 7(b). Subsequently, upon scrutinizing the damaged area with precision, it was determined that the thickness of the damaged layer on the polished copper wafer was measured at a mere 3.1 nm, as depicted in Fig. 7(b). Furthermore, diverse damaged areas at distinct locations were meticulously characterized, revealing the presence of stacking faults composed of single-layer atoms, as impeccably exemplified in Fig. 7(c). Fig. 7(d) offers valuable insights into the core structure of twins, each measuring approximately 2 nm in length. To comprehensively assess the stress introduced by the polishing process, a microstrain analysis was conducted on the high-resolution TEM image employing geometric phase analysis (GPA) techniques, as elaborated in prior studies.^{45,46} The strain maps meticulously charted the variations along $[11\overline{1}]$ and

[200] directions (Fig. 7(b)). Within these strain maps, regions colored blue denoted compressive strain, whereas red and green regions signified tensile strain and an absence of strain, respectively. Notably, a conspicuous variation in strain was particularly pronounced along the [111] direction, whereas the [200] direction exhibited a notable lack of substantial stress distribution (ε_{xx} in Fig. 7(e)). It is worth mentioning the presence of a considerable degree of compressive stress between the (111) planes (ε_{yy} in Fig. 7(f)). The findings highlight that the CMP technology generates processing stress, notably manifesting in a direction parallel to the wafer's surface.

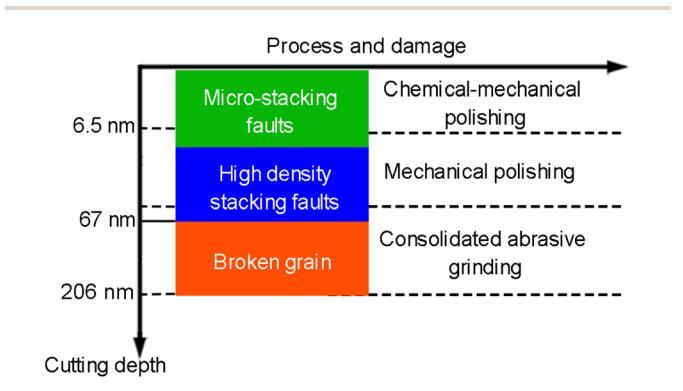
Fig. 8 Diagram of damage evolution under different process conditions.

Cutting depth is a crucial parameter that affects the quality of machining surfaces and the structure of the damage layer. According to the above experimental results, a relationship between the cutting depth and the damage generated during precision machining is established. The cutting depth for different processes was calculated, with specific details explained in the ESI.[†] The surface damage layer produced by the lapping process contains defects such as lattice distortions, broken grains, and edge dislocations. The surface of the sample was subjected to higher lapping stress, resulting in more severe damage, with a large number of broken grains in the damaged layer. The subsurface, on the other hand, experiences lower lapping stress, leading to relatively lower damage, characterized by the presence of numerous crystal defects such as highdensity stacking faults in the damaged layer (Fig. 8). During the mechanical polishing process, the stress on the copper surface exceeds the MPa level.¹⁹ The damaged layer contains a significant amount of dislocation structures, and the density of dislocations decreases with increasing depth of the damaged layer. Moreover, in chemical mechanical polishing, copper atoms are collectively removed under mechanical and chemical action, forming micro-stacking faults composed of only a few atomic layers on the surface (Fig. 8). In high-precision machining, severe damage caused by broken grains significantly affects the surface quality and material mechanical

properties of copper devices. It is essential to avoid such damage in practical machining processes. The *in situ* nano-indentation technique, employed in this study, determines the critical depth required for grain breakage to be 67 nm.
