Journal of Materials Chemistry C

Infiltration issues in printed mesoporous carbon perovskite solar cells: a troubleshooting guide

C. A. Worsley, (1) * T. Dunlop, (1) S. J. Potts, (1) R. Bolton, E. Jewell and T. M. Watson (1) *

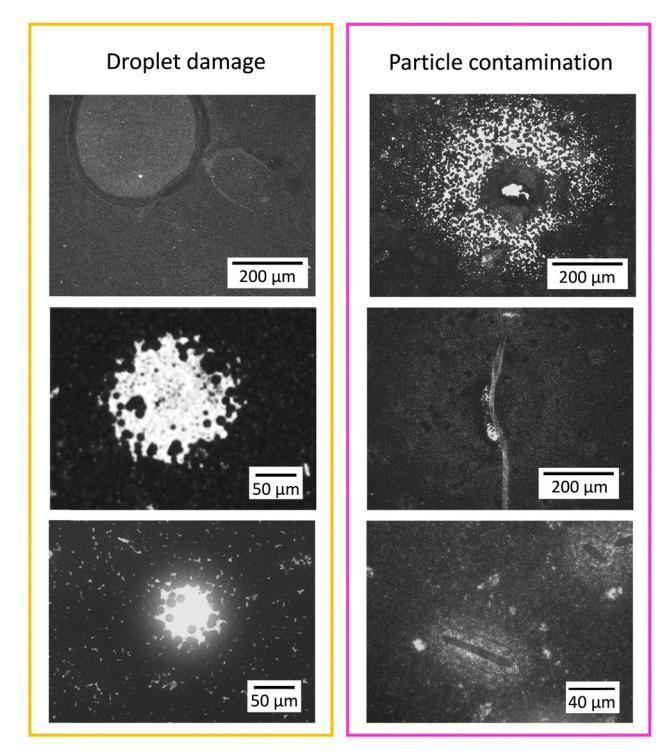
Fig. 2 Optical images of infiltration defects caused by solvent droplet damage and particle contamination.

Often (but not always) visible at the macro-scale, contaminants and solvent damage produce similar issues in completed devices, producing uneven defects of varied size, sometimes with a distinctive 'halo' or ringed surrounding pattern (Fig. 2). In the case of physical contaminants, a particle can be present at the defect centre, whereas solvent contamination issues are particle free. Particles will be visible through the glass substrate if the associated contamination is under, in, or on the TiO_2 print. Particle contamination of the ZrO_2 and carbon may also result in defects, but the given particle is unlikely to be visible through the glass substrate.

While solvent damage can be easily prevented through careful handling of liquids around printed stacks (especially when wet), physical contamination can be more persistent depending on the source. Wet and dry printed layers, screens and printing equipment should all be stored under covers to protect from dust and other airborne particulates. Placing wet films in areas of high airflow is not advised, as it can prevent film settling/slumping and increase the likelihood of particle contamination.

Upon observing these defects in cells or modules, pastes, screens, and printing equipment should be carefully inspected for particles or blockages. Blocked screens require cleaning, while contaminated pastes should be disposed of. If equipment and materials appear clean, the printing, film relaxation/ slumping, annealing and storage areas should be wiped down to eliminate the source of particles, and storage procedures reviewed where necessary.

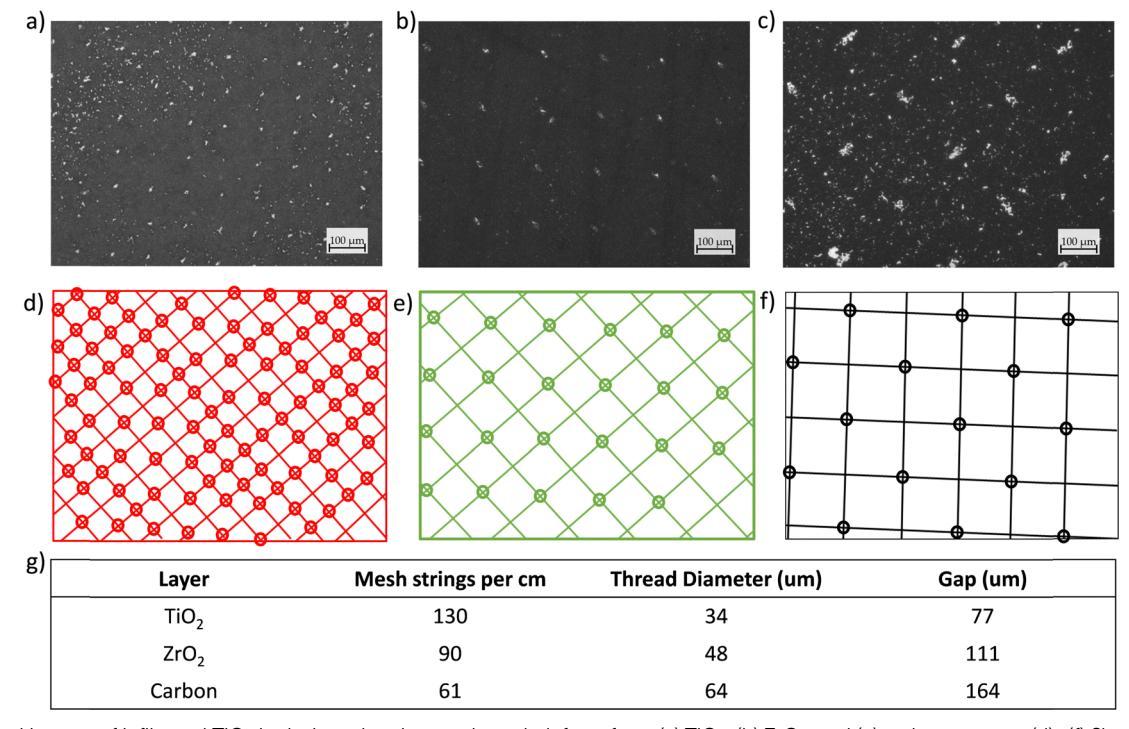
Fig. 3 Optical images of infiltrated TiO_2 in devices showing mesh mark defects from (a) TiO_2 , (b) ZrO_2 , and (c) carbon screens. (d)–(f) Show diagrams of mesh dimensions of TiO_2 , ZrO_2 and carbon screens respectively, with circles representing cross sections where an infiltration issue is present in the device. (g) Shows mesh types and calculated gap size for each layer.

Perhaps the most characteristic defects are those caused by mesh marks; troughs or peaks at the surface of a screen printed layer. Mesh marks occur due to ink filaments forming at mesh crossover sections as the screen separates from the substrate during printing. This produces round, evenly spaced infiltration defects in the finished device. Usually present across a large area, these features are obvious when examining the infiltrated TiO₂ layer with an optical microscope (Fig. 3a–c). Critically, mesh marks in the ZrO_2 or carbon print can cause infiltration defects at the base of the TiO₂. (Fig. 3a–c) shows optical microcopy images of infiltrated TiO₂ layers from three devices, which respectively show evidence of TiO₂, ZrO_2 and carbon related mesh mark infiltration defects.

As presented in Fig. 3, observed infiltration defects will correspond with the mesh dimensions of the relevant screen. Therefore, if different screens have been used for TiO_2 , ZrO_2 and carbon, defect spacing can be measured to conclude in which layer the problematic marks reside. For example, the small defects in Fig. 3a must correspond with those from the TiO_2 layer, as this was the only deposition where a fine mesh was used (Fig. 3c). Note that defects may only appear (or be more severe) at alternate cross sections, as is the case in Fig. 3b and c. If similar mesh screens are used for different layers, the problematic layer can be identified using WLI (white light interferometry) of any remaining uninfiltrated devices single prints (Fig. 3b).

shown that slight increases in ZrO_2 roughness can cause severe increases in marking of the subsequent carbon print.²² Therefore, the topology of all layers (in an uninfiltrated sample) should be examined upon observing mesh marking to ascertain the root cause of the problem.

As mesh marks are caused by ink filamentation during printing, printer setup and ink formulation are critical to their prevention. Printer setup techniques to avoid mesh marking include using the minimum printable squeegee pressure or switching to a finer mesh.^{22,23} It should be noted that not all pastes are suitable for fine mesh screens- for example, the large graphite flakes in carbon inks are likely to cause blockages. A flow coat print regime, where paste is spread over the screen before a single squeegee pass can also reduce marking. Unless pastes are considerably viscous, a print–print (or two squeegee passes) is not likely required and unnecessarily increases the risk of severe marking.^{22,23} Alternatively, pastes can be altered to reduce filamentation by lowering viscosity and/or elasticity.²³ This can be achieved with careful dilution or by changing the amount or type of binders used.²²

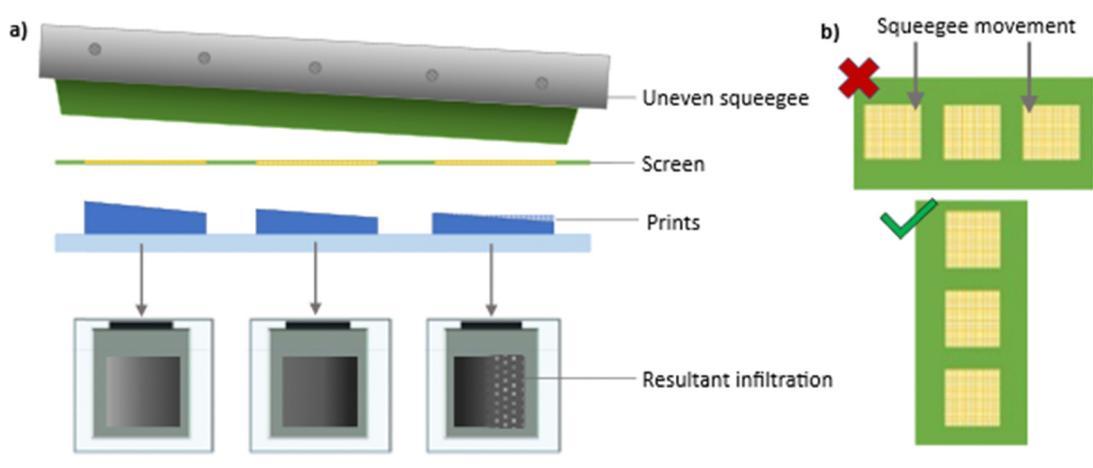
Fig. 4 (a) Diagrammatic representation of the consequences of uneven squeegee pressure and its resultant impact on device infiltration. Note that mesh marking defects in real samples will only be visible *via* optical microscopy. (b) Screen alignment to limit horizontal print variations.

Careful setup and pressure monitoring can help prevent squeegee related issues. Changing screen designs to limit the horizontal print width (depicted in Fig. 4b) can also improve uniformity and batch variation. In the case of glass warping, ramped heating and cooling steps for blocking layer spraying and each high temperature anneal can help minimise these issues.

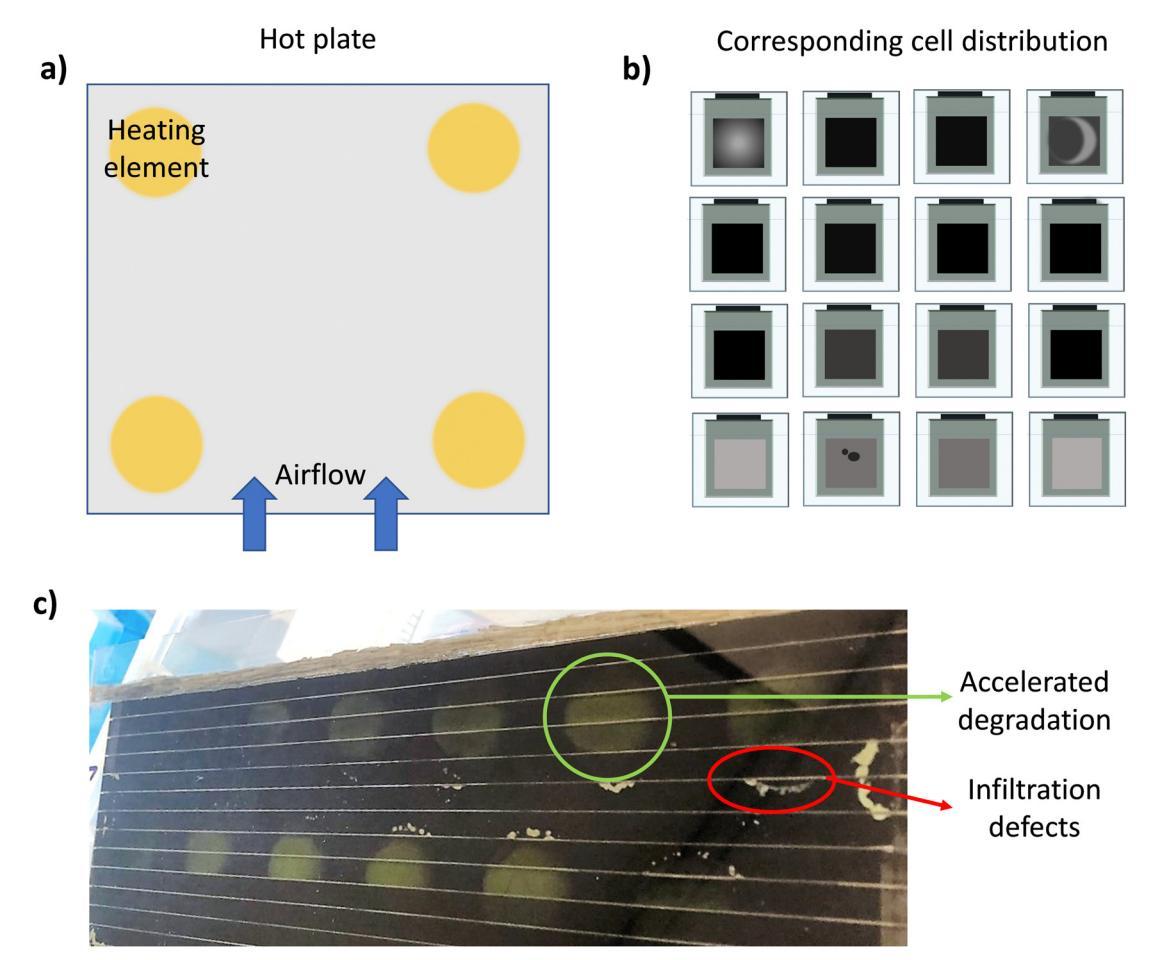
Fig. 5 Diagrammatic representation of (a) an unevenly heating hot plate and (b) resultant impact on device infiltration. Depicted in (c) is a photograph of damage on a 30×30 cm² module caused by heating elements and airflow during perovskite annealing.

This issue can occur at multiple scales and using different equipment setup. For example, Fig. 5c shows a 30×30 cm² module annealed on a conveyor dryer. Through the glass substrate, greyish white and yellow defects can be seen, impacting multiple cells. The grey or white perovskite free voids indicate an infiltration issue caused by fast crystallisation and high airflow, whereas the yellow areas show accelerated degradation due to uneven heating. On examination of equipment, the yellow defects corresponded with overhead heating elements in the dryer and the white and grey with areas of high airflow.

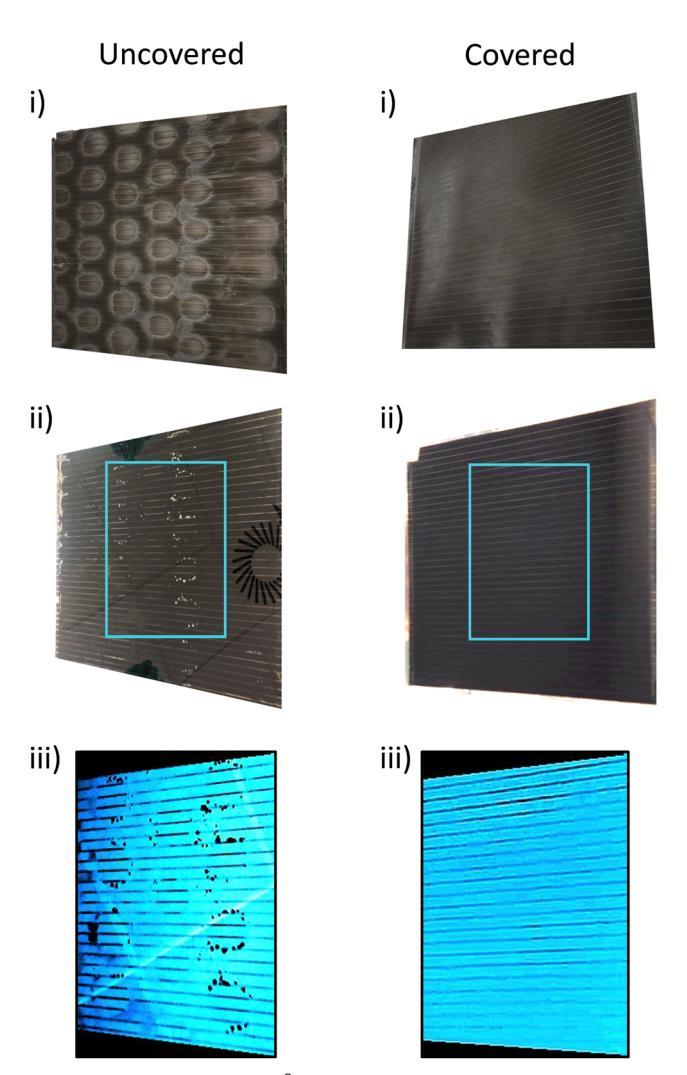
Fig. 6 Photographs of 519 cm² active area modules with (RHS) and without (LHS) a cover during perovskite annealing. (i) Back electrode, (ii) through glass substrate, (iii) magnified with applied colour filter to highlight infiltration problems.

A simple partial cover was thus applied, to protect the module surface while allowing sufficient solvent removal. This completely eliminated the defects, as shown in Fig. 6.

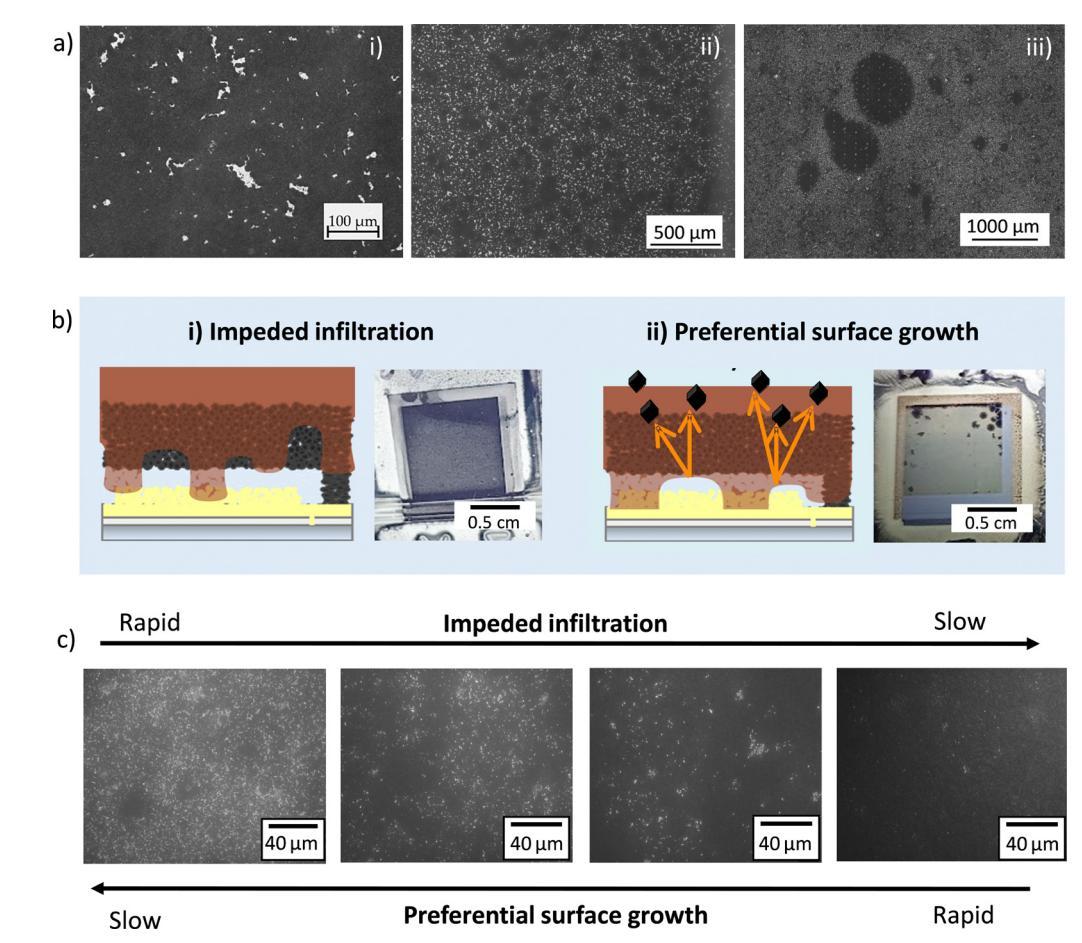
Fig. 7 (a) Optical microscopy images of randomly distributed infiltration defects at different scales. (b) Diagrammatic representation and example photograph of (i) impeded infiltration and (ii) preferential surface growth. (c) The impact of crystallisation speed with each mechanism.

Perhaps the most difficult to diagnose is when devices present with apparently random infiltration issues spread. As shown in Fig. 7a, this can appear at multiple scales with extreme variation in the shape and distribution of observed defects.

There exist two distinct mechanisms that can cause these problems, depicted in Fig. 7b. Impeded infiltration (Fig. 7b(i)) occurs when precursor cannot effectively reach the base of the stack, while preferential surface growth (Fig. 7b(ii)) is seen when nucleation and crystal growth occurs more favourably atop or within the carbon layer, reducing crystal formation in the small pores of the TiO₂ electrode. Both mechanisms can also occur concurrently: *e.g.* upon applying a new precursor formulation that favours surface crystal growth to a batch of cells with thick, rough carbon prints.

Example photographs of devices with particularly severe infiltration issues caused by each mechanism are shown in Fig. 7b. It should be noted that although the devices in the example look very different, they are not characteristic of the associated infiltration issue: without further examination or specific knowledge of the given sample, is not possible to tell visually which mechanism is present.

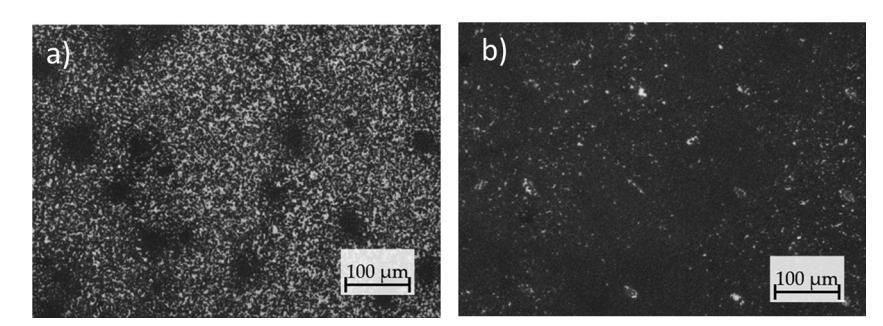
Fig. 8 Optical microscopy images of two devices with impeded infiltration, (a) annealed on an open hot plate and (b) under a partial cover. (b) Reveals mesh marks not observed.

Severe issues are usually caused by multiple concurrent problems acting in tandem. Fig. 8 shows images of TiO_2 infiltration from two devices from the same print batch, (a) annealed on the hot plate and (b) under a partial cover to limit surface airflow. Reducing surface airflow has produced better infiltration in sample b, revealing mesh marking defects that were not observable in the more sparsely filled sample a. Both issues (high surface airflow and mesh marking) therefore require resolving to ensure high-quality infiltration.
