Cite this: *Nanoscale*, 2018, **10**, 7058

## Non-destructive characterization of extended crystalline defects in confined semiconductor device structures†

Andreas Schulze,<sup>a</sup> Libor Strakos,<sup>b</sup> Tomas Vystavel,<sup>b</sup> Roger Loo,<sup>a</sup>  
Antoine Pacco,<sup>a</sup> Nadine Collaert,<sup>a</sup> Wilfried Vandervorst<sup>a,c</sup> and Matty Caymax<sup>a</sup>

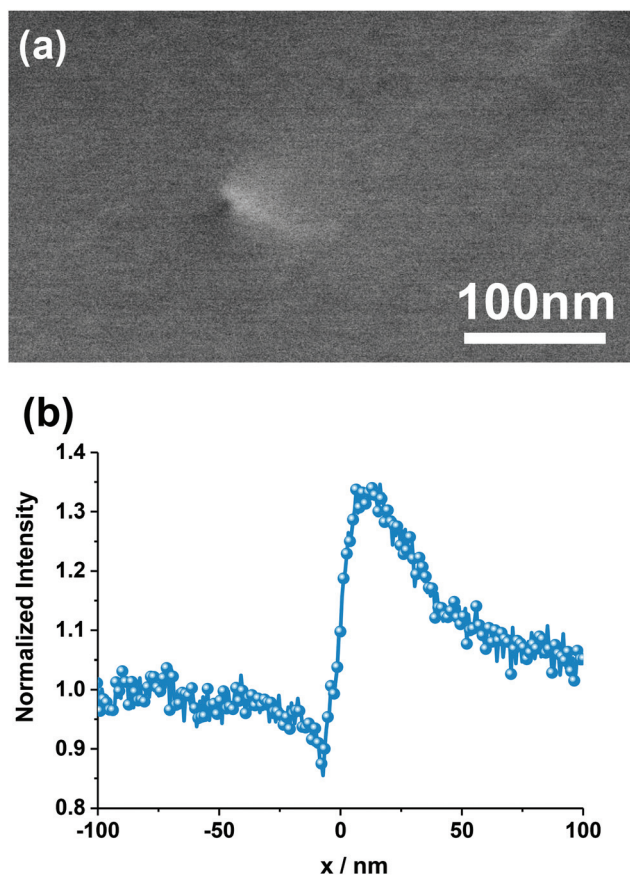
**Fig. 1** (a) ECCI micrograph obtained on a lowly defective SiGe buffer layer showing a single threading dislocation emerging at the layer surface. The typical contrast inversion across the defect is clearly visible. (b) Horizontal line section through the defect illustrating the contrast inversion quantitatively (*i.e.* transition from reduced backscatter signal to an increased backscatter signal when crossing the defect from left to right).

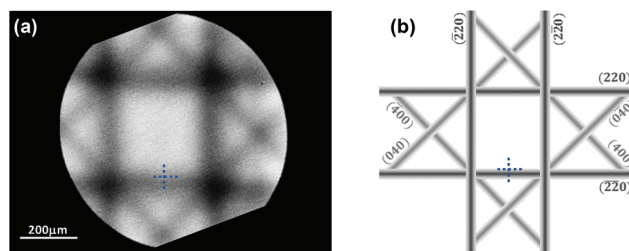
**Fig. 2** (a) Electron channeling pattern (ECP) obtained experimentally on a Si (001) substrate containing arrays of SiGe fin structures. The STI oxide between the fins has been removed selectively and the sample has been slightly moved out of focus to improve the visibility of the ECP while suppressing interference effects between the electron beam and the fin structures. (b) Indexed diagram corresponding to the ECP shown in (a). The selected diffraction condition corresponding to  $\mathbf{g} = [-2-20]$  is indicated by the blue cross.

For this purpose, we used an Apreo SEM from Thermo Fisher equipped with a solid state concentric backscatter (CBS) detector mounted below the pole piece of the electron column. For optimum spatial resolution and signal-to-noise ratio we used beam energies between (5–20) keV and beam currents ranging from (0.4–3.2) nA. A magnetic immersion lens has been used to allow for maximum spatial resolution. To facilitate a precise alignment of the primary electron beam with the lattice planes of the sample, we selectively removed the STI oxide between the fins using buffered hydrofluoric acid (HF). Scanning the primary beam across the sample at low magnification enabled us to generate an electron channeling pattern (ECP) from the Si substrate (Fig. 2). Undesired interference effects caused by the interaction of the electron beam with the nanoscale fin structures on the substrate have been suppressed by moving the structures slightly out of the focal plane. Using sample tilt and rotation we then aligned the sample such that the center of the ECP (cross in Fig. 2)

coincides with the transition between a Kikuchi line (dark line corresponding to a region of weak backscattering) and a Kikuchi band (bright band corresponding to a region of strong backscattering). In this way, when imaging at high magnification, the alignment condition providing the maximum defect contrast is ensured. In essence, the ECP greatly facilitates the selection of a certain diffraction condition (*i.e.* diffraction vector  $\mathbf{g}$ ) in a controlled and reproducible manner.<sup>28</sup>

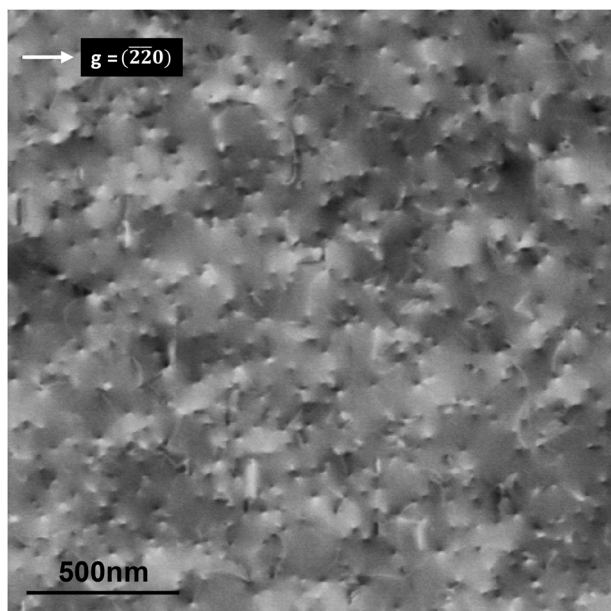
**Fig. 3** ECCI micrograph obtained on a  $\text{Si}_{0.3}\text{Ge}_{0.7}$  layer grown into a several micrometer large window. The selected diffraction condition (cf. Fig. 2) is indicated by the arrow in the upper left corner of the graph. The same diffraction condition and hence  $g$  vector have been used throughout the paper for all ECCI micrographs. Individual threading dislocations are clearly resolved. The layer exhibits a threading dislocation density of  $\sim 10^{10} \text{ cm}^{-2}$ .

In the first experiment, we acquired an ECCI micrograph (Fig. 3) on a several micrometer large area, which was fabricated by selective epitaxial growth of  $\text{Si}_{0.3}\text{Ge}_{0.7}$  into a large opening in the STI. Since the lateral dimensions of that area are much larger than the layer thickness ( $\sim 200$  nm as-grown), no defect trapping occurs and the structure is therefore equivalent to a blanket layer. Since the layer thickness exceeds the critical thickness and elastic relaxation can be excluded given the large lateral dimensions of the pad, the layer must be plastically relaxed. Indeed, the  $\text{Si}_{0.3}\text{Ge}_{0.7}$  peak position ( $\sim 3900$  arcsec) in the (004)  $\omega$ - $2\theta$  high-resolution X-ray diffraction (HRXRD) scan confirms the high degree of strain relaxation (Fig. 4).<sup>32,33</sup> Plastic relaxation is associated with misfit dislocations at the buried layer-substrate interface whereby the misfit dislocations accommodate the lattice mismatch between both materials in the direction perpendicular to the dislocation line.<sup>34</sup>

The stress fields associated with these threading dislocations cause a local deformation of the crystal lattice planes, which can be imaged using ECCI, as described in the Experimental section. As a consequence, each of the dot-like features visible in the ECCI micrograph shown in Fig. 3 can be attributed to a single threading dislocation intersecting with the layer surface. The number of these features and hence the density of threading dislocations on the surface can now be extracted straightforwardly, resulting in a value of  $10^{10} \text{ cm}^{-2}$ . The overall contrast variations which become apparent from the ECC image in Fig. 3 are due to the mosaicity and the associated lattice tilt of the material, which is caused by the high density of threading dislocations. The mosaicity and hence limited lateral coherence length of the layer causes a significant broadening of the HRXRD  $\omega$ -rocking curve (inset Fig. 4). It has been demonstrated that from this peak broadening, the threading dislocation density can be estimated for the case of highly defective materials.<sup>36</sup> Using the model of Ayers<sup>36</sup> and a full width at half maximum (FWHM) of  $1650$  arcsec (inset Fig. 4) we could derive a threading dislocation density of  $9.5 \times 10^9 \text{ cm}^{-2}$ , which is in good agreement with the aforementioned defect density obtained from the ECCI micrograph shown in Fig. 3.

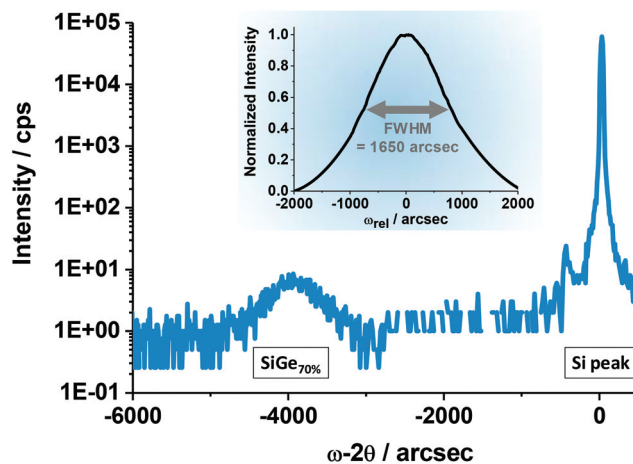
**Fig. 4** HRXRD (004)  $\omega$ - $2\theta$  scan acquired on the large  $\text{Si}_{0.3}\text{Ge}_{0.7}$  pad. The peak around  $-3900$  arcsec corresponds to fully relaxed  $\text{Si}_{0.3}\text{Ge}_{0.7}$ . The inset shows an  $\omega$  rocking curve obtained around the SiGe layer peak. The pronounced peak broadening with a FWHM value of  $1650$  arcsec is due to the high defect density and the associated mosaicity of the material.

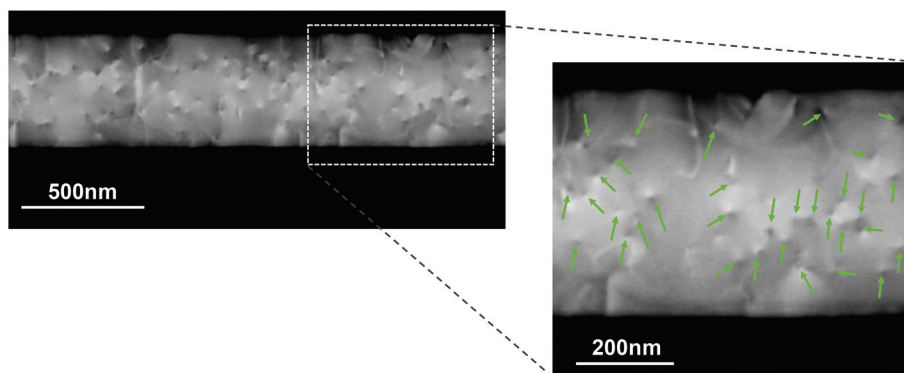
**Fig. 5** ECCI micrograph acquired on a 460 nm wide selectively grown SiGe fin. Individual threading dislocations are indicated by green arrows in the zoomed image. Similar to the blanket case (Fig. 3), a threading dislocation density of  $\sim 10^{10} \text{ cm}^{-2}$  could be extracted.

Next, we imaged  $460$  nm wide fin structures which have an aspect ratio AR (height : width) of  $\sim 0.4$ . Given the low AR, one does not expect an effective trapping of threading arms at the trench sidewalls during the selective epitaxial growth. Indeed, we observed a high density of threading dislocations terminating at the fin surface as can be seen in the ECCI micrographs displayed in Fig. 5. We extracted again a density equal to  $10^{10} \text{ cm}^{-2}$ . In the magnified image, single threading dislocations

(labeled with green arrows) can be observed in detail and the contrast inversion phenomenon discussed in the Experimental section of the paper can be clearly seen.

quantified using top-view SEM analysis (Fig. 6b) and confirmed the defect density determined by ECCI (Fig. 5) and hence the validity and accuracy of our approach.

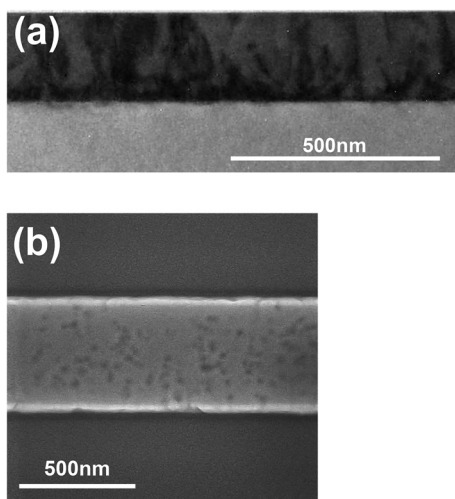
**Fig. 6** (a) TEM image acquired on a lamella prepared parallel to a 460 nm wide fin confirming a high density of threading dislocations. (b) Top-view SEM image after decorating the threading dislocations using Secco etch leading to the formation of etch pits at the defect sites. The density of etch pits is in agreement with the defect density extracted from ECCI analysis (Fig. 5).

For verification purposes we additionally performed TEM analysis on a specimen prepared along the length axis of a 460 nm wide fin. The cross-section TEM image in Fig. 6a confirms the high density of threading dislocations, though it is difficult to precisely quantify the number of threading arms reaching the fin surface due to the projection and overlap of the various defects present throughout the thickness of the TEM specimen. We furthermore applied wet chemical defect etching using the so-called Secco etch solution<sup>37</sup>, which consists of a solution of the Cr(VI) oxidant and the chemical dissolving agent HF in water. Diluted solutions were used in order to obtain sufficiently low etch rates to avoid overlapping etch pits associated with nearby defects. The density of etch pits was

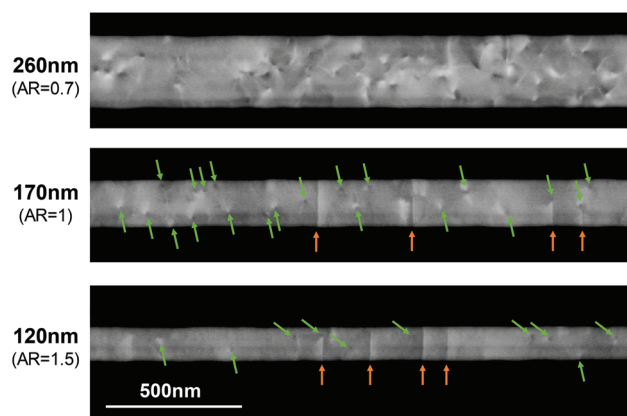
**Fig. 7** Top-view ECCI micrographs obtained on selectively grown SiGe fins of different widths. The density of threading dislocations reduces with decreasing fin width resulting in an effective threading dislocation density of  $4 \times 10^9 \text{ cm}^{-2}$  for the 120 nm wide fins. At the same time, however, the number of planar defects (stacking faults) emerging at the fin surface increases. The fins' aspect ratios AR (height : width) are indicated as well.

The picture changed upon decreasing the width of the selectively grown fins. While we could still observe a threading dislocation density of  $\sim 10^{10} \text{ cm}^{-2}$  on the surface of 260 nm wide fins, fewer threading dislocations (labeled with green arrows) reach the fin surface once the fin width is reduced to 170 nm and below (Fig. 7). In fact, for the 170 nm wide fins, we determined a reduction of the threading dislocation density to  $6 \times 10^9 \text{ cm}^{-2}$  and for the 120 nm wide fins to  $4 \times 10^9 \text{ cm}^{-2}$ . At the same time, however, we detected an increasing number of line-like features on the fin surface when decreasing the fin width. These lines (highlighted by orange arrows in Fig. 7, 8 and 10) are oriented perpendicular to the fin length and they correspond to planar defects emerging at the fin surface as will be discussed further below.

As is already noted above, we furthermore identified line-like features on the surface of fins which are  $\leq 170$  nm in width (Fig. 7 and 8). As illustrated in Fig. 10, such a line in an ECCI micrograph can be explained by lattice distortions associated with planar defects such as stacking faults oriented parallel to the (111) or (11 $\bar{1}$ ) planes emerging at the fin surface.

lying fin can either cross the entire fin from one sidewall to the other or they extend only partially across the fin width (see e.g. the different line features highlighted by the orange arrows on top of the 170 nm wide fin in Fig. 7). In the latter case, the stacking fault is boarded by a partial dislocation.

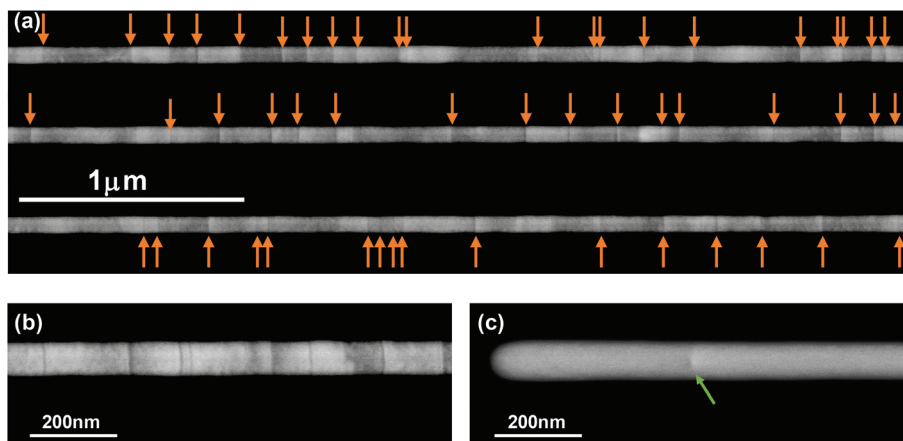
**Fig. 8** (a) Overview ECCI micrograph obtained on 75 nm wide ( $AR = 2.3$ ) selectively grown SiGe fins at lower magnification, which allows for the non-destructive and fast determination of statistically relevant numbers on the density of planar defects (stacking faults, highlighted by orange arrows). In the presented case, a linear density of 44 planar defects per 10  $\mu\text{m}$  fin length could be extracted. (b) ECCI micrograph of the same fin at higher magnification. Threading dislocations as observed for wider fins could not be detected. (c) ECCI micrograph acquired on a fin of similar dimensions which has been etched from a plastically relaxed blanket Ge layer. A single threading dislocation (highlighted by a green arrow) on the fin surface can be easily resolved.

In the case of 75 nm wide fins ( $AR = 2.3$ ), we could not observe any threading dislocation reaching the fin surface (Fig. 8a/b) whereby we inspected a fin surface area equal to 3.4  $\mu\text{m}^2$  in total, out of which a representative part is shown in Fig. 8a. Hence, the threading dislocation density for fins of this dimension must be below  $3 \times 10^7 \text{ cm}^{-2}$  if one assumes a uniform defect distribution. In this regard one must realize that in order to ascertain a defect density as low as *e.g.*  $10^5 \text{ cm}^{-2}$  (*i.e.* one threading dislocation per 1000  $\mu\text{m}^2$  on average) one needs to inspect a fin surface area of several thousand  $\mu\text{m}^2$  in order to obtain statistically relevant information. We are currently extending our setup to enable automated measurements to facilitate the inspection of such large areas thereby achieving better statistics and hence a lower overall detection limit.

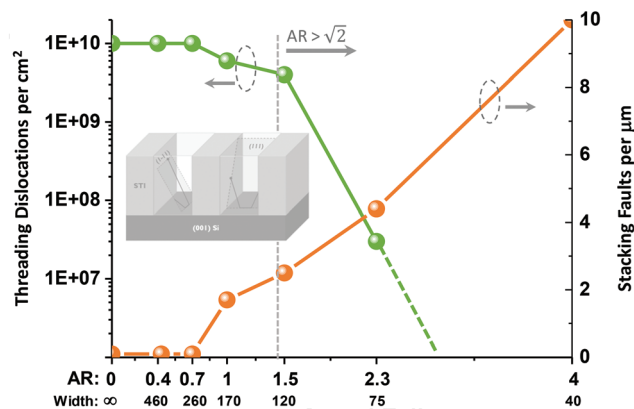
**Fig. 9** Areal density of threading dislocations (left y-axis) and the linear density of stacking faults (right y-axis) for fins of different widths as determined by ECCI. On the x-axis, the fin aspect ratio AR (height : width) as well as the fin width in nanometer are indicated. The inset schematically illustrates the trapping of threading dislocations at the STI sidewalls.

The threading dislocation densities obtained on the selectively grown SiGe fin structures of varying fin width (and hence aspect ratio AR) are summarized quantitatively in Fig. 9. The reason for the observed reduction in threading dislocation

density for larger aspect ratios can be attributed to the aspect ratio trapping mechanism.<sup>16</sup> Threading dislocations are connected to misfit dislocation lines in the (001) plane at the trench bottom (*i.e.* Si/SiGe interface) and they move towards the fin surface in the {111} planes. Since the angle between any {111} plane and the bottom of the trench (*i.e.* (001) plane) equals 54.7° in the case of a cubic crystal, any threading arm originating from the trench bottom and rising up in a ( $\bar{1}\bar{1}$ ) or ( $1\bar{1}\bar{1}$ ) plane will be blocked by the STI sidewalls if the aspect ratio of the trench exceeds  $\sqrt{2}$ . From Fig. 9 it becomes apparent that the threading dislocation density indeed drops significantly once the AR exceeds  $\sqrt{2}$ , although those threading arms rising upwards in the (111) or ( $1\bar{1}\bar{1}$ ) planes (which do not inter-

islands grow. Upon coalescence of these islands, stacking faults can form due to less perfect matching of the growth fronts of the islands at this position. The linear density of stacking faults for fins of different widths is summarized in Fig. 9. In contrast to the threading dislocation density, the number of planar defects increases for narrower trenches. This can be explained by the fact that the distance between nucleation islands is inversely related to the trench width,<sup>39</sup> for which reason islands in narrower trenches can grow bigger and hence are more prone to elastic distortions before they coalesce. This leads to an increased probability for the formation of stacking faults in narrower trenches. Moreover, after coalescence of the various nucleation islands, stacking faults can also arise higher up in the trench due to irregularities (*i.e.* roughness) at the STI trench sidewalls.<sup>32,40</sup> This mechanism can be neglected in wide structures, however, it becomes relevant in the case of narrower trenches exhibiting rougher sidewalls. Since the aspect ratio of these narrow trenches is higher than  $\sqrt{2}$ , planar defects oriented parallel to the (1 $\bar{1}$ 1) or (11 $\bar{1}$ ) planes are efficiently trapped by the STI sidewalls. Hence, only stacking faults running parallel to the (111) or (11 $\bar{1}$ ) planes do reach the fin surface leading to the observed line-like features oriented along the [1 $\bar{1}$ 0] direction in the top-view ECCI micrographs. Besides, it is worthwhile to note that the described lines and hence the associated planar defects in the under-

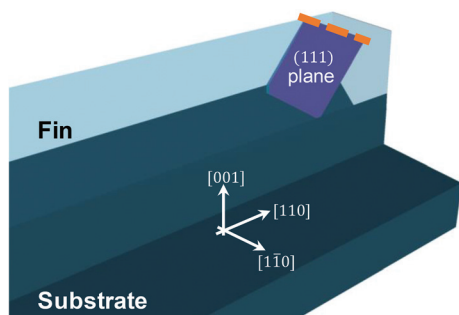
**Fig. 10** Schematic illustrating the positioning of a (111) plane in a fin oriented along the [110] direction. Planar defects such as stacking faults are plane-parallel to the {111} planes in a diamond crystal structure. Independent of the fin's aspect ratio, planar defects in the (111) and (11 $\bar{1}$ ) plane (*i.e.* running perpendicular to the fin) are not trapped at the fin sidewall. The intersection of these planar defects with the fin top surface leads to a line-like feature (dashed orange line) oriented along the [1 $\bar{1}$ 0] direction.

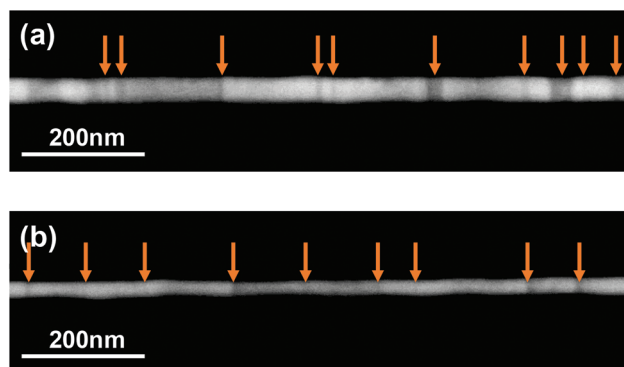
**Fig. 12** ECCI micrograph obtained on (a) 40 nm and (b) 30 nm wide selectively grown SiGe fin. A linear density of approximately 10 planar defects per micrometer fin length could be determined.

Moreover, to further support the aforementioned relationship between planar defect density and fin width (Fig. 9), we investigated selectively grown SiGe fins with widths down to 30 nm. From Fig. 12 it becomes apparent that using ECCI we are able to resolve stacking faults on the surface of these down-scaled 3D fin structures. Thereby, we could ascertain a linear density of approximately 10 planar defects per micrometer fin length. We attribute this increase compared to the wider fins shown in Fig. 7 and 8a/b to the aforementioned increased size and hence elastic distortion of nucleation islands at the point of coalescence as well as the increased STI sidewall roughness in the case of the narrowest trenches.

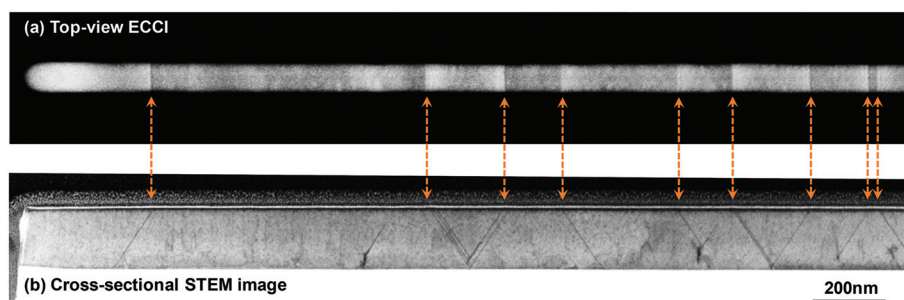
**Fig. 11** Correlation of (a) ECCI and (b) cross-sectional STEM analysis on the same selectively grown SiGe fin structure (75 nm wide, AR = 2.3). Each line-like feature in the top-view ECCI micrograph can be attributed to a stacking fault emerging at the surface of the SiGe fin.

In order to verify the origin of the line-like features observed by ECCI, we performed ECCI and subsequently cross-sectional STEM analysis on the very same fin structure (Fig. 11). Thereby, we could confirm an excellent correlation between planar defects emerging at the fin surface (as observed by cross-sectional STEM imaging – Fig. 11b) and the line-like features detected by ECCI (Fig. 11a).
