# Corrosion behaviour of welded low-carbon steel in the Arctic marine environment†

Arctic offshore sites have high potential for the exploration of energy resources; thus, data concerning the behaviour of structural materials in the Arctic environment are required. Here, we report the corrosive characteristics of welded low-carbon steels under simulated Arctic low-temperature conditions. The corrosion tendencies in the submerged and splash zones of offshore structures were investigated by immersion tests, salt spray tests (SST), and cyclic corrosion tests (CCT). The effects of decreasing seawater temperature on the corrosion were identified, and the differences in corrosion between the base metal (BM) and weld metal (WM) were analysed. In particular, the BM showed higher corrosion than the WM, indicating that the parent metal (PM) is corroded more than the fusion zone (FZ) in weld joints under severe corrosion conditions. Thus, we have identified the importance and influence of the thermal expansion of materials on corrosion under Arctic conditions.

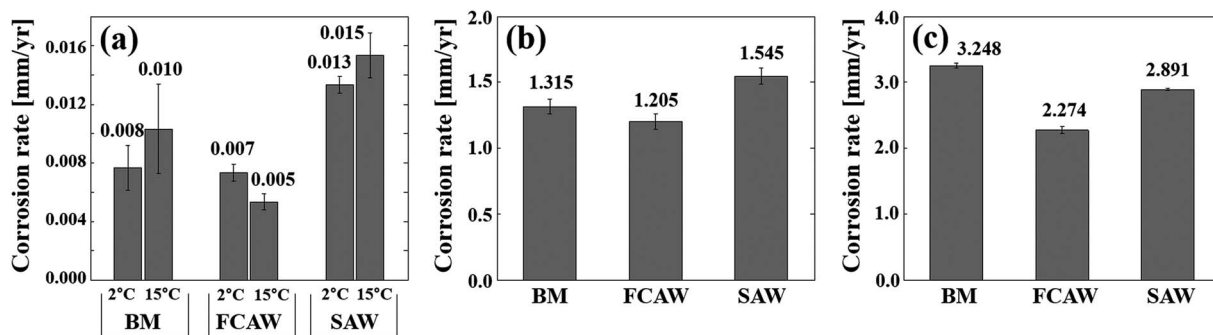
Fig. 1 Corrosion rates of experimental specimens obtained from various corrosion tests. (a) Immersion test, (b) salt-spray test, and (c) cyclic corrosion test.

Concerning the immersion test results (Fig. 1a), the corrosion rate of all specimens showed a satisfactory value of 0.005–0.015 mm y<sup>−1</sup>. The degree of corrosion was in the order of FCAW < BM < SAW, and the difference between BM and FCAW was very small. The BM specimen showed a slight higher corrosion rate than FCAW but lower than SAW, thus the degree of corrosion was in the order of FCAW < BM < SAW. As the seawater temperature decreased, no noticeable decrease in corrosion was observed. No pitting corrosion was found, and partial red-brown general corrosion was observed.

In the salt spray tests (Fig. 1b), the corrosion rate was 1.205–1.545 mm y<sup>−1</sup>, which is 70 times higher than that measured in the seawater immersion tests. This indicates that the base material is very weak in salt spray exposure conditions. The corrosion tendency was similar to the results of immersion test in the order of FCAW < BM < SAW. In general, SST is less relevant to reproduce practical corrosive conditions, but tests were conducted to compare corrosion differences between specimens under constant temperature conditions in saline conditions and for comparison with the CCT test results.

Fig. 1c, serious corrosion rate in the range of 2.274 to 3.248 mm y<sup>−1</sup> was confirmed. The degree of corrosion was in the order of FCAW < SAW < BM, and the formation of a significant rust layer was visually observed (ESI†). The corrosion level determined from the CCT was more than 130 times higher than the seawater immersion test, and it was confirmed that the corrosion change of the steel was caused by the repeated wetting and drying, as well as temperature changes. In particular, by comparing the results shown in Fig. 1a and b we confirmed the specific corrosion of the BM is slightly higher than FCAW but much lower than SAW. This is important information for base metals and weld joints in the design of the offshore materials; thus, we identified the causes.

As shown in Fig. 1, the corrosion trends for the BM and the WM under Arctic conditions were confirmed. In the submerged simulated condition test, rust was produced in the form of general corrosion, but it was difficult to visually distinguish the corrosive difference between the BM and the WM specimens because of the small amount of corrosion. However, when comparing the corrosion rates *via* measuring the weight loss, the values for the WM specimens were generally higher than those of the BM specimens. This indicates that the corrosion influence on FZ or HAZ is relatively higher than those of the PM.

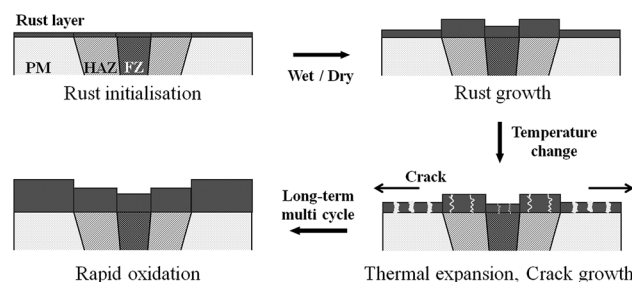
Fig. 6 Schematic of the rapid oxidation of the parent metal (PM), heat affected zone (HAZ), and fusion zone (FZ) under CCT conditions.

primarily affected by the compactness and adhesiveness of the rust layer than any other factors under severe corrosion conditions. Although many studies have dealt with the rust-expansion-induced cracking of steel bars in reinforced concrete structures,<sup>32,33</sup> no studies have shown the difference in rust cracking between the PM and FZ in weld joint regions.

Consequently, it can be seen that a difference in CTE is a critical factor for the corrosion behaviour under heavy corrosion conditions. It also shows the possibility of significant corrosion progression by repeated rust layer cracking. Therefore, this study suggests the severe influence of corrosion on PM in weld joints, and further related research will be needed in the future.
