Cite this: *Nanoscale*, 2018, **10**, 7058

Non-destructive characterization of extended crystalline defects in confined semiconductor device structures†

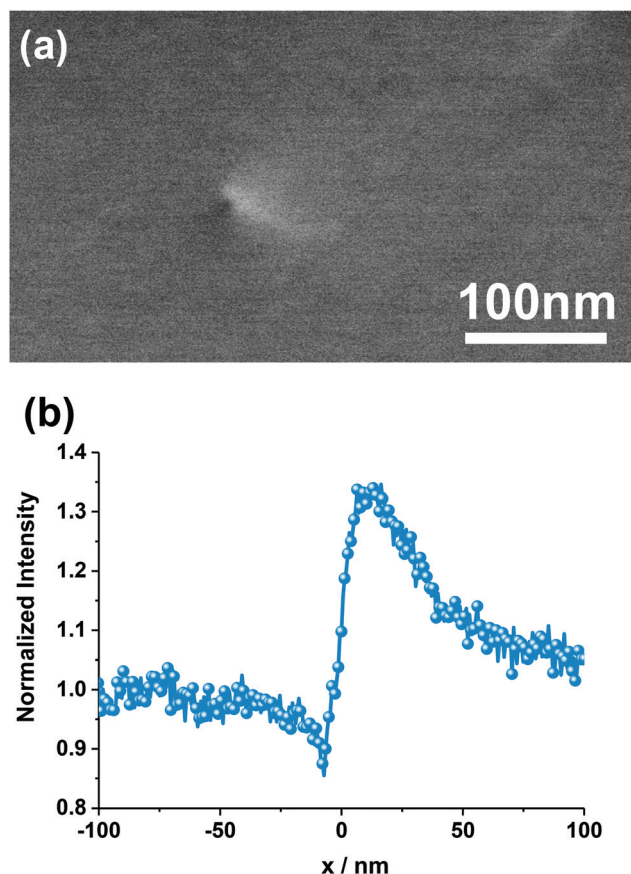
Fig. 1 (a) ECCI micrograph obtained on a lowly defective SiGe buffer layer showing a single threading dislocation emerging at the layer surface. The typical contrast inversion across the defect is clearly visible. (b) Horizontal line section through the defect illustrating the contrast inversion quantitatively (*i.e.* transition from reduced backscatter signal to an increased backscatter signal when crossing the defect from left to right).

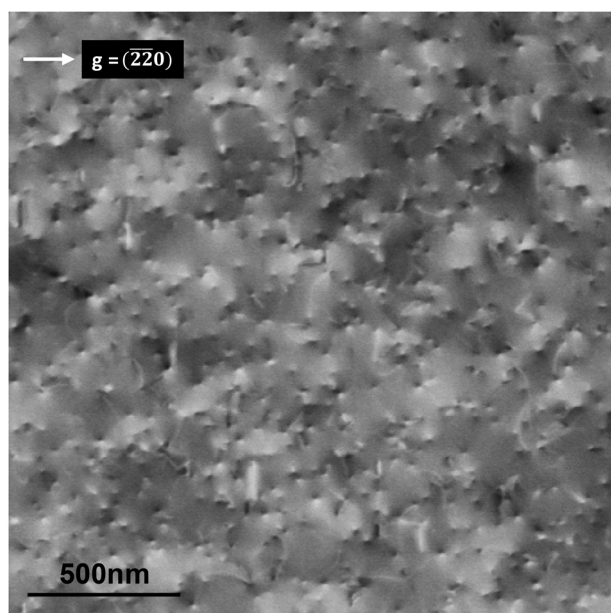
Fig. 3 ECCI micrograph obtained on a $\text{Si}_{0.3}\text{Ge}_{0.7}$ layer grown into a several micrometer large window. The selected diffraction condition (cf. Fig. 2) is indicated by the arrow in the upper left corner of the graph. The same diffraction condition and hence g vector have been used throughout the paper for all ECCI micrographs. Individual threading dislocations are clearly resolved. The layer exhibits a threading dislocation density of $\sim 10^{10} \text{ cm}^{-2}$.

In the first experiment, we acquired an ECCI micrograph (Fig. 3) on a several micrometer large area, which was fabricated by selective epitaxial growth of $\text{Si}_{0.3}\text{Ge}_{0.7}$ into a large opening in the STI. Since the lateral dimensions of that area are much larger than the layer thickness (~ 200 nm as-grown), no defect trapping occurs and the structure is therefore equivalent to a blanket layer. Since the layer thickness exceeds the critical thickness and elastic relaxation can be excluded given the large lateral dimensions of the pad, the layer must be plastically relaxed. Indeed, the $\text{Si}_{0.3}\text{Ge}_{0.7}$ peak position (~ 3900 arcsec) in the (004) ω - 2θ high-resolution X-ray diffraction (HRXRD) scan confirms the high degree of strain relaxation (Fig. 4).^{32,33} Plastic relaxation is associated with misfit dislocations at the buried layer-substrate interface whereby the misfit dislocations accommodate the lattice mismatch between both materials in the direction perpendicular to the dislocation line.³⁴

The stress fields associated with these threading dislocations cause a local deformation of the crystal lattice planes, which can be imaged using ECCI, as described in the Experimental section. As a consequence, each of the dot-like features visible in the ECCI micrograph shown in Fig. 3 can be attributed to a single threading dislocation intersecting with the layer surface. The number of these features and hence the density of threading dislocations on the surface can now be extracted straightforwardly, resulting in a value of 10^{10} cm^{-2} . The overall contrast variations which become apparent from the ECC image in Fig. 3 are due to the mosaicity and the associated lattice tilt of the material, which is caused by the high density of threading dislocations. The mosaicity and hence limited lateral coherence length of the layer causes a significant broadening of the HRXRD ω -rocking curve (inset Fig. 4). It has been demonstrated that from this peak broadening, the threading dislocation density can be estimated for the case of highly defective materials.³⁶ Using the model of Ayers³⁶ and a full width at half maximum (FWHM) of 1650 arcsec (inset Fig. 4) we could derive a threading dislocation density of $9.5 \times 10^9 \text{ cm}^{-2}$, which is in good agreement with the aforementioned defect density obtained from the ECCI micrograph shown in Fig. 3.

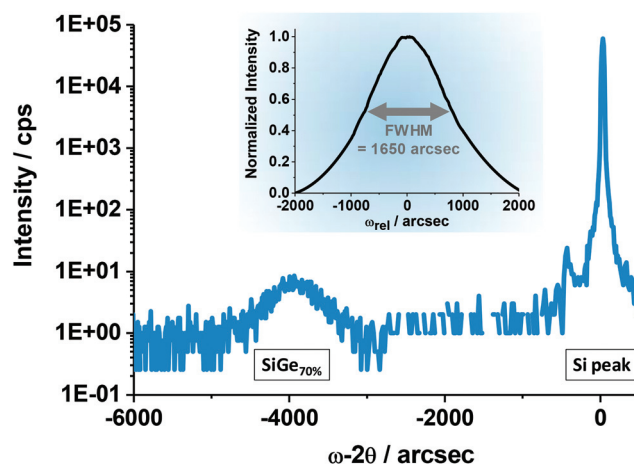
Fig. 4 HRXRD (004) ω - 2θ scan acquired on the large $\text{Si}_{0.3}\text{Ge}_{0.7}$ pad. The peak around -3900 arcsec corresponds to fully relaxed $\text{Si}_{0.3}\text{Ge}_{0.7}$. The inset shows an ω rocking curve obtained around the SiGe layer peak. The pronounced peak broadening with a FWHM value of 1650 arcsec is due to the high defect density and the associated mosaicity of the material.

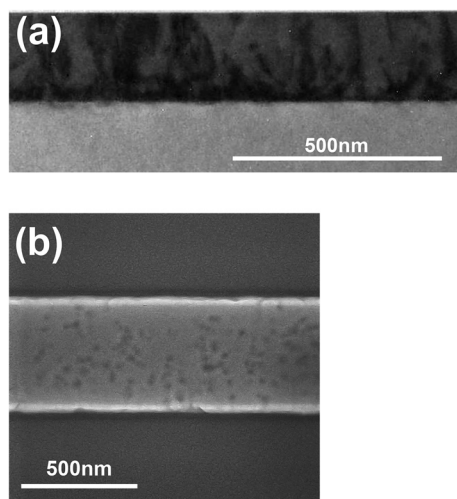
Fig. 6 (a) TEM image acquired on a lamella prepared parallel to a 460 nm wide fin confirming a high density of threading dislocations. (b) Top-view SEM image after decorating the threading dislocations using Secco etch leading to the formation of etch pits at the defect sites. The density of etch pits is in agreement with the defect density extracted from ECCI analysis (Fig. 5).

For verification purposes we additionally performed TEM analysis on a specimen prepared along the length axis of a 460 nm wide fin. The cross-section TEM image in Fig. 6a confirms the high density of threading dislocations, though it is difficult to precisely quantify the number of threading arms reaching the fin surface due to the projection and overlap of the various defects present throughout the thickness of the TEM specimen. We furthermore applied wet chemical defect etching using the so-called Secco etch solution³⁷, which consists of a solution of the Cr(vi) oxidant and the chemical dissolving agent HF in water. Diluted solutions were used in order to obtain sufficiently low etch rates to avoid overlapping etch pits associated with nearby defects. The density of etch pits was

quantified using top-view SEM analysis (Fig. 6b) and confirmed the defect density determined by ECCI (Fig. 5) and hence the validity and accuracy of our approach.

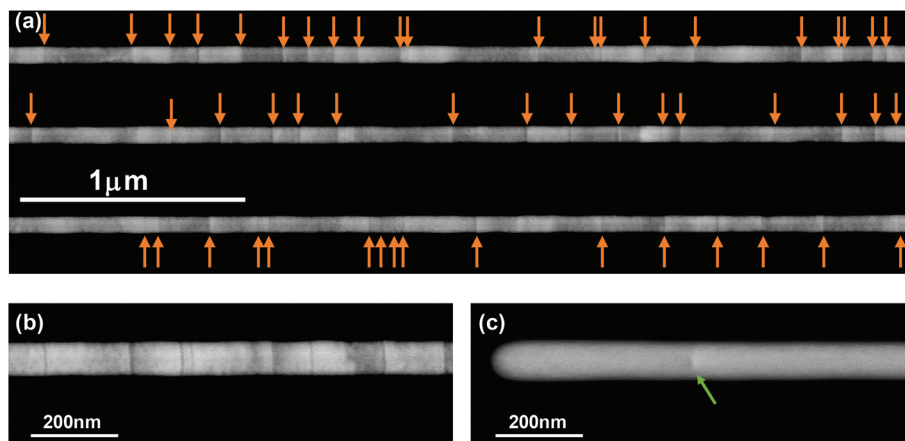
Fig. 8 (a) Overview ECCI micrograph obtained on 75 nm wide ($AR = 2.3$) selectively grown SiGe fins at lower magnification, which allows for the non-destructive and fast determination of statistically relevant numbers on the density of planar defects (stacking faults, highlighted by orange arrows). In the presented case, a linear density of 44 planar defects per 10 μm fin length could be extracted. (b) ECCI micrograph of the same fin at higher magnification. Threading dislocations as observed for wider fins could not be detected. (c) ECCI micrograph acquired on a fin of similar dimensions which has been etched from a plastically relaxed blanket Ge layer. A single threading dislocation (highlighted by a green arrow) on the fin surface can be easily resolved.

In the case of 75 nm wide fins ($AR = 2.3$), we could not observe any threading dislocation reaching the fin surface (Fig. 8a/b) whereby we inspected a fin surface area equal to $3.4 \mu\text{m}^2$ in total, out of which a representative part is shown in Fig. 8a. Hence, the threading dislocation density for fins of this dimension must be below $3 \times 10^7 \text{ cm}^{-2}$ if one assumes a uniform defect distribution. In this regard one must realize that in order to ascertain a defect density as low as *e.g.* 10^5 cm^{-2} (*i.e.* one threading dislocation per 1000 μm^2 on average) one needs to inspect a fin surface area of several thousand μm^2 in order to obtain statistically relevant information. We are currently extending our setup to enable automated measurements to facilitate the inspection of such large areas thereby achieving better statistics and hence a lower overall detection limit.

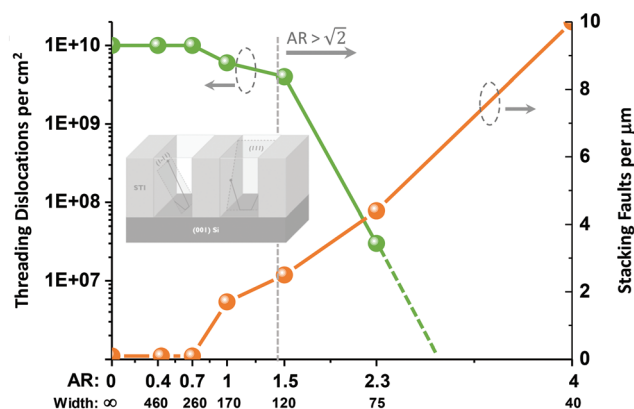
Fig. 9 Areal density of threading dislocations (left y-axis) and the linear density of stacking faults (right y-axis) for fins of different widths as determined by ECCI. On the x-axis, the fin aspect ratio AR (height : width) as well as the fin width in nanometer are indicated. The inset schematically illustrates the trapping of threading dislocations at the STI sidewalls.

The threading dislocation densities obtained on the selectively grown SiGe fin structures of varying fin width (and hence aspect ratio AR) are summarized quantitatively in Fig. 9. The reason for the observed reduction in threading dislocation

density for larger aspect ratios can be attributed to the aspect ratio trapping mechanism.¹⁶ Threading dislocations are connected to misfit dislocation lines in the (001) plane at the trench bottom (*i.e.* Si/SiGe interface) and they move towards the fin surface in the $\{111\}$ planes. Since the angle between any $\{111\}$ plane and the bottom of the trench (*i.e.* (001) plane) equals 54.7° in the case of a cubic crystal, any threading arm originating from the trench bottom and rising up in a $(1\bar{1}1)$ or $(11\bar{1})$ plane will be blocked by the STI sidewalls if the aspect ratio of the trench exceeds $\sqrt{2}$. From Fig. 9 it becomes apparent that the threading dislocation density indeed drops significantly once the AR exceeds $\sqrt{2}$, although those threading arms rising upwards in the (111) or $(11\bar{1})$ planes (which do not inter-

islands grow. Upon coalescence of these islands, stacking faults can form due to less perfect matching of the growth fronts of the islands at this position. The linear density of stacking faults for fins of different widths is summarized in Fig. 9. In contrast to the threading dislocation density, the number of planar defects increases for narrower trenches. This can be explained by the fact that the distance between nucleation islands is inversely related to the trench width,³⁹ for which reason islands in narrower trenches can grow bigger and hence are more prone to elastic distortions before they coalesce. This leads to an increased probability for the formation of stacking faults in narrower trenches. Moreover, after coalescence of the various nucleation islands, stacking faults can also arise higher up in the trench due to irregularities (*i.e.* roughness) at the STI trench sidewalls.^{32,40} This mechanism can be neglected in wide structures, however, it becomes relevant in the case of narrower trenches exhibiting rougher sidewalls. Since the aspect ratio of these narrow trenches is higher than $\sqrt{2}$, planar defects oriented parallel to the ($\bar{1}\bar{1}\bar{1}$) or ($\bar{1}\bar{1}\bar{1}$) planes are efficiently trapped by the STI sidewalls. Hence, only stacking faults running parallel to the (111) or ($\bar{1}\bar{1}\bar{1}$) planes do reach the fin surface leading to the observed line-like features oriented along the [110] direction in the top-view ECCI micrographs. Besides, it is worthwhile to note that the described lines and hence the associated planar defects in the under-

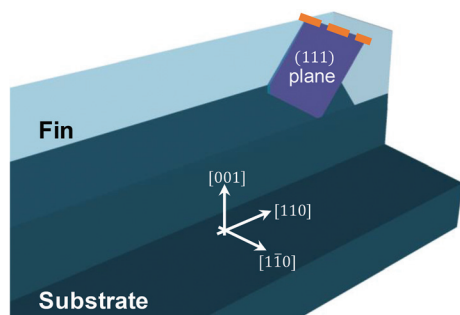
Fig. 10 Schematic illustrating the positioning of a (111) plane in a fin oriented along the [110] direction. Planar defects such as stacking faults are plane-parallel to the {111} planes in a diamond crystal structure. Independent of the fin's aspect ratio, planar defects in the (111) and ($\bar{1}\bar{1}\bar{1}$) plane (*i.e.* running perpendicular to the fin) are not trapped at the fin sidewall. The intersection of these planar defects with the fin top surface leads to a line-like feature (dashed orange line) oriented along the [110] direction.

As is already noted above, we furthermore identified line-like features on the surface of fins which are ≤ 170 nm in width (Fig. 7 and 8). As illustrated in Fig. 10, such a line in an ECCI micrograph can be explained by lattice distortions associated with planar defects such as stacking faults oriented parallel to the (111) or ($\bar{1}\bar{1}\bar{1}$) planes emerging at the fin surface.
