## PAPER

Cite this: *Environ. Sci.: Adv.*, 2025, 4, 606

# Impact of wildfires on the drinking water catchment for the capital area of Iceland – a case study†

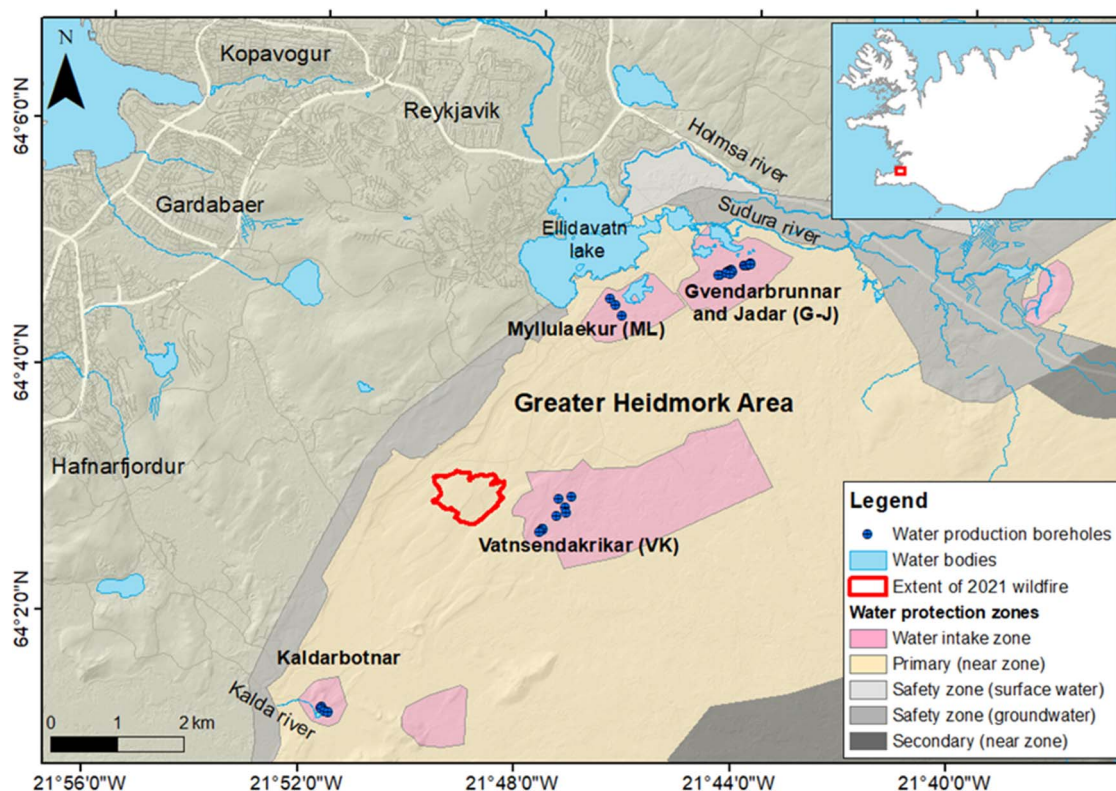
Fig. 1 The greater Heidmork area – the water protection area for the capital region. Drinking water production boreholes are shown. The wildfire area is marked as red (based on data from the Icelandic Institute of Natural History).

The groundwater resources for drinking water for the capital region of Iceland are in the greater Heidmork area (see Fig. 1). The area supplies water to six municipalities—Reykjavik, Kopavogur, Gardabaer, Hafnarfjörður, Mosfellsbaer, and Seltjarnarnes—serving 64% of the population of Iceland (about 230 thousand residents) and is harnessed by six publicly owned water utilities with a yearly average of about 1100 l s<sup>-1</sup>.<sup>44</sup> Furthermore, the area is designated as a nature reserve and serves as the largest outdoor recreational area in the vicinity of the city, covering approximately 32 square kilometers. Almost 90% of the area is vegetated land, of which about 20% is cultivated woodland and 20% is wild birch forest and scrub.<sup>45</sup> According to the NDVI (Normalized Difference Vegetation Index), measured since 1982, there has been a great increase in vegetation in the northern latitudes, including Iceland, since the 1980s.<sup>40,46</sup>

Groundwater flows from the mountain area south-east of Heidmork towards the lowlands in the north-west. At Vatnsendakrikar (VK), harnessed by Veitur Utilities and Kopavogur Utility (also delivering water to the water utility in Gardabaer), the groundwater stream divides, as part of the stream flows north and north-west to Myllulækur (ML) and Gvendarbrunnar-Jadar (G-J), and part flows south-west to Kaldarbotnar, harnessed by Hafnarfjörður.<sup>48</sup>

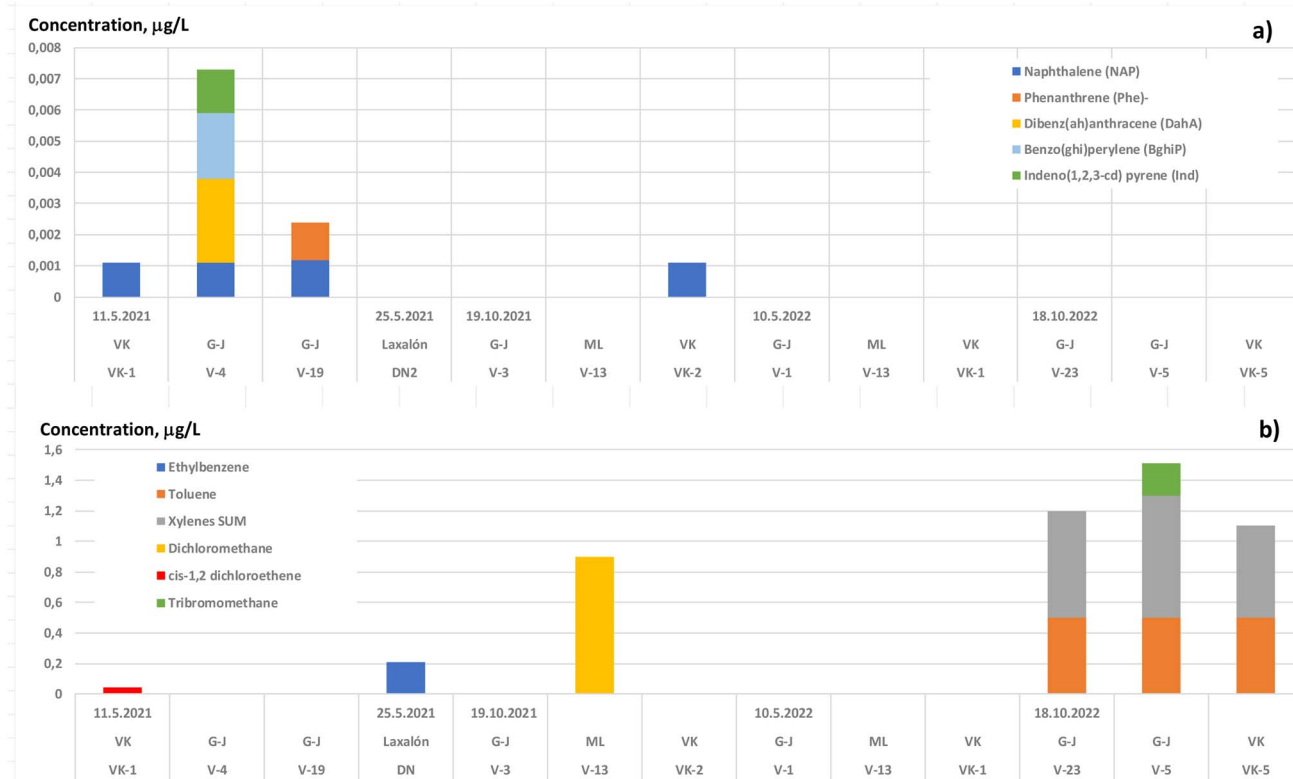
Fig. 2 PAHs (a) and VOCs (b) detected in samples from 11.5.2021 until 18.10.2022 (VK = Vatnsendakrikar, G-J = Gvendarbrunnar–Jadar, DN = distribution network, and ML = Myllulaekur).

Results from sampling taken a week after the fire (May 11) from boreholes in the two water intake zones VK and G-J showed various PAHs and some VOCs following the fire (Fig. 2 and Table 4). Although the analysis of organic compounds is part of the routine monitoring program at the Heidmork production site, the detection limits of the employed methods were, most often, up to an order of magnitude higher prior to the wildfire compared to post-wildfire. The detection limit for all organic chemicals is shown in the ESI† to this article. None of the pre-fire samples exceeded the detection limits for PAHs.

Five of the 16 priority PAHs were above the detection limit in zones G-J and VK within weeks of the wildfire (ML was not measured then). These include naphthalene (NAP) and phenanthrene (Phe) with two or three benzene rings; these are

classified as non-carcinogenic. Dibenz(ah)anthracene (DahA), benzo(ghi)perylene (BghiP) and indeno(1,2,3-cd) pyrene (Ind), in turn, are carcinogens with 5 to 6 benzene rings.<sup>49</sup> While some of the concentrations were close to the detection limit, they were always well below health limits. The highest concentrations were two to three times the detection limit. The fact that the concentrations mostly exceeded detection limits one week after the fire, coinciding with an increase in some metal concentrations (Fig. 3), supports that the pollution is linked to the wildfire. The total sum of the five PAHs detected a week after the wildfire ranged from 1.1 to 7.3 ng l<sup>-1</sup>. The three carcinogenic PAHs were only detected in borehole V4 in the lower intake area (G-J), where the groundwater level is only 1–10 m (Table 1). Because of the lack of sampling after the precipitation at the end of May (29th, 2021), it is difficult to know the influence of infiltration into groundwater aquifers and thus the phase-out of the PAH contamination.

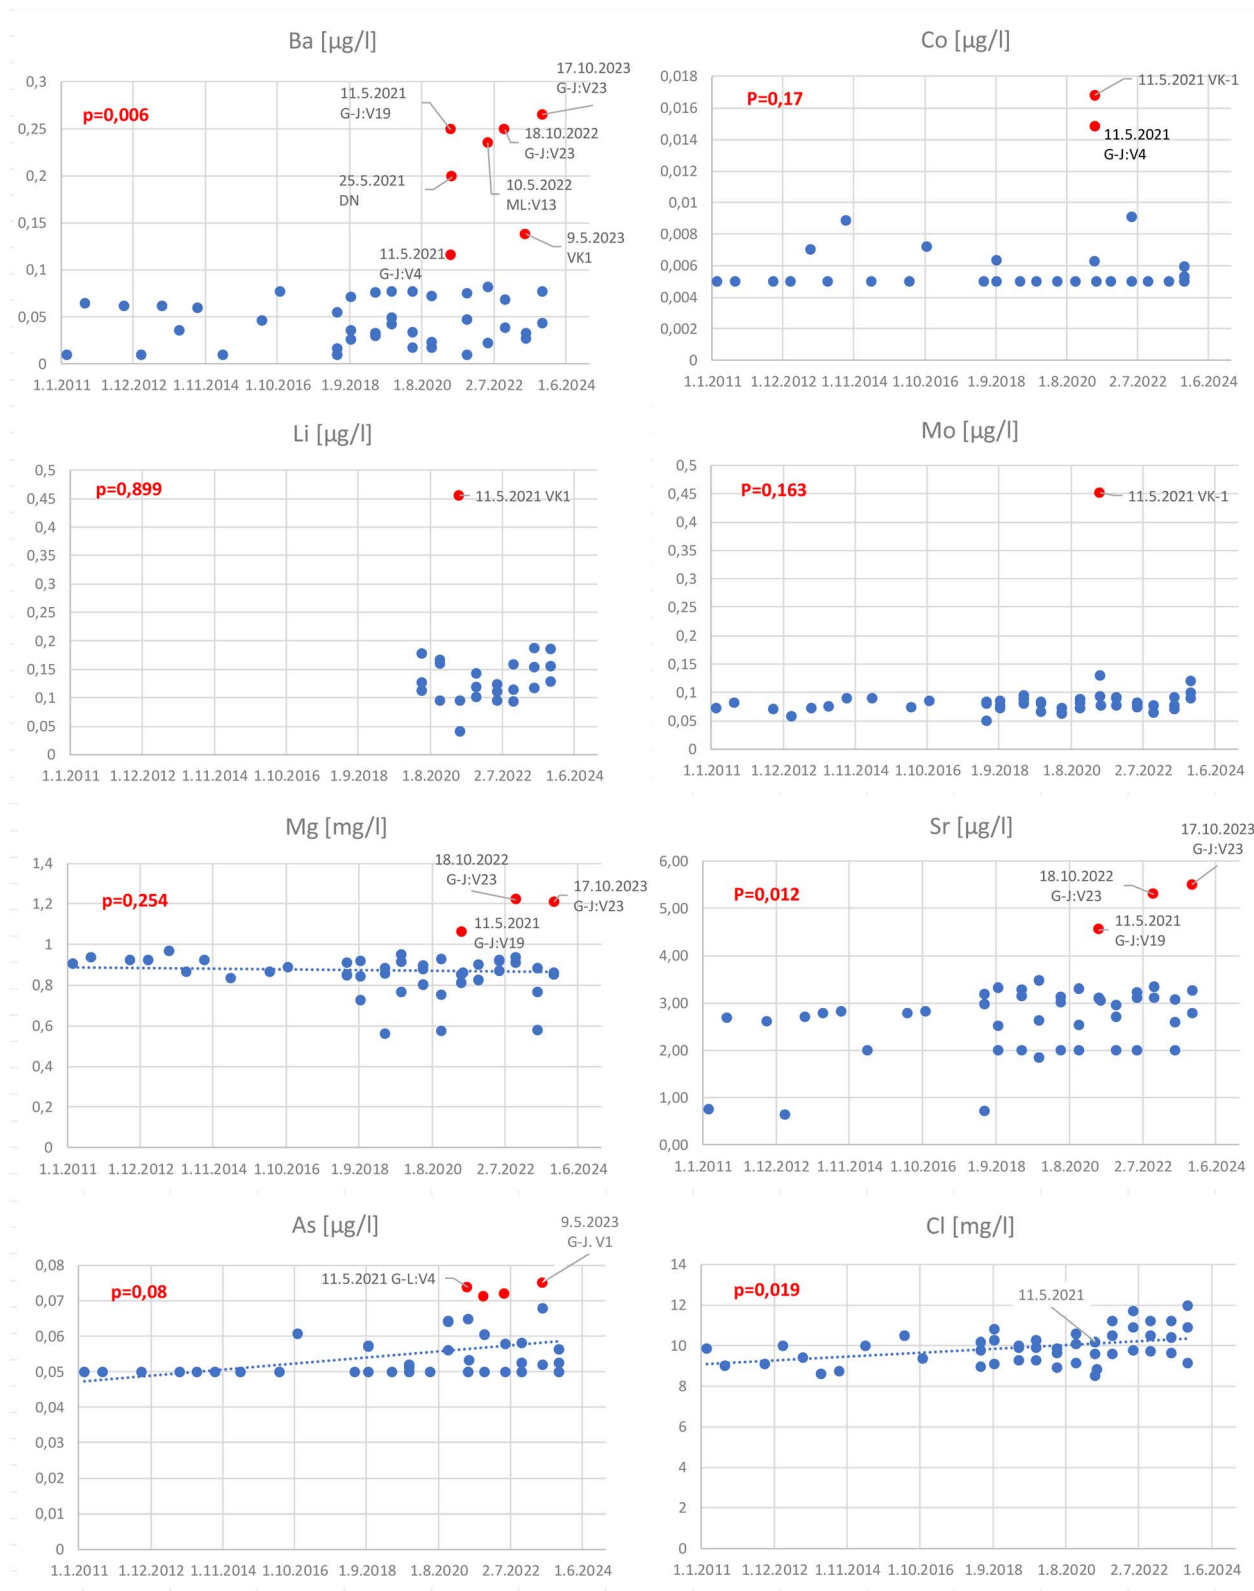
Fig. 3 Eight elements measured in samples taken between 2011 and 2023 showing either a temporary increase after the fire or a significant post-fire increase.

Six metals, barium (Ba), cobalt (Co), lithium (Li), molybdenum (Mo), magnesium (Mg) and strontium (Sr), were measured in two to nearly six-fold higher concentrations after the fire compared to the median value (Fig. 3 and Table 3). Some increases were short-lived, namely Co, Li, Mg and Mo, while Ba and Sr showed a tendency for longer-lasting impacts and there was a significant post-fire increase in concentration in both ( $p < 0.05$ ). Arsenic (As) and chloride (Cl) also have significantly higher post-fire concentrations. However, this does not seem to be related to the wildfire as shown in Fig. 3. It is noted that the elevated concentration of

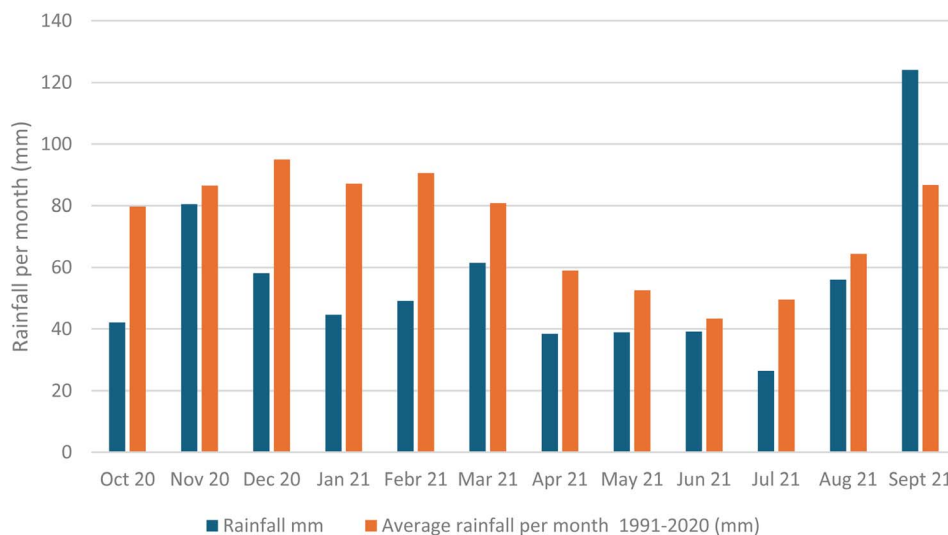
Fig. 4 Monthly rainfall in Reykjavik from 1.10.2020 to 1.10.2021 compared to the average monthly rainfall for the period 1991–2020.

Meteorological measurements clearly show the impact of the drought on the hydrology (Fig. 4). The average precipitation in December, January and February preceding the fire was approximately half the monthly average (90 mm). This resulted in a low volumetric water content in the soil in the open field of the water intake zone at ML and an exceptionally low groundwater level in boreholes at VK. The volumetric water content in soil was low for the late winter period leading up to the fire, fell significantly at the beginning of January and did not recover to the normal stage until after the heavy rain incident on May 29th (Fig. 5). The groundwater level in borehole VK-1 was low in the first months of 2021 compared to the daily average (2008–2020) and exceptionally low in the weeks leading up to the fire (Fig. 6). These measurements demonstrate the importance of systematically monitoring the hydrometeorological parameters to provide early warning for potential wildfires.

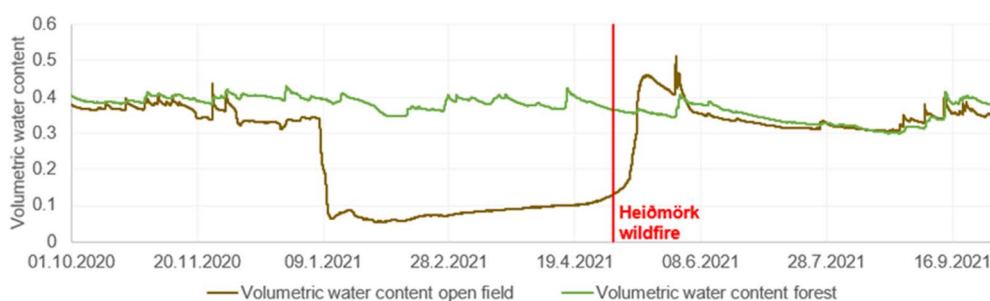
Fig. 5 Volumetric water content in soil in pine forest (green) and open field (brown) from 1.10.2020 to 1.10.2021 measured in the water protection area ML. The vertical line shows the timing of the wildfire.

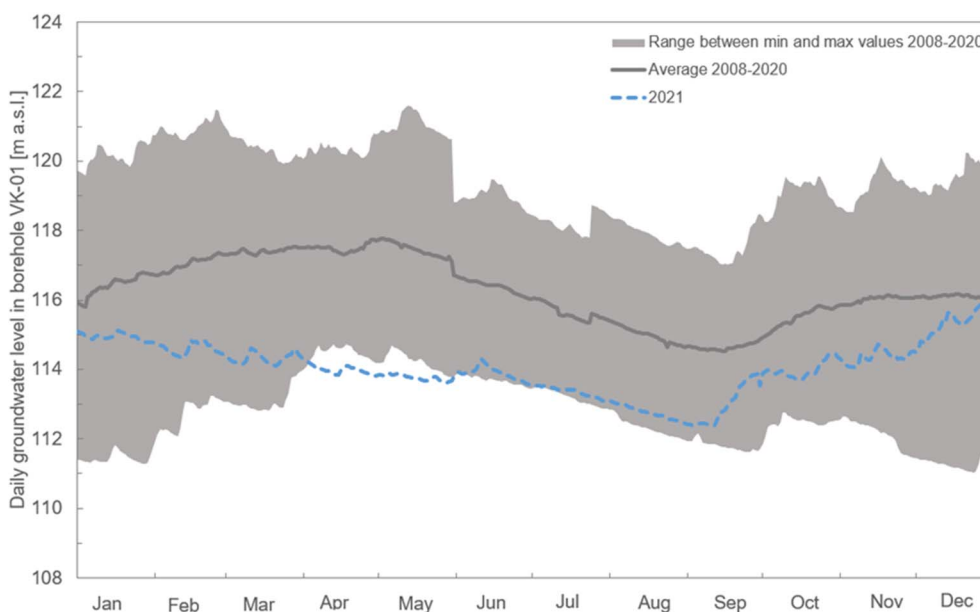
Fig. 6 Average groundwater level for VK-1 for the period 2008–2020, where the shaded area shows the range of the max mean values. The blue line shows the level for 2021.

values were used. Records of the historical groundwater level in the VK production zone east of the wildfire were available from 2008. Daily averages from borehole VK-1 were used.
