Environmental Science Advances

Impact of wildfires on the drinking water catchment for the capital area of Iceland — a case study†

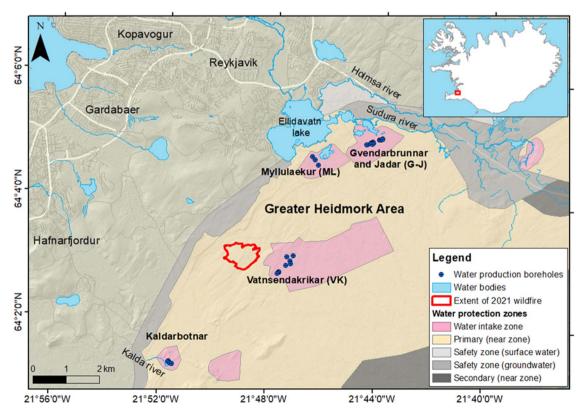
Fig. 1 The greater Heidmork area – the water protection area for the capital region. Drinking water production boreholes are shown. The wildfire area is marked as red (based on data from the Icelandic Institute of Natural History).

The groundwater resources for drinking water for the capital region of Iceland are in the greater Heidmork area (see Fig. 1). The area supplies water to six municipalities—Reykjavik, Kopavogur, Gardabaer, Hafnarfjordur, Mosfellsbaer, and Seltjarnarnes—serving 64% of the population of Iceland (about 230 thousand residents) and is harnessed by six publicly owned water utilities with a yearly average of about 1100 l s⁻¹.44 Furthermore, the area is designated as a nature reserve and serves as the largest outdoor recreational area in the vicinity of the city, covering approximately 32 square kilometers. Almost 90% of the area is vegetated land, of which about 20% is cultivated woodland and 20% is wild birch forest and scrub. 45 According to the NDVI (Normalized Difference Vegetation Index), measured since 1982, there has been a great increase in vegetation in the northern latitudes, including Iceland, since the 1980s.40,46

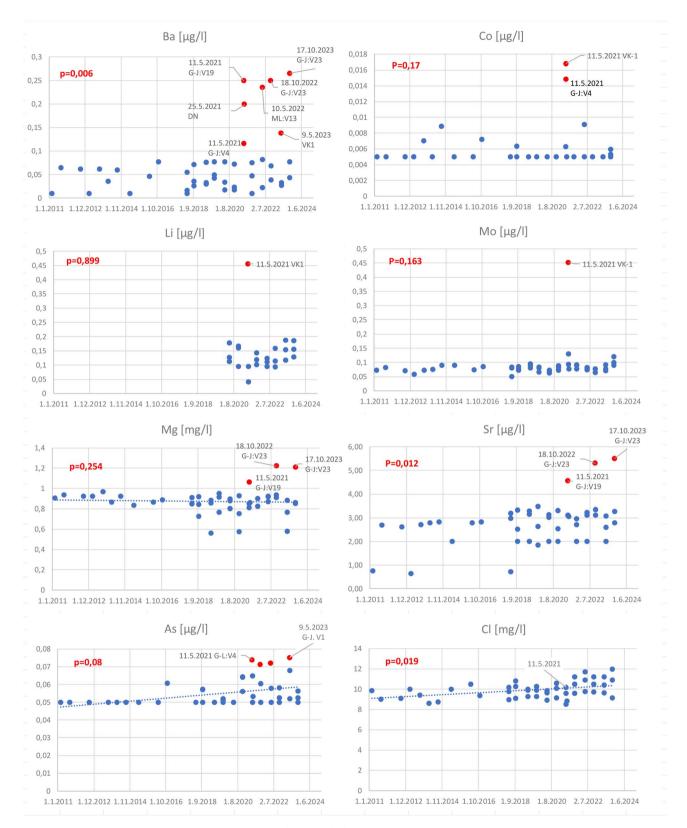
Fig. 3 Eight elements measured in samples taken between 2011 and 2023 showing either a temporary increase after the fire or a significant postfire increase.

Six metals, barium (Ba), cobalt (Co), lithium (Li), molybdenum (Mo), magnesium (Mg) and strontium (Sr), were measured in two to nearly six-fold higher concentrations after the fire compared to the median value (Fig. 3 and Table 3). Some increases were short-lived, namely Co, Li, Mg and Mo, while Ba and Sr showed a tendency for longer-lasting impacts and there was a significant post-fire increase in concentration in both (p < 0.05). Arsenic (As) and chloride (Cl) also have significantly higher post-fire concentrations. However, this does not seem to be related to the wildfire as shown in Fig. 3. It is noted that the elevated concentration of

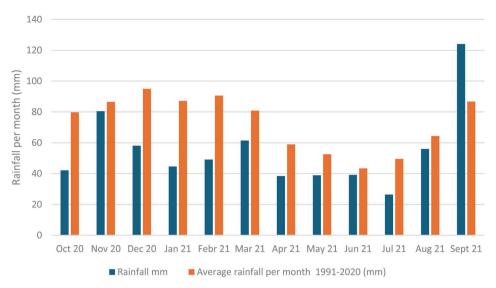
Fig. 4 Monthly rainfall in Reykjavik from 1.10.2020 to 1.10.2021 compared to the average monthly rainfall for the period 1991–2020.

Meteorological measurements clearly show the impact of the drought on the hydrology (Fig. 4). The average precipitation in December, January and February preceding the fire was approximately half the monthly average (90 mm). This resulted in a low volumetric water content in the soil in the open field of the water intake zone at ML and an exceptionally low groundwater level in boreholes at VK. The volumetric water content in soil was low for the late winter period leading up to the fire, fell significantly at the beginning of January and did not recover to the normal stage until after the heavy rain incident on May 29th (Fig. 5). The groundwater level in borehole VK-1 was low in the first months of 2021 compared to the daily average (2008–2020) and exceptionally low in the weeks leading up to the fire (Fig. 6). These measurements demonstrate the importance of systematically monitoring the hydrometeorological parameters to provide early warning for potential wildfires.
