Cite this: *Energy Environ. Sci.*, 2025, 18, 264

## Removal of residual contaminants by minute-level washing facilitates the direct regeneration of spent cathodes from retired EV Li-ion batteries<sup>†</sup>

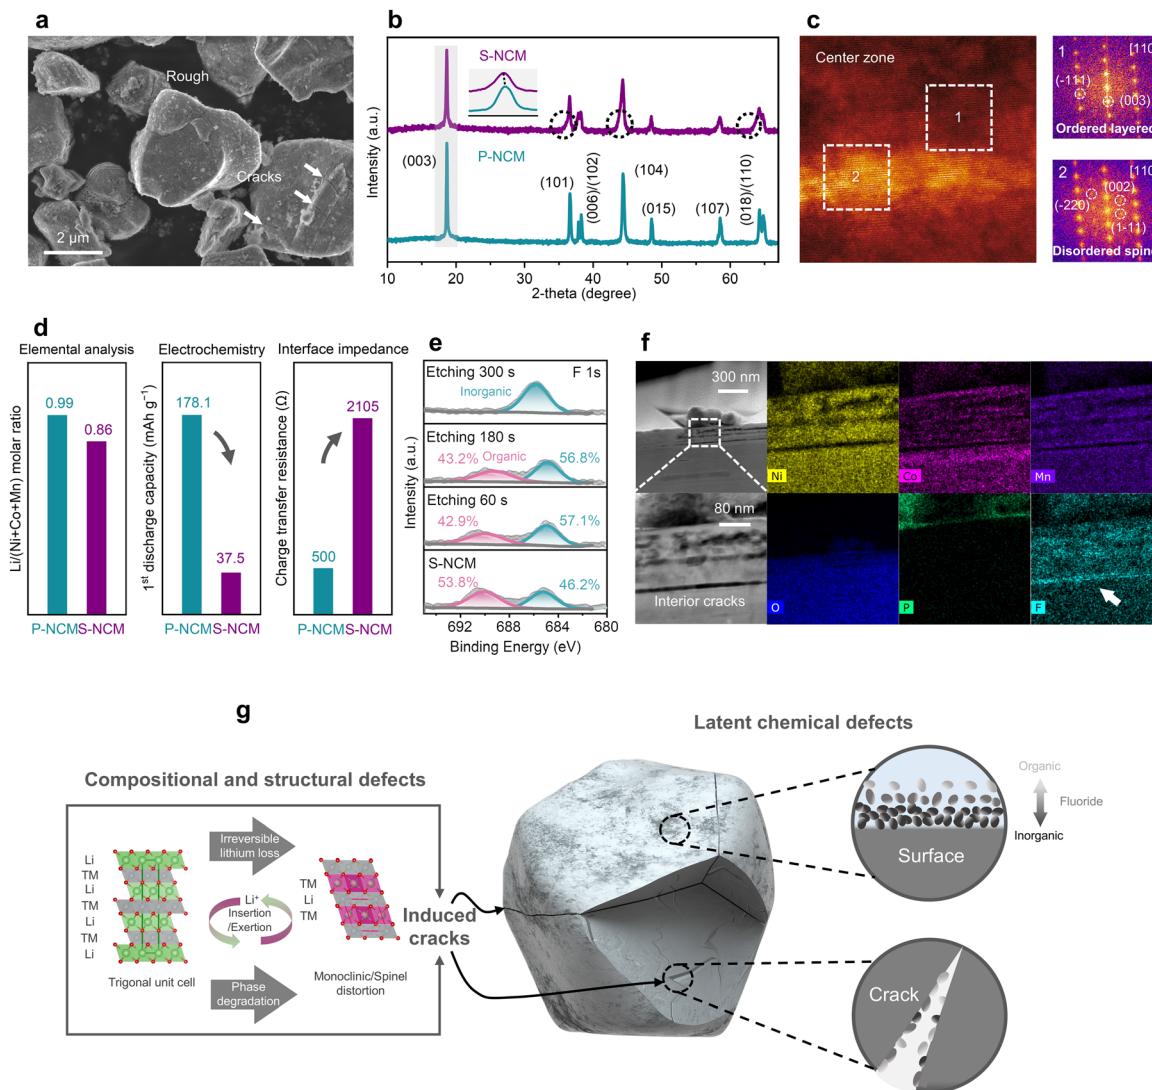
**Fig. 1** Neglected chemical residuals on the 250k-miles-serviced cathode. (a) SEM image and (b) XRD pattern of the degraded S-NCM. The black dotted circle accentuates the subtle peaks that do not belong to the layered structure; (c) high-resolution HAADF-STEM images on the central area of the S-NCM particle and the FFT patterns of the selected dark and bright regions; (d) comprehensive comparison of lithium loss in degraded powders measured by ICP-OES, electrochemical capacity, and charge-transfer resistance analyses in the half-cell using S-NCM and P-NCM powders as cathode active materials; (e) F 1s XPS patterns of S-NCM powders for different sputtering times using an ion-beam. Based on the calculated integral area, the proportional values of the organics and inorganics in fluoride are presented in the patterns; (f) HAADF-STEM images based on focused ion beam cutting and an enlarged view displaying the interior microcracks. Corresponding EDS mapping analysis indicates the presence of F elements along these microcracks pointed out by a white arrow. (g) Deficiencies of S-NCM addressed before direct regeneration, including the compositional and structural aspects (e.g., irreversible lithium-ionic loss, phase degradation, internal and external cracks) and latent chemical defects (e.g., surface and crack-edge impurities enriching the F element).

As shown in the Materials and methods and Fig. S1 (ESI†), a series of pretreatments, such as sorting, dismantling, crushing, and shredding, were employed to collect the spent NCM cathode (denoted as S-NCM) with minor metal and polyvinylidene fluoride (PVDF) binder (Table S3 and Fig. S2, ESI†). First, a comprehensive comparison between S-NCM and pristine NCM cathodes (P-NCM) was conducted to identify the failure mechanism of the S-NCM materials. As shown in scanning electron microscope (SEM) images (Fig. 1a and Fig. S3, ESI†), the end-of-life battery S-NCM cathode showed intensive rough surface residuals with minor cracks after 250 000-mile service, with the planar gliding degradation and cracks in the single-crystal cathode consistent with previous reports.<sup>26,27</sup> The X-ray diffraction (XRD) analysis, shown in Fig. 1b, demonstrated that the S-NCM still preserved an ordered layered  $R\bar{3}m$  structure with a minor degraded phase near the (101), (104), and (018) peaks, possibly corresponding to the subtle monoclinic phase transition due to lithium loss.<sup>28</sup> According to the high angle annular dark field scanning transmission electron microscopy (HAADF-STEM) analysis and fast Fourier transform (FFT) pattern (Fig. 1c and Fig. S4, ESI†), the degraded S-NCM cathode showed a spinel phase in zone 2 and exhibited significant spatial heterogeneity. Besides the structural degradation, the inductively coupled plasma optical emission spectrometry (ICP-OES) result (Fig. 1d and Table S4, ESI†) indicated that, even after the long-term cycling, the end-of-life S-NCM cathode showed only 13.1% loss of Li inventory compared to the pristine P-NCM. Contradictorily, the specific capacity of S-NCM significantly declined to 37.5 mA h g<sup>−1</sup> compared to 178.1 mA h g<sup>−1</sup> for the P-NCM, as shown in Fig. 1d. Especially in the follow-up cycle, see Fig. S5 (ESI†), the S-NCM cathode exhibited a capacity of less than 10 mA h g<sup>−1</sup> after 100 cycles. Note that, there was only 13.1% Li deficiencies, which could not sufficiently account for the 78.9% capacity fading of S-NCM. Therefore, to further reveal the origin of the poor electrochemical performance, electrochemical impedance spectroscopy (EIS) characterization was conducted, as shown in Fig. 1d and Fig. S6 (ESI†), the charge-transfer resistance ( $R_{ct}$ ) for S-NCM steeply climbed to 2105 Ω and was

four times larger than the P-NCM of  $500\ \Omega$ . The increased impedance deteriorates the  $\text{Li}^+$  diffusion, thus leading to the critical capacity decay. Therefore, the surface state of the spent cathode was recognized as the key issue limiting its capacity delivery, compared to compositional lithium loss and structural bulk defects.

To understand the surface state of the spent cathode, energy-dispersive spectroscopy (EDS) element mapping and X-ray photoelectron spectroscopy (XPS) were conducted. As shown in Fig. S7–S9, and Tables S5, S6 (ESI<sup>†</sup>), the S-NCM cathode surface residuals consisted of C, O, F, and P elements, and displayed a surface-rich gradient distribution, as revealed

by XPS with etching. The F 1s XPS peaks with etching for S-NCM are shown in Fig. 1e, where two F 1s peaks could be observed before sputtering, with the major peak centered at 685.5 eV, which was attributed to inorganic fluorides and the minor F 1s peak centered at 690.4 eV, which could be assigned to organic fluorides, with the ratio of 53.8% for organic fluorides.<sup>29</sup> However, the organic-related F peak declined significantly after sputtering, and completely disappeared after 300 s  $\text{Ar}^+$  sputtering. The surface-rich distribution of organic fluoride was consistent with the cathode electrolyte interphase (CEI) composition previously reported.<sup>29,30</sup>

To further reveal the microscopic distribution of those F-rich residuals, SEM combined with time-of-flight secondary ion mass spectrometry (SEM-ToF-SIMS) characterization was conducted for the cycled cathode. The results are shown in Fig. S10 and Videos S1, S2 (ESI<sup>†</sup>). Based on the spatial distribution of F<sup>−</sup> secondary ion fragments, it was confirmed that fluoride impurities were primarily deposited on the particle surface. Moreover, during the long-time battery service, it could be observed from the HAADF-STEM image and corresponding element mapping (see Fig. 1f) that, in the S-NCM cathode, the fluorides could spread into the interior of the cathode along the intragranular cracks. Coincidentally, from the selected FFT figure shown in Fig. S4 (ESI<sup>†</sup>), the existence of an amorphous ring was observed along the intragranular cracking, which may be related to the fluorides also observed in the bulk. To sum up, the collected S-NCM exhibited limited structural and compositional degradation, while preserving the fluoride-containing impurities aggregated on the surface and along the intragranular cracks, as illustrated in Fig. 1g.

Furthermore, it was previously widely accepted that the source of F-rich impurities in the spent cathode was due to decomposition of the PVDF binder during the heat delamination process at around 350 °C,<sup>11,23–25,31</sup> however, during the thermal decomposition of PVDF, most the fluoride-containing products were gas species (*i.e.*, HF) and fragments (−CF<sup>−</sup> and −CH−CF<sup>−</sup>),<sup>32–34</sup> which are subject to ejection instead of propagating along the cathode intragranular cracks. To confirm the source of those observed residual impurities, four kinds of cathodes with varying cycling conditions were collected and examined, namely cathode laminates with/without electrolyte filling, and laminates from 125k and 250k miles-serviced batteries, as listed in Table S7 (ESI<sup>†</sup>). The SEM images and electrochemical performance are shown in Fig. S11 and S12 (ESI<sup>†</sup>). Compared with the pristine one (sample A), the other spent cathodes from battery formation and cycling exhibited a rough surface and limited discharge capacity. Notably, the laminate from formation only but with no cycling (sample B), which it was believed would retain the full lithium inventory and show negligible structural degradation since it had not undergone charge/discharge cycling, showed a poor discharge capacity, which was the same as the other long-cycled ones. Moreover, the heat exfoliation used to pyrolyze the adhesive binders deteriorated the original CEI layer on the spent cathodes and generated more harmful byproducts (*e.g.*, Li<sub>2</sub>CO<sub>3</sub>, Li<sub>3</sub>PO<sub>4</sub>, LiF). This, combined with electrolyte decomposition during electrochemical cycling, exacerbates chemical degradation, resulting in a significant capacity decline. Therefore, the above comparison revealed that the cathode residual impurities should originate from the electrolyte components (such as LiPF<sub>6</sub>, DMC, ethylene carbonate (EC)) decomposition during battery formation, cycling, and common heat exfoliation, leading to severe capacity loss in spent cathodes (Fig. 1d).

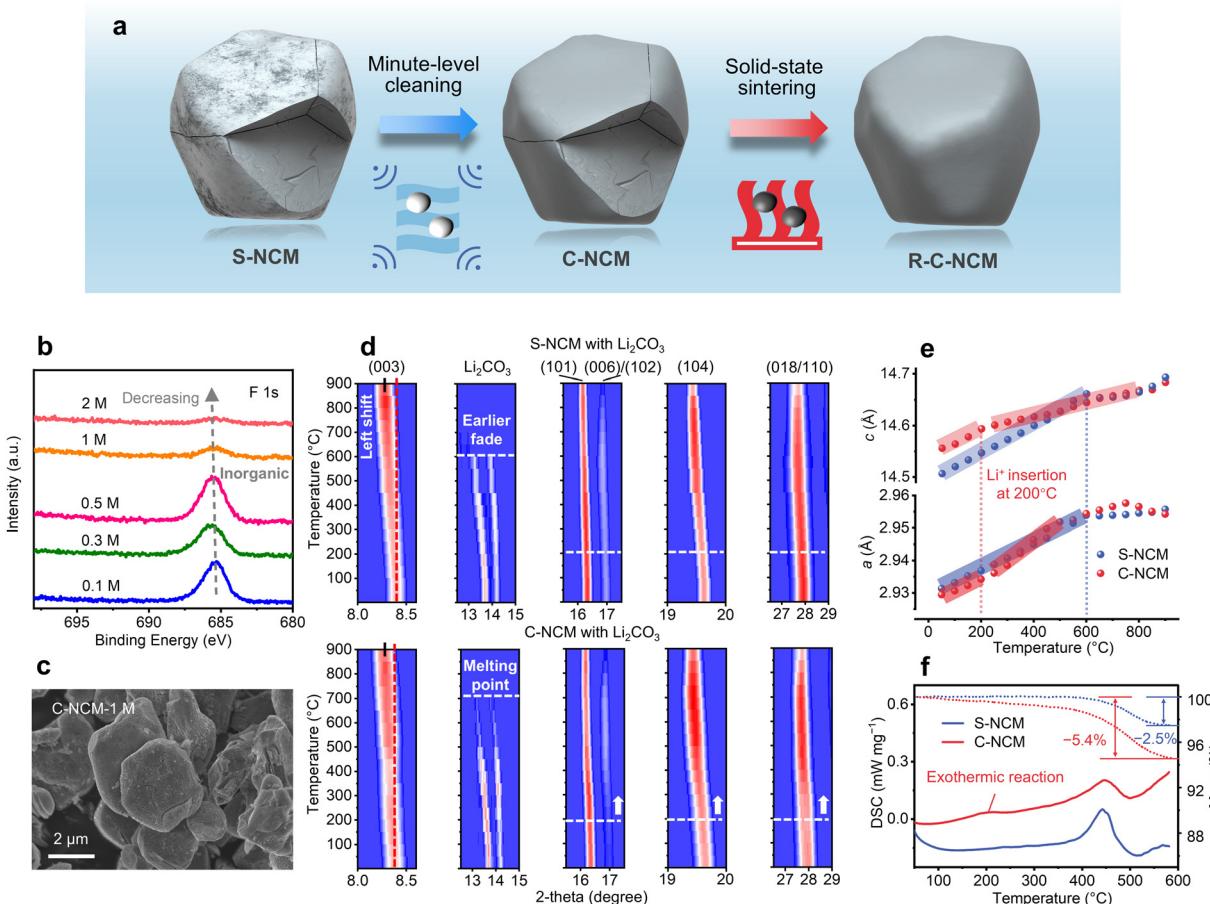
**Fig. 2** Removal of the impurities and change in the crystal structure during the direct regeneration process combined with pretreatment. (a) Traditional direct regeneration path using solid-state sintering and the minute-level pretreatment introduced in an advanced path targeted to the critical obstacles within degraded cathode materials; (b) F 1s XPS fine patterns of C-NCM undergoing ultrasonic stirring in solutions with different concentrations; (c) SEM image of C-NCM obtained by soaking S-NCM in 1 M  $\text{HNO}_3$  solution; (d) partial *in situ* XRD patterns of S-NCM and C-NCM mixed with a Li resource, keeping a constant heating rate ( $20\text{ }^\circ\text{C min}^{-1}$ ) and holding the temperature for diffraction at  $50\text{ }^\circ\text{C}$  intervals; (e) evolution of the unit cell parameters  $a$  and  $c$  for S-NCM (blue symbols) and C-NCM (red symbols) mixed with Li slate through Rietveld refinement. The earlier  $\text{Li}^+$  insertion at  $200\text{ }^\circ\text{C}$  changed the variation tendency of the unit parameters for the sample after cleaning. (f) Heat generation measured by DSC from mixtures.

To reveal the effect of the residuals during the direct regeneration of the recycled cathode, *in situ* XRD characterizations were compared following the regeneration of S-NCM and C-NCM. During the heating, the unit cell lattice first nearly linearly expanded until there was a differentiation of the expansion ratio caused by the lithium insertion. As shown in Fig. 2d, the shift of the (003) peak of C-NCM was less pronounced than that of S-NCM when heating to  $900\text{ }^\circ\text{C}$ , indicating its unit cell lattice  $c$  was not expanded as much as for the S-NCM due to its more efficient lithium insertion. Therefore, more lithium insertion was observed for the C-NCM cathode. Correspondingly, the  $\text{Li}_2\text{CO}_3$  in the mixture of S-NCM and C-NCM also performed differently, whereby the  $\text{Li}_2\text{CO}_3$  in the

C-NCM cathode was consumed gradually until it disappeared at its melting point around  $730\text{ }^\circ\text{C}$ , while the  $\text{Li}_2\text{CO}_3$  in the S-NCM cathode completely vanished at around only  $600\text{ }^\circ\text{C}$ , and this earlier consumption of the lithium source may be attributed to the reaction between  $\text{Li}_2\text{CO}_3$  and the residual impurities (such as  $\text{LiF}$ ,  $\text{LiOH}$ , and  $\text{Li}_3\text{PO}_4$ ) by co-melting, vaporizing, and replenishing in S-NCM.<sup>42</sup> Equivalently, the high angle reflection peak intensity spanning from (006) to (110), representing the layered structure, significantly increased starting from around  $200\text{ }^\circ\text{C}$  for the C-NCM cathode after the purifying treatment compared to there being no obvious enhancement for S-NCM, indicating the better repair of the layered structure during heating. To further unveil the underlying mechanism, Rietveld refinement of each XRD pattern was conducted, which can depict the continuous change of the unit cell parameters during regeneration. Generally, the unit cell parameter  $c$  decreases and  $a$  increases with the insertion of Li ions into a layered structure, similar to in the discharge process.<sup>28</sup> As shown in Fig. 2e, the lattice evolution of the S- and C-NCM

cathodes were compared. For C-NCM, the lattice *c* expansion slope became obviously flatter at 200 °C, denoting a lattice *c* shrinkage at this temperature induced by the Li-ion insertion and repairing. However, for the S-NCM without undergoing purifying treatment for the residuals, the lattice expanded still nearly linearly with no obvious lithium insertion until 600 °C. Concurrently, the lattice *a* expansion slope became steeper at 200 °C for C-NCM. Last but not least, Differential scanning calorimetry (DSC) characterization was also conducted during the regeneration process to confirm the lithium insertion pattern for the S- and C-NCM cathodes, which can trace the lithium replenishment associated with the exothermic reaction as reported by others.<sup>43</sup> As shown in Fig. 2f, the characteristic exothermic reaction at around 200 °C was only observed for C-NCM, confirmed the earlier lithium insertion after the purifying treatment. The earlier lithium insertion was also supported by the CO<sub>2</sub> gas release observed during Li<sub>2</sub>CO<sub>3</sub> decomposition to supply the lithium source for the C-NCM cathode, as shown Fig. S23 (ESI†). Moreover, from the thermogravimetric results

shown in Fig. 2f, the weight loss of C-NCM was 5.4%, which was significantly larger than that of S-NCM of 2.5%, indicating that more Li<sub>2</sub>CO<sub>3</sub> was activated and decomposed to provide the lithium source for C-NCM.<sup>43,44</sup> To sum up, through multiple *in situ* and *ex situ* characterizations, we proved that, with a purifying pretreatment, the direct regeneration could be facilitated to start at a lower temperature of 200 °C from the spent cathode.

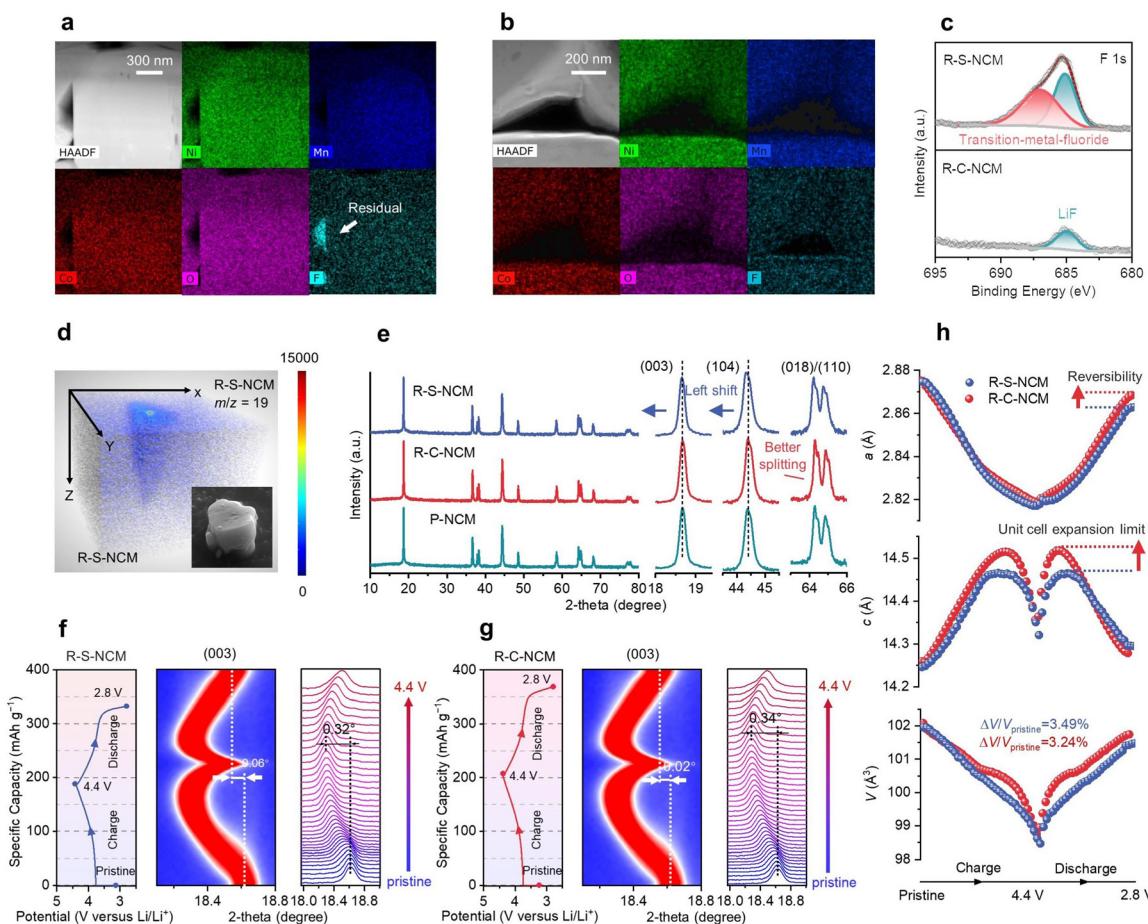
**Fig. 3** Chemical and structural details of the regenerated cathode materials under the influence of impurities. (a) HAADF-STEM images and (b) corresponding EDS element mappings of R-S-NCM and R-C-NCM particles, focusing on the pores of the packing particles. (c) F 1s XPS high-resolution patterns of R-S-NCM and R-C-NCM powders. (d) Pseudo-three-dimensional distribution of F element and SEM image of the corresponding R-S-NCM particle. (e) Full patterns and characteristic peak comparison of the regenerated and pristine NCM cathodes with Cu K $\alpha$  radiation at a scan rate of 8° min $^{-1}$ . (f) 1st charge–discharge curves, corresponding XRD patterns of R-S-NCM, and (g) (003) peak position variation when the cell charge from pristine to 4.4 V and comparison with R-C-NCM. (h) Lattice parameters *a*, *c*, and the unit cell volume *V* of R-S-NCM and R-C-NCM in the 1st charge–discharge test according to the refinement.

the spent cathode could completely decompose in air with an  $O_2$  atmosphere at 550 °C and 750 °C, which suggested these additives led to only minor residuals for the regenerated cathode after the high-temperature regeneration. Comparing the morphology (Fig. S25, ESI†) and element composition (Table S4, ESI†) showed that both the regenerated cathodes exhibited a smooth surface without cracks and possessed a similar composition as pristine P-NCM. However, the element distribution was distinct, as indicated by the corresponding EDS mapping shown in Fig. 3a and b, where it could be clearly seen that there were fluorine residuals aggregated in the nanopores inside the R-S-NCM cathode, while the R-C-NCM cathode did not show a F-rich area. Meanwhile, the XPS (Fig. 3c and Fig. S26, ESI†) results showed that the R-C-NCM cathode exhibited a much less intense F 1s characteristic peak and more similar C 1s and O 2p peaks with the P-NCM one compared with R-S-NCM without the purifying treatment. The SEM-ToFSIMS results (Fig. 3d and Fig. S27 and Videos S5, S6, ESI†) also demonstrated that even though long-time calcination was

applied, the F-rich residual impurities in R-S-NCM had hardly vaporized and were still concentrated on the surface and in the bulk due to their strong electronegativity.<sup>45</sup>

Furthermore, the crystal structure of the regenerated cathode could also be affected by the residual impurities. As shown in Fig. 3e and Fig. S28 (ESI†), the XRD pattern indicated a layered structure with no impurities phase for both the R-S-NCM and R-C-NCM cathodes. However, the R-C-NCM cathode had a higher (003)/(104) intensity ratio and larger splitting degree for the (018)/(110) peaks compared to R-S-NCM, suggesting its more ideal layered structure similar to P-NCM cathodes. After regeneration accompanied by impurities, the diffraction peaks of R-S-NCM were shifted toward a low-angle direction, indicating the lattice expansion, as supported by the refined parameters (Table S11, ESI†) and *in situ* experiments (Fig. 2d). Furthermore, *in situ* XRD was performed during the 1st charge/discharge process for both regenerated cathodes (see Fig. 3f and g). The R-C-NCM cathode showed a higher capacity with a smaller offset (0.02°) of the (003) peak position than the

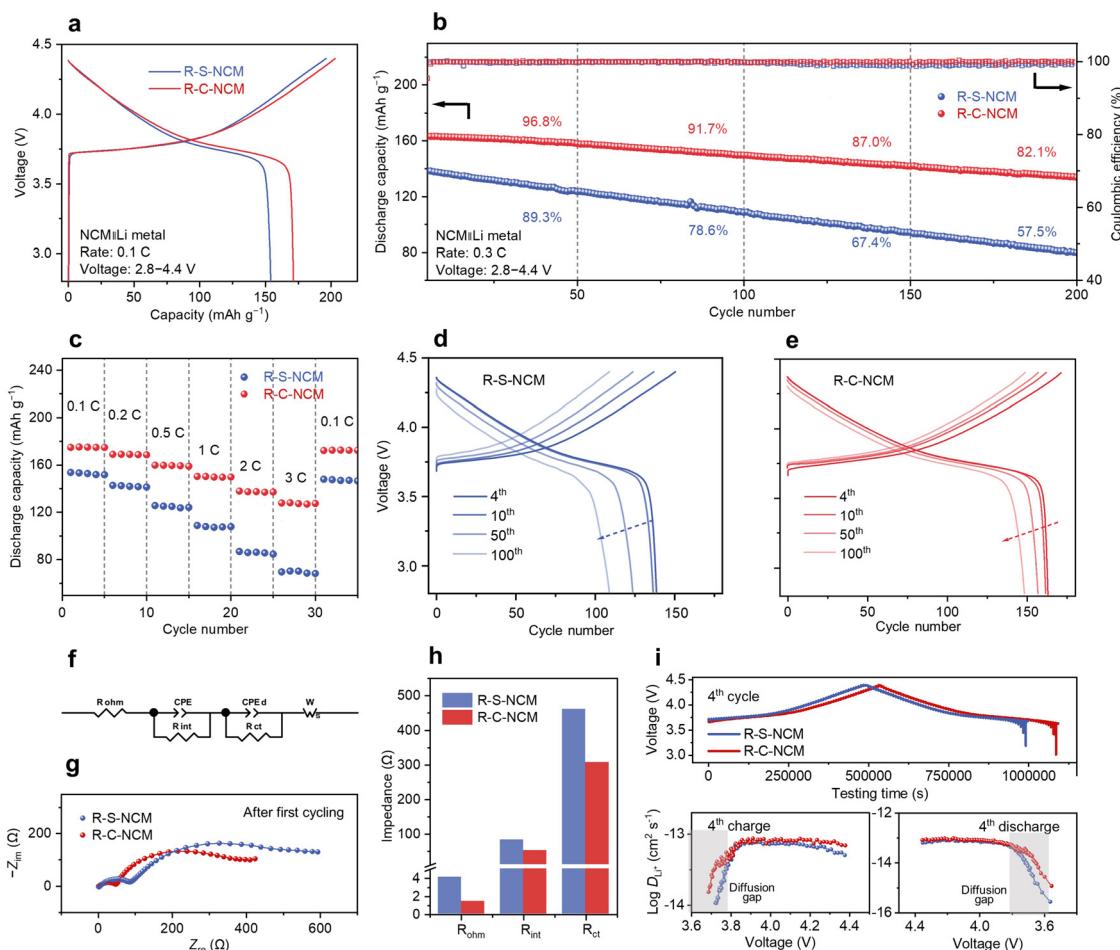
**Fig. 4** Electrochemical deterioration for the regenerated NCM cathodes with impurity residue. (a) Initial galvanostatic charge–discharge curves of R-S-NCM and R-C-NCM at 0.1C (1C = 150 mA h g<sup>-1</sup>) and (b) long cycling test and capacity retention in a half-cell. (c) Rate capabilities of R-S-NCM and R-C-NCM. Charge–discharge curves of (d) R-S-NCM, (e) R-C-NCM in the voltage range of 2.8–4.4 V (vs. Li/Li<sup>+</sup>) at different cycles. (f) Equivalent circuit applied in the EIS measurements. Nyquist plots of (g) R-S-NCM and R-C-NCM and (h) fitting results showing the Ohmic resistance ( $R_{\text{ohm}}$ ), interface resistance ( $R_{\text{int}}$ ), and charge-transfer resistance ( $R_{\text{ct}}$ ). (i) GITT curves and the calculated Li<sup>+</sup>-diffusion rate of R-S-NCM and R-C-NCM for the 4th cycle number after activation in the same charge–discharge period. The shadow area indicates low Li<sup>+</sup> diffusion in a certain voltage range.

As shown in Fig. 4a and Fig. S30 (ESI†), the initial discharge capacity increased from 154.1 mA h g<sup>-1</sup> for R-S-NCM to 171.4 mA h g<sup>-1</sup> for R-C-NCM after the purifying treatment, although this was slightly lower than for P-NCM. In Fig. 4b and Fig. S31 (ESI†), the R-C-NCM cathode exhibit 91.7% and 82.1% capacity retention after 100 cycles and 200 cycles, respectively, compared with 91.6% and 78.3% for P-NCM, and 78.6% and

57.5% for R-S-NCM, indicating the R-C-NCM cathode had better cycling stability, even compared to the pristine one. As for the rate performance, the R-C-NCM cathode demonstrated a better high-rate capability (Fig. 4c and Fig. S30, ESI<sup>†</sup>) at 3C (127.8 mA h g<sup>-1</sup>) compared to R-S-NCM (69.8 mA h g<sup>-1</sup>) and P-NCM (108.9 mA h g<sup>-1</sup>), which was commonly observed on the regenerated NCM cathodes and may be attributed to appropriate F element doping.<sup>12,47</sup> The plateau at ~3.6 V in the voltage profiles (Fig. 4d and e and Fig. S30, ESI<sup>†</sup>) for R-S-NCM nearly disappears after 100 cycles, suggesting that R-S-NCM had a rising polarization after long-term cycling. Based on the cyclic voltammetry curves at different scan rates and calculations (Fig. S31 and Table S12, ESI<sup>†</sup>), the fitting line slope for R-S-NCM was found to be the lowest among all the samples. According to the equivalent circuit (Fig. 4f), the calculated impedance values ( $R_{\text{ohm}}$ ,  $R_{\text{int}}$ , and  $R_{\text{ct}}$ ) of R-C-NCM (Fig. 4g and h) were 1.4, 51.1, and 307.1 Ω, respectively, and were smaller than that of R-S-NCM. These results indicate the deteriorated kinetics of Li<sup>+</sup> transportation due to the residual impurities, especially on the surfaces of the regenerated cathodes. According to the chemical state of the electrode surface (Fig. S32, ESI<sup>†</sup>), R-C-NCM exposed less inorganic fluoride and more lattice oxide, leading to the suppressed interfacial resistance growing during the long-term cycling. Furthermore, the galvanostatic intermittent titration technique (GITT) test also revealed the kinetic characteristics of the solid phase. The current pulse profile and calculated Li-ion diffusion coefficient ( $D_{\text{Li}^+}$ ) after activation are shown in Fig. 4i. The average  $D_{\text{Li}^+}$  values of R-C-NCM and R-S-NCM were calculated to be  $5.78 \times 10^{-14}$  and  $2.99 \times 10^{-14}$  for the charge process (and  $4.56 \times 10^{-14}$  and  $4.29 \times 10^{-14}$  for the discharge process), suggesting that residual impurities penetrating the interior bulk after regeneration hamper Li<sup>+</sup> hopping within the lattice of the NCM cathode, as supported by the observed F element (Fig. 3c and Fig. S27, ESI<sup>†</sup>).

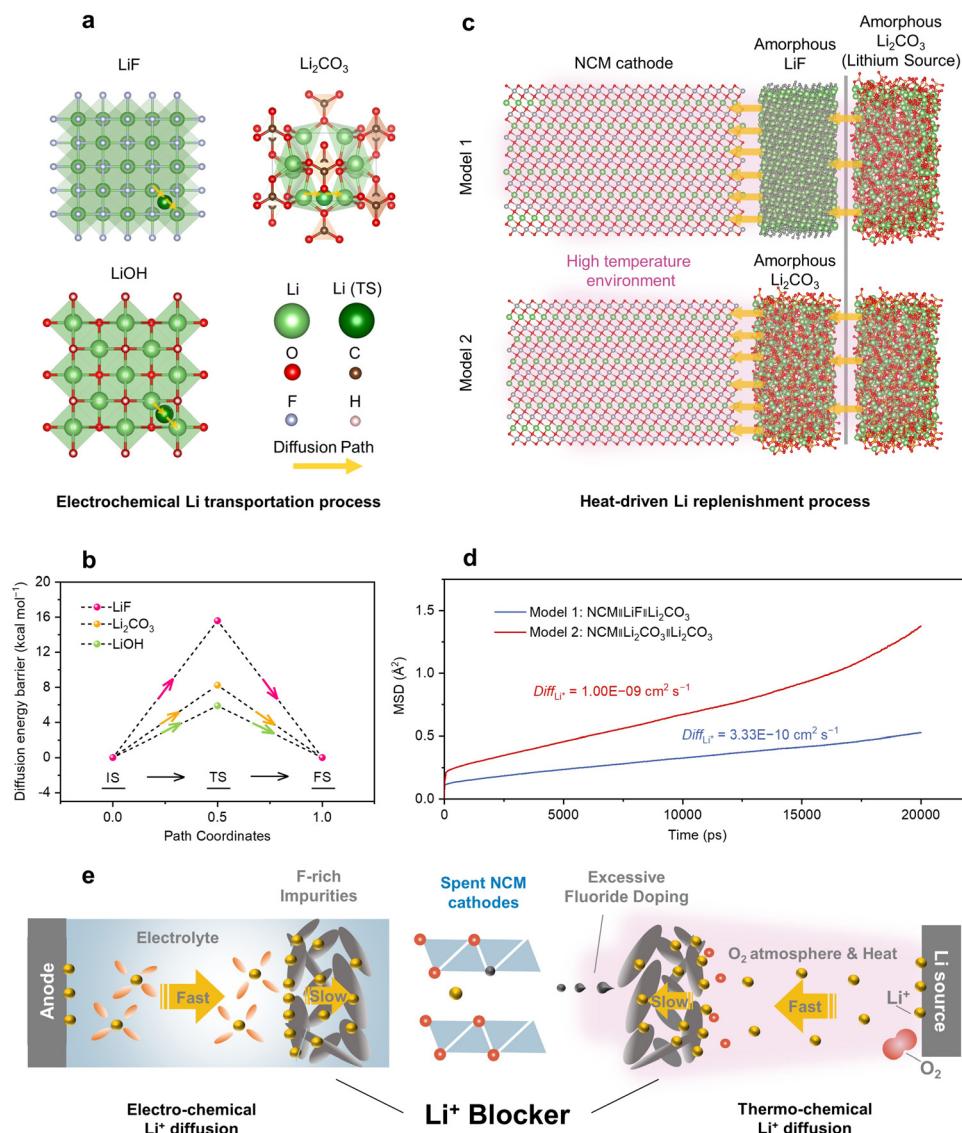
Fig. 5 Role of the F-rich impurities as a blocker in electrochemical and thermochemical  $\text{Li}^+$  diffusion as ascertained from thermodynamic and kinetic simulations. (a) Illustrations of the selected migration pathways with a similar distance for  $\text{Li}^+$  inside the crystal lattice of three common components. The initial state, transition state, and final state of  $\text{Li}^+$  transportation are denoted as IS, TS, and FS, respectively. (b) Calculated energy diffusion barrier for  $\text{Li}^+$  ions in selected phases. (c) Two models for stimulating the kinetics of  $\text{Li}^+$  transportation in direct regeneration. Model 1 consists of the NCM cathode substrate, the amorphous LiF layer, and Li<sub>2</sub>CO<sub>3</sub> as a lithium source in direct regeneration, which is denoted as NCM||LiF||Li<sub>2</sub>CO<sub>3</sub>. In Model 2 (NCM||Li<sub>2</sub>CO<sub>3</sub>||Li<sub>2</sub>CO<sub>3</sub> in short), the middle LiF layer is replaced by a common residual alkali (Li<sub>2</sub>CO<sub>3</sub>), which is used to simulate the regeneration of NCM cathodes after cleaning pretreatment. Each shape symbol is the same as for Fig. 5a. (d) MSD of the Li atoms in 20 ns and calculated  $\text{Li}^+$  diffusivity based on the above model. "E - 9" means  $10^{-9}$ . (e) Mechanism diagram for preventing the NCM cathodes from reusing and directly regenerating under the influence of impurities.

According to the above results (Fig. 1d, Fig. S6, S16 (ESI<sup>†</sup>), and Fig. 4h, i), the migration rate of lithium ions was significantly influenced by the residual impurities; therefore it was crucial to theoretically investigate their influence on capacity delivery in the reuse case and during direct regeneration. Considering the impurities were mostly concentrated at the surface before and after regeneration, and that F-rich residuals could be observed, as shown in Fig. S9 and S10 (ESI<sup>†</sup>) and Fig. 3c, we chose three representative inorganic components (LiF, Li<sub>2</sub>CO<sub>3</sub>, and LiOH) in the CEI layer<sup>48</sup> or residual alkali<sup>49</sup> to calculate the Li<sup>+</sup> diffusion from a thermodynamic perspective, and their structures are shown in Fig. 5a. By maintaining a similar distance and concentration of mobile Li-ions, the diffusion energy barrier of lithium ions ( $\Delta E_{\text{Li}^+}$ ) during the cycling of spent cathodes within the different crystal structures (Fig. 5b) allowed valid comparisons. We found that the  $\Delta E_{\text{Li}^+}$  of the LiF phase, as a common inorganic component from CEI, was about 2 and 3 times higher than that of the LiOH and Li<sub>2</sub>CO<sub>3</sub> phases from

Fig. 5b. Therefore, this result confirmed that the presence of fluoride-rich impurity residuals on the cathode surface significantly increased the diffusion resistance of Li ions when cycling, ultimately exacerbating the cell impedance and interfacial parasitic reactions (Fig. 1d). To comprehend the larger-scale kinetic characteristics and understand the effect of impurity coatings during heating for regeneration of the spent cathodes, two molecular dynamics models were established for simulating Li<sup>+</sup> transportation at 1000 K over 20 ns. Specifically, Model 1 was devised to include an impurity barrier consisting of a LiF layer (Fig. 5c and Fig. S33, ESI<sup>†</sup>). Through computing the mean square displacement (MSD) of Li atoms and fitting curves (Fig. 5d), we determined that the Li diffusivity (Diff<sub>Li<sup>+</sup></sub>) of Model 1 was  $3.33 \times 10^{-10}$ , which was an order of magnitude lower than that of Model 2 ( $1.00 \times 10^{-9}$ ). The differences in molecular dynamics models under practical conditions suggest that fluoride-rich impurity coatings increase the resistance to Li-ion diffusion into spent cathodes with Li deficiencies during thermo-driven regeneration, leading to inadequate compositional and structural recovery.

As illustrated in Fig. 5e, the impurity phase containing the F element served as an electro- and thermo-diffusion blocker of Li ions hindering the reuse and direct regeneration of the spent cathode. In the spent cathodes collected by physical pretreatment and collection from used lithium-ion batteries, the ubiquitous electrolyte was decomposed to form an ion barrier with slow ion diffusivity. However, these impurities have long been overlooked in most studies (Table S2, ESI<sup>†</sup>), mainly due to the use of lab-scale degraded cathodes and fine manual separation pretreatment. In previous studies,<sup>12–16,42</sup> the latent impact of the residual impurities on direct regeneration remains untouched because impurities are easily converted into other inconspicuous matter in extreme physical or chemical regeneration environments. Looking ahead, the direct regeneration of next-generation sensitive cathode materials, such as Li-rich Mn-based, Co-free, and ultra-high-Ni cathode materials, faces serious challenges from these latent impurities if they enter the recycling circle. From another perspective, establishing the controlling law for the inherent impurities doping within the closed-loop material flow could instructively enhance the performance of such recycled materials in the future. Moreover, only by revealing the effect of the overlooked impurities or by getting rid of impurities, can evolving technologies and mechanisms for direct regeneration and upcycling be reasonably evaluated.<sup>50</sup>
