Cite this: *Energy Environ. Sci.*, 2025, 18, 264

Removal of residual contaminants by minute-level washing facilitates the direct regeneration of spent cathodes from retired EV Li-ion batteries[†]

DOI: 10.1039/d4ee03021d

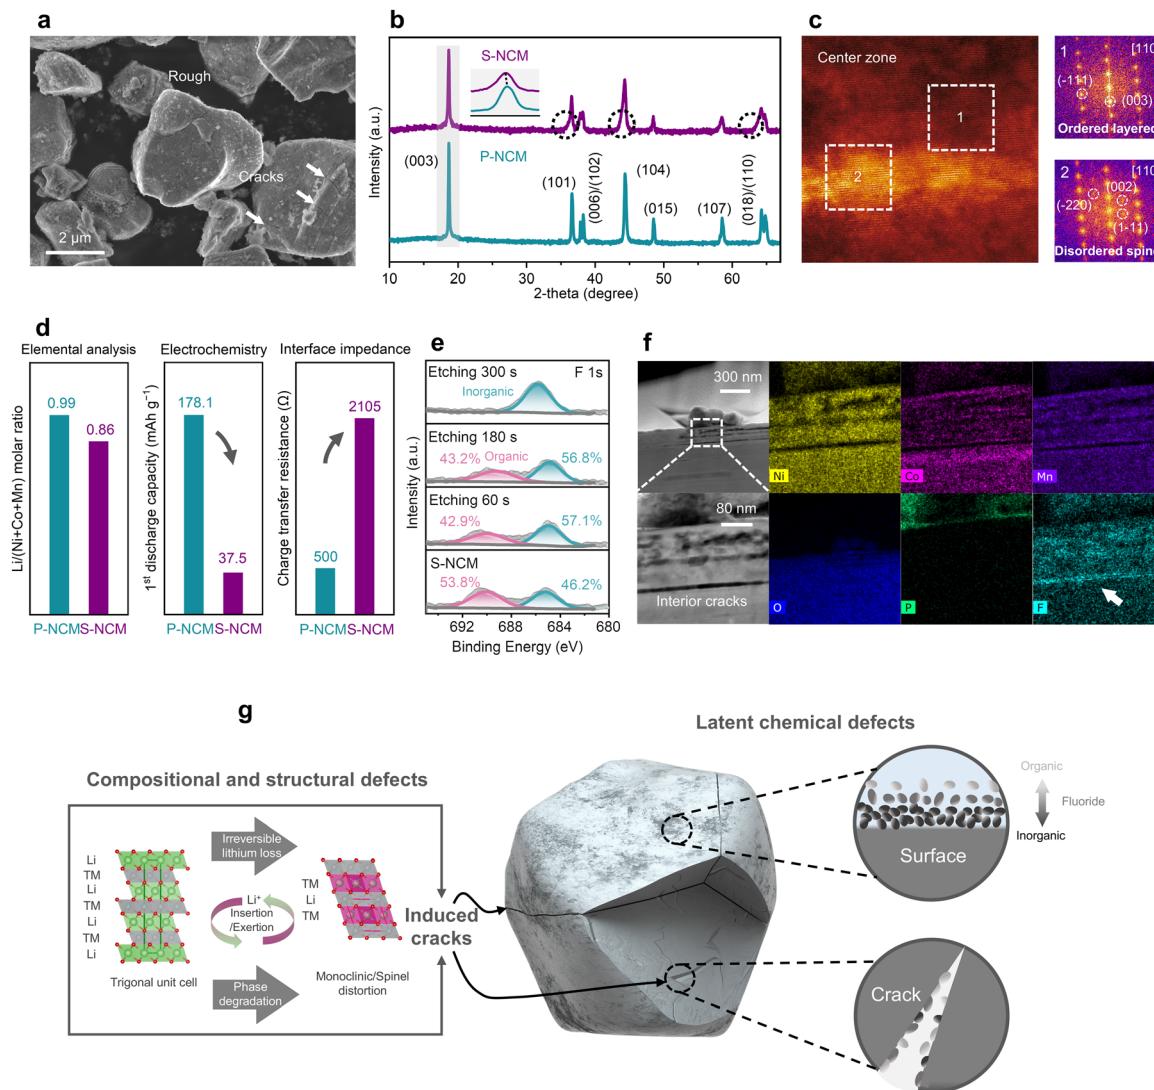
Fig. 1 Neglected chemical residuals on the 250k-miles-serviced cathode. (a) SEM image and (b) XRD pattern of the degraded S-NCM. The black dotted circle accentuates the subtle peaks that do not belong to the layered structure; (c) high-resolution HAADF-STEM images on the central area of the S-NCM particle and the FFT patterns of the selected dark and bright regions; (d) comprehensive comparison of lithium loss in degraded powders measured by ICP-OES, electrochemical capacity, and charge-transfer resistance analyses in the half-cell using S-NCM and P-NCM powders as cathode active materials; (e) F 1s XPS patterns of S-NCM powders for different sputtering times using an ion-beam. Based on the calculated integral area, the proportional values of the organics and inorganics in fluoride are presented in the patterns; (f) HAADF-STEM images based on focused ion beam cutting and an enlarged view displaying the interior microcracks. Corresponding EDS mapping analysis indicates the presence of F elements along these microcracks pointed out by a white arrow. (g) Deficiencies of S-NCM addressed before direct regeneration, including the compositional and structural aspects (e.g., irreversible lithium-ionic loss, phase degradation, internal and external cracks) and latent chemical defects (e.g., surface and crack-edge impurities enriching the F element).

As shown in the Materials and methods and Fig. S1 (ESI†), a series of pretreatments, such as sorting, dismantling, crushing, and shredding, were employed to collect the spent NCM cathode (denoted as S-NCM) with minor metal and polyvinylidene fluoride (PVDF) binder (Table S3 and Fig. S2, ESI†). First, a comprehensive comparison between S-NCM and pristine NCM cathodes (P-NCM) was conducted to identify the failure mechanism of the S-NCM materials. As shown in scanning electron microscope (SEM) images (Fig. 1a and Fig. S3, ESI†), the end-of-life battery S-NCM cathode showed intensive rough surface residuals with minor cracks after 250 000-mile service, with the planar gliding degradation and cracks in the single-crystal cathode consistent with previous reports.^{26,27} The X-ray diffraction (XRD) analysis, shown in Fig. 1b, demonstrated that the S-NCM still preserved an ordered layered $R\bar{3}m$ structure with a minor degraded phase near the (101), (104), and (018) peaks, possibly corresponding to the subtle monoclinic phase transition due to lithium loss.²⁸ According to the high angle annular dark field scanning transmission electron microscopy (HAADF-STEM) analysis and fast Fourier transform (FFT) pattern (Fig. 1c and Fig. S4, ESI†), the degraded S-NCM cathode showed a spinel phase in zone 2 and exhibited significant spatial heterogeneity. Besides the structural degradation, the inductively coupled plasma optical emission spectrometry (ICP-OES) result (Fig. 1d and Table S4, ESI†) indicated that, even after the long-term cycling, the end-of-life S-NCM cathode showed only 13.1% loss of Li inventory compared to the pristine P-NCM. Contradictorily, the specific capacity of S-NCM significantly declined to 37.5 mA h g^{−1} compared to 178.1 mA h g^{−1} for the P-NCM, as shown in Fig. 1d. Especially in the follow-up cycle, see Fig. S5 (ESI†), the S-NCM cathode exhibited a capacity of less than 10 mA h g^{−1} after 100 cycles. Note that, there was only 13.1% Li deficiencies, which could not sufficiently account for the 78.9% capacity fading of S-NCM. Therefore, to further reveal the origin of the poor electrochemical performance, electrochemical impedance spectroscopy (EIS) characterization was conducted, as shown in Fig. 1d and Fig. S6 (ESI†), the charge-transfer resistance (R_{ct}) for S-NCM steeply climbed to 2105 Ω and was

four times larger than the P-NCM of 500 Ω. The increased impedance deteriorates the Li⁺ diffusion, thus leading to the critical capacity decay. Therefore, the surface state of the spent cathode was recognized as the key issue limiting its capacity delivery, compared to compositional lithium loss and structural bulk defects.

To understand the surface state of the spent cathode, energy-dispersive spectroscopy (EDS) element mapping and X-ray photoelectron spectroscopy (XPS) were conducted. As shown in Fig. S7–S9, and Tables S5, S6 (ESI[†]), the S-NCM cathode surface residuals consisted of C, O, F, and P elements, and displayed a surface-rich gradient distribution, as revealed

by XPS with etching. The F 1s XPS peaks with etching for S-NCM are shown in Fig. 1e, where two F 1s peaks could be observed before sputtering, with the major peak centered at 685.5 eV, which was attributed to inorganic fluorides and the minor F 1s peak centered at 690.4 eV, which could be assigned to organic fluorides, with the ratio of 53.8% for organic fluorides.²⁹ However, the organic-related F peak declined significantly after sputtering, and completely disappeared after 300 s Ar⁺ sputtering. The surface-rich distribution of organic fluoride was consistent with the cathode electrolyte interphase (CEI) composition previously reported.^{29,30}

To further reveal the microscopic distribution of those F-rich residuals, SEM combined with time-of-flight secondary ion mass spectrometry (SEM-ToF-SIMS) characterization was conducted for the cycled cathode. The results are shown in Fig. S10 and Videos S1, S2 (ESI[†]). Based on the spatial distribution of F[−] secondary ion fragments, it was confirmed that fluoride impurities were primarily deposited on the particle surface. Moreover, during the long-time battery service, it could be observed from the HAADF-STEM image and corresponding element mapping (see Fig. 1f) that, in the S-NCM cathode, the fluorides could spread into the interior of the cathode along the intragranular cracks. Coincidentally, from the selected FFT figure shown in Fig. S4 (ESI[†]), the existence of an amorphous ring was observed along the intragranular cracking, which may be related to the fluorides also observed in the bulk. To sum up, the collected S-NCM exhibited limited structural and compositional degradation, while preserving the fluoride-containing impurities aggregated on the surface and along the intragranular cracks, as illustrated in Fig. 1g.

Furthermore, it was previously widely accepted that the source of F-rich impurities in the spent cathode was due to decomposition of the PVDF binder during the heat delamination process at around 350 °C,^{11,23–25,31} however, during the thermal decomposition of PVDF, most the fluoride-containing products were gas species (*i.e.*, HF) and fragments (−CF[−] and −CH−CF[−]),^{32–34} which are subject to ejection instead of propagating along the cathode intragranular cracks. To confirm the source of those observed residual impurities, four kinds of cathodes with varying cycling conditions were collected and examined, namely cathode laminates with/without electrolyte filling, and laminates from 125k and 250k miles-serviced batteries, as listed in Table S7 (ESI[†]). The SEM images and electrochemical performance are shown in Fig. S11 and S12 (ESI[†]). Compared with the pristine one (sample A), the other spent cathodes from battery formation and cycling exhibited a rough surface and limited discharge capacity. Notably, the laminate from formation only but with no cycling (sample B), which it was believed would retain the full lithium inventory and show negligible structural degradation since it had not undergone charge/discharge cycling, showed a poor discharge capacity, which was the same as the other long-cycled ones. Moreover, the heat exfoliation used to pyrolyze the adhesive binders deteriorated the original CEI layer on the spent cathodes and generated more harmful byproducts (*e.g.*, Li₂CO₃, Li₃PO₄, LiF). This, combined with electrolyte decomposition during electrochemical cycling, exacerbates chemical degradation, resulting in a significant capacity decline. Therefore, the above comparison revealed that the cathode residual impurities should originate from the electrolyte components (such as LiPF₆, DMC, ethylene carbonate (EC)) decomposition during battery formation, cycling, and common heat exfoliation, leading to severe capacity loss in spent cathodes (Fig. 1d).

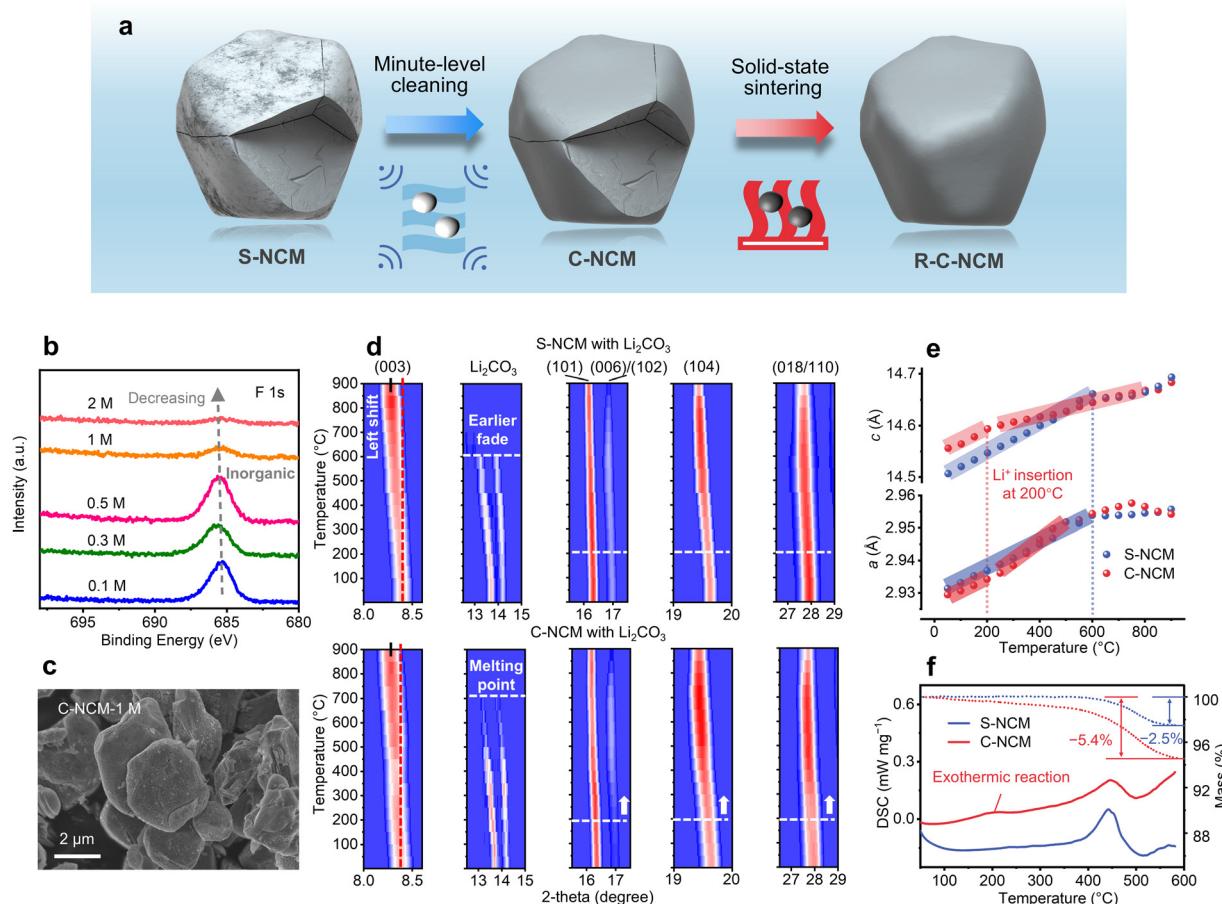
Fig. 2 Removal of the impurities and change in the crystal structure during the direct regeneration process combined with pretreatment. (a) Traditional direct regeneration path using solid-state sintering and the minute-level pretreatment introduced in an advanced path targeted to the critical obstacles within degraded cathode materials; (b) F 1s XPS fine patterns of C-NCM undergoing ultrasonic stirring in solutions with different concentrations; (c) SEM image of C-NCM obtained by soaking S-NCM in 1 M HNO_3 solution; (d) partial *in situ* XRD patterns of S-NCM and C-NCM mixed with a Li resource, keeping a constant heating rate ($20\text{ }^\circ\text{C min}^{-1}$) and holding the temperature for diffraction at $50\text{ }^\circ\text{C}$ intervals; (e) evolution of the unit cell parameters a and c for S-NCM (blue symbols) and C-NCM (red symbols) mixed with Li slate through Rietveld refinement. The earlier Li^+ insertion at $200\text{ }^\circ\text{C}$ changed the variation tendency of the unit parameters for the sample after cleaning. (f) Heat generation measured by DSC from mixtures.

morphology of the cathode remained unchanged, which may be related to the Li^+/H^+ exchange mechanism with the stabilizing lattice structure.^{40,41} Moreover, as shown in Fig. 2b and Fig. S22 (ESI†), based on the charge/discharge efficiency, we further optimized the solution concentration as 1 M in the following investigations.

To reveal the effect of the residuals during the direct regeneration of the recycled cathode, *in situ* XRD characterizations were compared following the regeneration of S-NCM and C-NCM. During the heating, the unit cell lattice first nearly linearly expanded until there was a differentiation of the expansion ratio caused by the lithium insertion. As shown in Fig. 2d, the shift of the (003) peak of C-NCM was less pronounced than that of S-NCM when heating to $900\text{ }^\circ\text{C}$, indicating its unit cell lattice c was not expanded as much as for the S-NCM due to its more efficient lithium insertion. Therefore, more lithium insertion was observed for the C-NCM cathode. Correspondingly, the Li_2CO_3 in the mixture of S-NCM and C-NCM also performed differently, whereby the Li_2CO_3 in the

C-NCM cathode was consumed gradually until it disappeared at its melting point around $730\text{ }^\circ\text{C}$, while the Li_2CO_3 in the S-NCM cathode completely vanished at around only $600\text{ }^\circ\text{C}$, and this earlier consumption of the lithium source may be attributed to the reaction between Li_2CO_3 and the residual impurities (such as LiF , LiOH , and Li_3PO_4) by co-melting, vaporizing, and replenishing in S-NCM.⁴² Equivalently, the high angle reflection peak intensity spanning from (006) to (110), representing the layered structure, significantly increased starting from around $200\text{ }^\circ\text{C}$ for the C-NCM cathode after the purifying treatment compared to there being no obvious enhancement for S-NCM, indicating the better repair of the layered structure during heating. To further unveil the underlying mechanism, Rietveld refinement of each XRD pattern was conducted, which can depict the continuous change of the unit cell parameters during regeneration. Generally, the unit cell parameter c decreases and a increases with the insertion of Li ions into a layered structure, similar to in the discharge process.²⁸ As shown in Fig. 2e, the lattice evolution of the S- and C-NCM

cathodes were compared. For C-NCM, the lattice *c* expansion slope became obviously flatter at 200 °C, denoting a lattice *c* shrinkage at this temperature induced by the Li-ion insertion and repairing. However, for the S-NCM without undergoing purifying treatment for the residuals, the lattice expanded still nearly linearly with no obvious lithium insertion until 600 °C. Concurrently, the lattice *a* expansion slope became steeper at 200 °C for C-NCM. Last but not least, Differential scanning calorimetry (DSC) characterization was also conducted during the regeneration process to confirm the lithium insertion pattern for the S- and C-NCM cathodes, which can trace the lithium replenishment associated with the exothermic reaction as reported by others.⁴³ As shown in Fig. 2f, the characteristic exothermic reaction at around 200 °C was only observed for C-NCM, confirmed the earlier lithium insertion after the purifying treatment. The earlier lithium insertion was also supported by the CO₂ gas release observed during Li₂CO₃ decomposition to supply the lithium source for the C-NCM cathode, as shown Fig. S23 (ESI[†]). Moreover, from the thermogravimetric results

shown in Fig. 2f, the weight loss of C-NCM was 5.4%, which was significantly larger than that of S-NCM of 2.5%, indicating that more Li₂CO₃ was activated and decomposed to provide the lithium source for C-NCM.^{43,44} To sum up, through multiple *in situ* and *ex situ* characterizations, we proved that, with a purifying pretreatment, the direct regeneration could be facilitated to start at a lower temperature of 200 °C from the spent cathode.

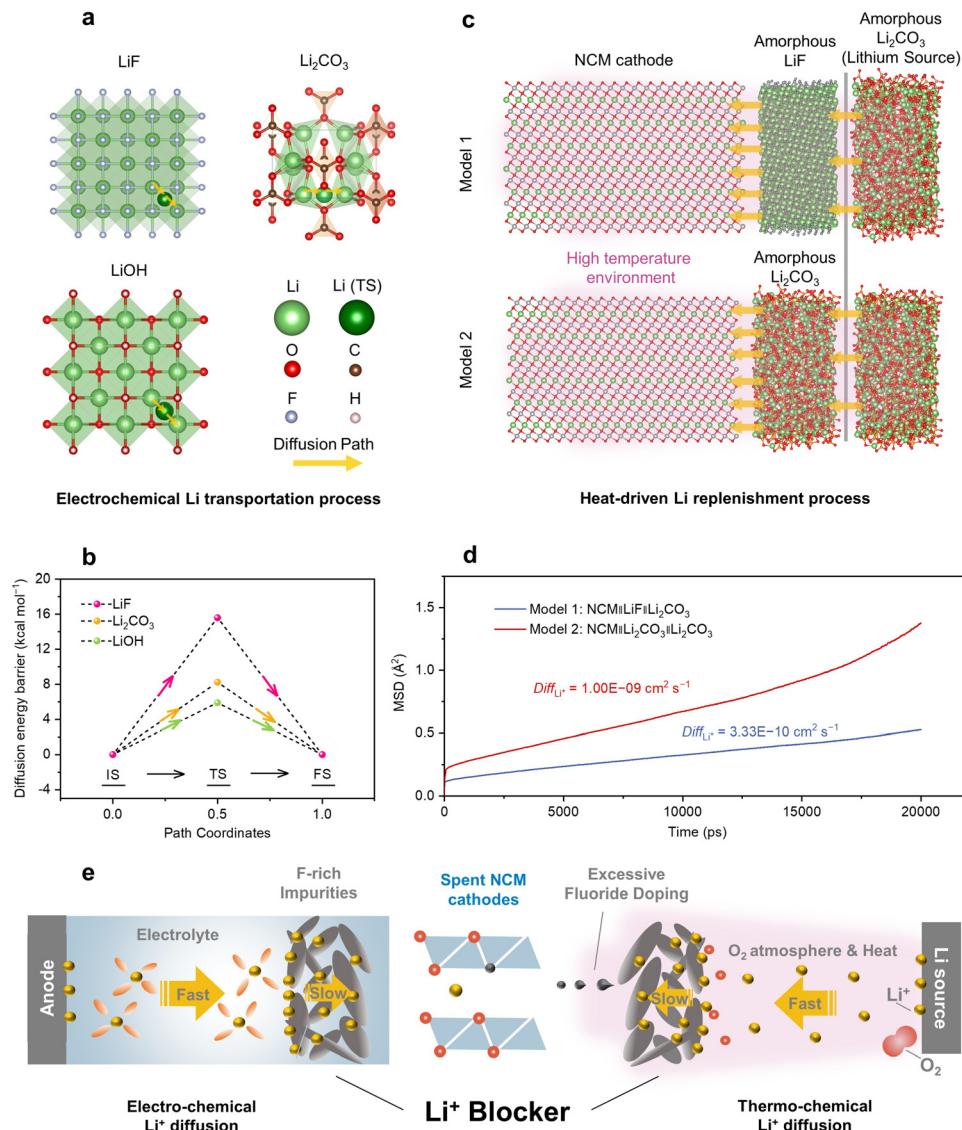
Fig. 5 Role of the F-rich impurities as a blocker in electrochemical and thermochemical Li^+ diffusion as ascertained from thermodynamic and kinetic simulations. (a) Illustrations of the selected migration pathways with a similar distance for Li^+ inside the crystal lattice of three common components. The initial state, transition state, and final state of Li^+ transportation are denoted as IS, TS, and FS, respectively. (b) Calculated energy diffusion barrier for Li^+ ions in selected phases. (c) Two models for stimulating the kinetics of Li^+ transportation in direct regeneration. Model 1 consists of the NCM cathode substrate, the amorphous LiF layer, and Li₂CO₃ as a lithium source in direct regeneration, which is denoted as NCM||LiF||Li₂CO₃. In Model 2 (NCM||Li₂CO₃||Li₂CO₃ in short), the middle LiF layer is replaced by a common residual alkali (Li₂CO₃), which is used to simulate the regeneration of NCM cathodes after cleaning pretreatment. Each shape symbol is the same as for Fig. 5a. (d) MSD of the Li atoms in 20 ns and calculated Li^+ diffusivity based on the above model. "E - 9" means 10^{-9} . (e) Mechanism diagram for preventing the NCM cathodes from reusing and directly regenerating under the influence of impurities.

According to the above results (Fig. 1d, Fig. S6, S16 (ESI[†]), and Fig. 4h, i), the migration rate of lithium ions was significantly influenced by the residual impurities; therefore it was crucial to theoretically investigate their influence on capacity delivery in the reuse case and during direct regeneration. Considering the impurities were mostly concentrated at the surface before and after regeneration, and that F-rich residuals could be observed, as shown in Fig. S9 and S10 (ESI[†]) and Fig. 3c, we chose three representative inorganic components (LiF, Li₂CO₃, and LiOH) in the CEI layer⁴⁸ or residual alkali⁴⁹ to calculate the Li⁺ diffusion from a thermodynamic perspective, and their structures are shown in Fig. 5a. By maintaining a similar distance and concentration of mobile Li-ions, the diffusion energy barrier of lithium ions (ΔE_{Li^+}) during the cycling of spent cathodes within the different crystal structures (Fig. 5b) allowed valid comparisons. We found that the ΔE_{Li^+} of the LiF phase, as a common inorganic component from CEI, was about 2 and 3 times higher than that of the LiOH and Li₂CO₃ phases from

Fig. 5b. Therefore, this result confirmed that the presence of fluoride-rich impurity residuals on the cathode surface significantly increased the diffusion resistance of Li ions when cycling, ultimately exacerbating the cell impedance and interfacial parasitic reactions (Fig. 1d). To comprehend the larger-scale kinetic characteristics and understand the effect of impurity coatings during heating for regeneration of the spent cathodes, two molecular dynamics models were established for simulating Li⁺ transportation at 1000 K over 20 ns. Specifically, Model 1 was devised to include an impurity barrier consisting of a LiF layer (Fig. 5c and Fig. S33, ESI[†]). Through computing the mean square displacement (MSD) of Li atoms and fitting curves (Fig. 5d), we determined that the Li diffusivity (Diff_{Li⁺}) of Model 1 was 3.33×10^{-10} , which was an order of magnitude lower than that of Model 2 (1.00×10^{-9}). The differences in molecular dynamics models under practical conditions suggest that fluoride-rich impurity coatings increase the resistance to Li-ion diffusion into spent cathodes with Li deficiencies during thermo-driven regeneration, leading to inadequate compositional and structural recovery.

As illustrated in Fig. 5e, the impurity phase containing the F element served as an electro- and thermo-diffusion blocker of Li ions hindering the reuse and direct regeneration of the spent cathode. In the spent cathodes collected by physical pretreatment and collection from used lithium-ion batteries, the ubiquitous electrolyte was decomposed to form an ion barrier with slow ion diffusivity. However, these impurities have long been overlooked in most studies (Table S2, ESI[†]), mainly due to the use of lab-scale degraded cathodes and fine manual separation pretreatment. In previous studies,^{12–16,42} the latent impact of the residual impurities on direct regeneration remains untouched because impurities are easily converted into other inconspicuous matter in extreme physical or chemical regeneration environments. Looking ahead, the direct regeneration of next-generation sensitive cathode materials, such as Li-rich Mn-based, Co-free, and ultra-high-Ni cathode materials, faces serious challenges from these latent impurities if they enter the recycling circle. From another perspective, establishing the controlling law for the inherent impurities doping within the closed-loop material flow could instructively enhance the performance of such recycled materials in the future. Moreover, only by revealing the effect of the overlooked impurities or by getting rid of impurities, can evolving technologies and mechanisms for direct regeneration and upcycling be reasonably evaluated.⁵⁰
