Cite this: *Energy Environ. Sci.*,  
2025, 18, 264Removal of residual contaminants by minute-level  
washing facilitates the direct regeneration of  
spent cathodes from retired EV Li-ion batteries†Yi Guo,<sup>‡a</sup> Yang Li,<sup>‡bcd</sup> Kai Qiu,<sup>d</sup> Yan Li,<sup>e</sup> Weijing Yuan,<sup>b</sup> Chenxi Li,<sup>b</sup> Xinyu Rui,<sup>a</sup>  
Lewei Shi,<sup>b</sup> Yukun Hou,<sup>a</sup> Saiyue Liu,<sup>a</sup> Dongsheng Ren,<sup>\*a</sup> Tiening Tan,<sup>\*d</sup>  
Gaolong Zhu,<sup>d</sup> Languang Lu,<sup>a</sup> Shengming Xu,<sup>idf</sup> Biao Deng,<sup>g</sup> Xiang Liu<sup>id</sup><sup>\*b</sup> and  
Minggao Ouyang<sup>id</sup><sup>\*a</sup>

DOI: 10.1039/d4ee03021d

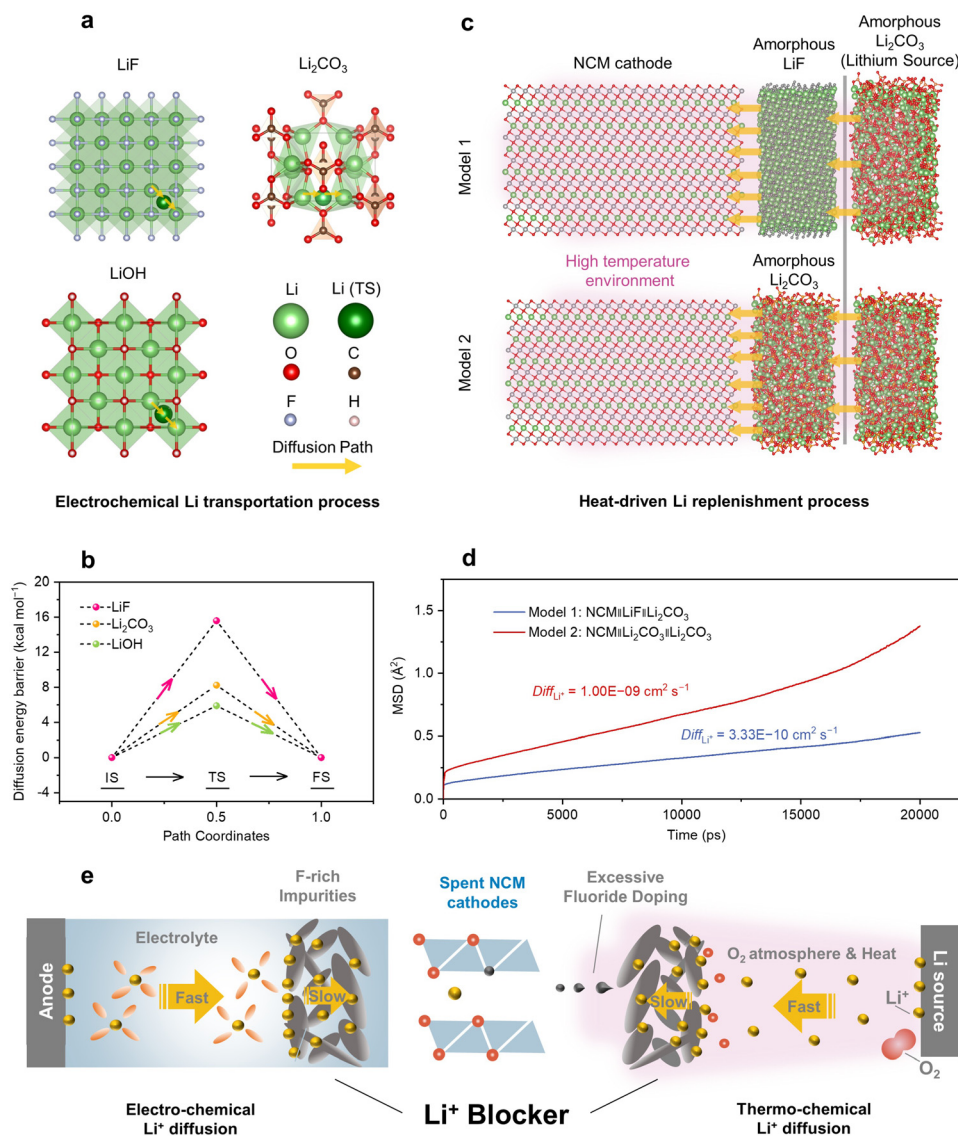
**Fig. 5** Role of the F-rich impurities as a blocker in electrochemical and thermochemical  $\text{Li}^+$  diffusion as ascertained from thermodynamic and kinetic simulations. (a) Illustrations of the selected migration pathways with a similar distance for  $\text{Li}^+$  inside the crystal lattice of three common components. The initial state, transition state, and final state of  $\text{Li}^+$  transportation are denoted as IS, TS, and FS, respectively. (b) Calculated energy diffusion barrier for Li ions in selected phases. (c) Two models for stimulating the kinetics of Li transportation in direct regeneration. Model 1 consists of the NCM cathode substrate, the amorphous LiF layer, and  $\text{Li}_2\text{CO}_3$  as a lithium source in direct regeneration, which is denoted as NCM||LiF|| $\text{Li}_2\text{CO}_3$ . In Model 2 (NCM|| $\text{Li}_2\text{CO}_3$ || $\text{Li}_2\text{CO}_3$  in short), the middle LiF layer is replaced by a common residual alkali ( $\text{Li}_2\text{CO}_3$ ), which is used to simulate the regeneration of NCM cathodes after cleaning pretreatment. Each shape symbol is the same as for Fig. 5a. (d) MSD of the Li atoms in 20 ns and calculated  $\text{Li}^+$  diffusivity based on the above model. "E – 9" means  $10^{-9}$ . (e) Mechanism diagram for preventing the NCM cathodes from reusing and directly regenerating under the influence of impurities.

According to the above results (Fig. 1d, Fig. S6, S16 (ESI†), and Fig. 4h, i), the migration rate of lithium ions was significantly influenced by the residual impurities; therefore it was crucial to theoretically investigate their influence on capacity delivery in the reuse case and during direct regeneration. Considering the impurities were mostly concentrated at the surface before and after regeneration, and that F-rich residuals could be observed, as shown in Fig. S9 and S10 (ESI†) and Fig. 3c, we chose three representative inorganic components ( $\text{LiF}$ ,  $\text{Li}_2\text{CO}_3$ , and  $\text{LiOH}$ ) in the CEI layer<sup>48</sup> or residual alkali<sup>49</sup> to calculate the  $\text{Li}^+$  diffusion from a thermodynamic perspective, and their structures are shown in Fig. 5a. By maintaining a similar distance and concentration of mobile Li-ions, the diffusion energy barrier of lithium ions ( $\Delta E_{\text{Li}^+}$ ) during the cycling of spent cathodes within the different crystal structures (Fig. 5b) allowed valid comparisons. We found that the  $\Delta E_{\text{Li}^+}$  of the  $\text{LiF}$  phase, as a common inorganic component from CEI, was about 2 and 3 times higher than that of the  $\text{LiOH}$  and  $\text{Li}_2\text{CO}_3$  phases from

Fig. 5b. Therefore, this result confirmed that the presence of fluoride-rich impurity residuals on the cathode surface significantly increased the diffusion resistance of Li ions when cycling, ultimately exacerbating the cell impedance and interfacial parasitic reactions (Fig. 1d). To comprehend the larger-scale kinetic characteristics and understand the effect of impurity coatings during heating for regeneration of the spent cathodes, two molecular dynamics models were established for simulating  $\text{Li}^+$  transportation at 1000 K over 20 ns. Specifically, Model 1 was devised to include an impurity barrier consisting of a  $\text{LiF}$  layer (Fig. 5c and Fig. S33, ESI†). Through computing the mean square displacement (MSD) of Li atoms and fitting curves (Fig. 5d), we determined that the Li diffusivity ( $\text{Diff}_{\text{Li}^+}$ ) of Model 1 was  $3.33 \times 10^{-10}$ , which was an order of magnitude lower than that of Model 2 ( $1.00 \times 10^{-9}$ ). The differences in molecular dynamics models under practical conditions suggest that fluoride-rich impurity coatings increase the resistance to Li-ion diffusion into spent cathodes with Li deficiencies during thermo-driven regeneration, leading to inadequate compositional and structural recovery.

As illustrated in Fig. 5e, the impurity phase containing the F element served as an electro- and thermo-diffusion blocker of Li ions hindering the reuse and direct regeneration of the spent cathode. In the spent cathodes collected by physical pretreatment and collection from used lithium-ion batteries, the ubiquitous electrolyte was decomposed to form an ion barrier with slow ion diffusivity. However, these impurities have long been overlooked in most studies (Table S2, ESI†), mainly due to the use of lab-scale degraded cathodes and fine manual separation pretreatment. In previous studies,<sup>12–16,42</sup> the latent impact of the residual impurities on direct regeneration remains untouched because impurities are easily converted into other inconspicuous matter in extreme physical or chemical regeneration environments. Looking ahead, the direct regeneration of next-generation sensitive cathode materials, such as Li-rich Mn-based, Co-free, and ultra-high-Ni cathode materials, faces serious challenges from these latent impurities if they enter the recycling circle. From another perspective, establishing the controlling law for the inherent impurities doping within the closed-loop material flow could instructively enhance the performance of such recycled materials in the future. Moreover, only by revealing the effect of the overlooked impurities or by getting rid of impurities, can evolving technologies and mechanisms for direct regeneration and upcycling be reasonably evaluated.<sup>50</sup>
