Cite this: *Energy Environ. Sci.*,  
2025, 18, 264

## Removal of residual contaminants by minute-level washing facilitates the direct regeneration of spent cathodes from retired EV Li-ion batteries†

The direct regeneration of spent cathodes stands out as an environmentally and economically benign strategy within the battery ecosystem, eclipsing the cumbersome metallurgical approaches. Before addressing the lithium loss and structural degradation, it is crucial to focus on the residual contaminants within the spent cathode collected from retired Li-ion batteries after industrial exfoliation processes. Here, comprehensive characterizations and calculations show that in contrast to metal scraps, the electrolyte decomposition after battery operation and heating exfoliation uniformly coat the particle surfaces of cathodes, severely impeding the reuse and rejuvenation of  $\text{LiNi}_x\text{Co}_y\text{Mn}_z\text{O}_2$  (NCM) cathodes with limited degradation by obstructing lithium diffusion. Considering the high costs and environmental risks of organic systems, we further propose a minute-level water-based pretreatment to purify the spent cathode and selectively eliminate these stubbo

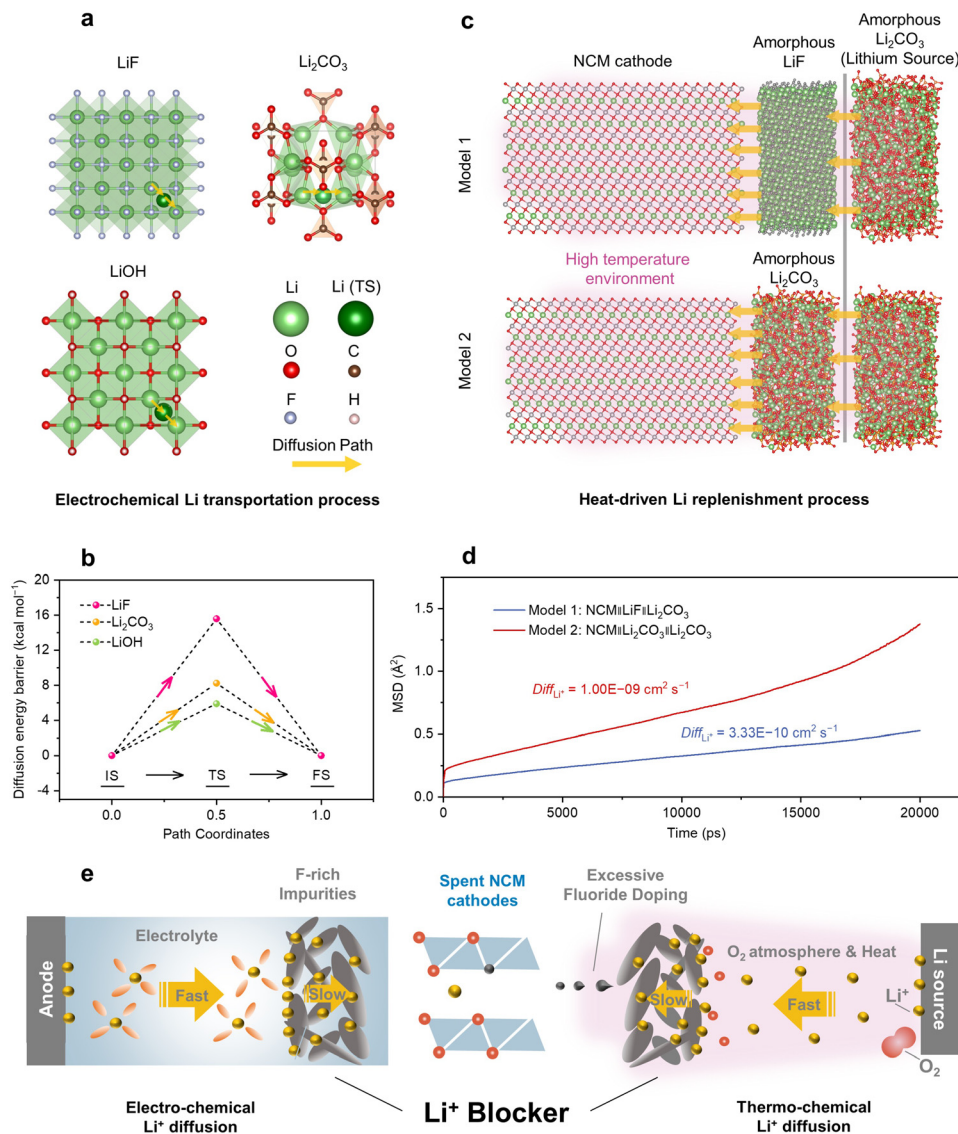
**Fig. 5** Role of the F-rich impurities as a blocker in electrochemical and thermochemical  $\text{Li}^+$  diffusion as ascertained from thermodynamic and kinetic simulations. (a) Illustrations of the selected migration pathways with a similar distance for  $\text{Li}^+$  inside the crystal lattice of three common components. The initial state, transition state, and final state of  $\text{Li}^+$  transportation are denoted as IS, TS, and FS, respectively. (b) Calculated energy diffusion barrier for Li ions in selected phases. (c) Two models for stimulating the kinetics of Li transportation in direct regeneration. Model 1 consists of the NCM cathode substrate, the amorphous LiF layer, and  $\text{Li}_2\text{CO}_3$  as a lithium source in direct regeneration, which is denoted as  $\text{NCM} \parallel \text{LiF} \parallel \text{Li}_2\text{CO}_3$ . In Model 2 ( $\text{NCM} \parallel \text{Li}_2\text{CO}_3 \parallel \text{Li}_2\text{CO}_3$  in short), the middle LiF layer is replaced by a common residual alkali ( $\text{Li}_2\text{CO}_3$ ), which is used to simulate the regeneration of NCM cathodes after cleaning pretreatment. Each shape symbol is the same as for Fig. 5a. (d) MSD of the Li atoms in 20 ns and calculated  $\text{Li}^+$  diffusivity based on the above model. "E – 9" means  $10^{-9}$ . (e) Mechanism diagram for preventing the NCM cathodes from reusing and directly regenerating under the influence of impurities.

According to the above results (Fig. 1d, Fig. S6, S16 (ESI†), and Fig. 4h, i), the migration rate of lithium ions was significantly influenced by the residual impurities; therefore it was crucial to theoretically investigate their influence on capacity delivery in the reuse case and during direct regeneration. Considering the impurities were mostly concentrated at the surface before and after regeneration, and that F-rich residuals could be observed, as shown in Fig. S9 and S10 (ESI†) and Fig. 3c, we chose three representative inorganic components ( $\text{LiF}$ ,  $\text{Li}_2\text{CO}_3$ , and  $\text{LiOH}$ ) in the CEI layer<sup>48</sup> or residual alkali<sup>49</sup> to calculate the  $\text{Li}^+$  diffusion from a thermodynamic perspective, and their structures are shown in Fig. 5a. By maintaining a similar distance and concentration of mobile Li-ions, the diffusion energy barrier of lithium ions ( $\Delta E_{\text{Li}^+}$ ) during the cycling of spent cathodes within the different crystal structures (Fig. 5b) allowed valid comparisons. We found that the  $\Delta E_{\text{Li}^+}$  of the  $\text{LiF}$  phase, as a common inorganic component from CEI, was about 2 and 3 times higher than that of the  $\text{LiOH}$  and  $\text{Li}_2\text{CO}_3$  phases from

Fig. 5b. Therefore, this result confirmed that the presence of fluoride-rich impurity residuals on the cathode surface significantly increased the diffusion resistance of Li ions when cycling, ultimately exacerbating the cell impedance and interfacial parasitic reactions (Fig. 1d). To comprehend the larger-scale kinetic characteristics and understand the effect of impurity coatings during heating for regeneration of the spent cathodes, two molecular dynamics models were established for simulating  $\text{Li}^+$  transportation at 1000 K over 20 ns. Specifically, Model 1 was devised to include an impurity barrier consisting of a  $\text{LiF}$  layer (Fig. 5c and Fig. S33, ESI†). Through computing the mean square displacement (MSD) of Li atoms and fitting curves (Fig. 5d), we determined that the Li diffusivity ( $\text{Diff}_{\text{Li}^+}$ ) of Model 1 was  $3.33 \times 10^{-10}$ , which was an order of magnitude lower than that of Model 2 ( $1.00 \times 10^{-9}$ ). The differences in molecular dynamics models under practical conditions suggest that fluoride-rich impurity coatings increase the resistance to Li-ion diffusion into spent cathodes with Li deficiencies during thermo-driven regeneration, leading to inadequate compositional and structural recovery.

As illustrated in Fig. 5e, the impurity phase containing the F element served as an electro- and thermo-diffusion blocker of Li ions hindering the reuse and direct regeneration of the spent cathode. In the spent cathodes collected by physical pretreatment and collection from used lithium-ion batteries, the ubiquitous electrolyte was decomposed to form an ion barrier with slow ion diffusivity. However, these impurities have long been overlooked in most studies (Table S2, ESI†), mainly due to the use of lab-scale degraded cathodes and fine manual separation pretreatment. In previous studies,<sup>12–16,42</sup> the latent impact of the residual impurities on direct regeneration remains untouched because impurities are easily converted into other inconspicuous matter in extreme physical or chemical regeneration environments. Looking ahead, the direct regeneration of next-generation sensitive cathode materials, such as Li-rich Mn-based, Co-free, and ultra-high-Ni cathode materials, faces serious challenges from these latent impurities if they enter the recycling circle. From another perspective, establishing the controlling law for the inherent impurities doping within the closed-loop material flow could instructively enhance the performance of such recycled materials in the future. Moreover, only by revealing the effect of the overlooked impurities or by getting rid of impurities, can evolving technologies and mechanisms for direct regeneration and upcycling be reasonably evaluated.<sup>50</sup>
