Cite this: *Energy Environ. Sci.*,  
2025, 18, 264

## Removal of residual contaminants by minute-level washing facilitates the direct regeneration of spent cathodes from retired EV Li-ion batteries†

DOI: 10.1039/d4ee03021d

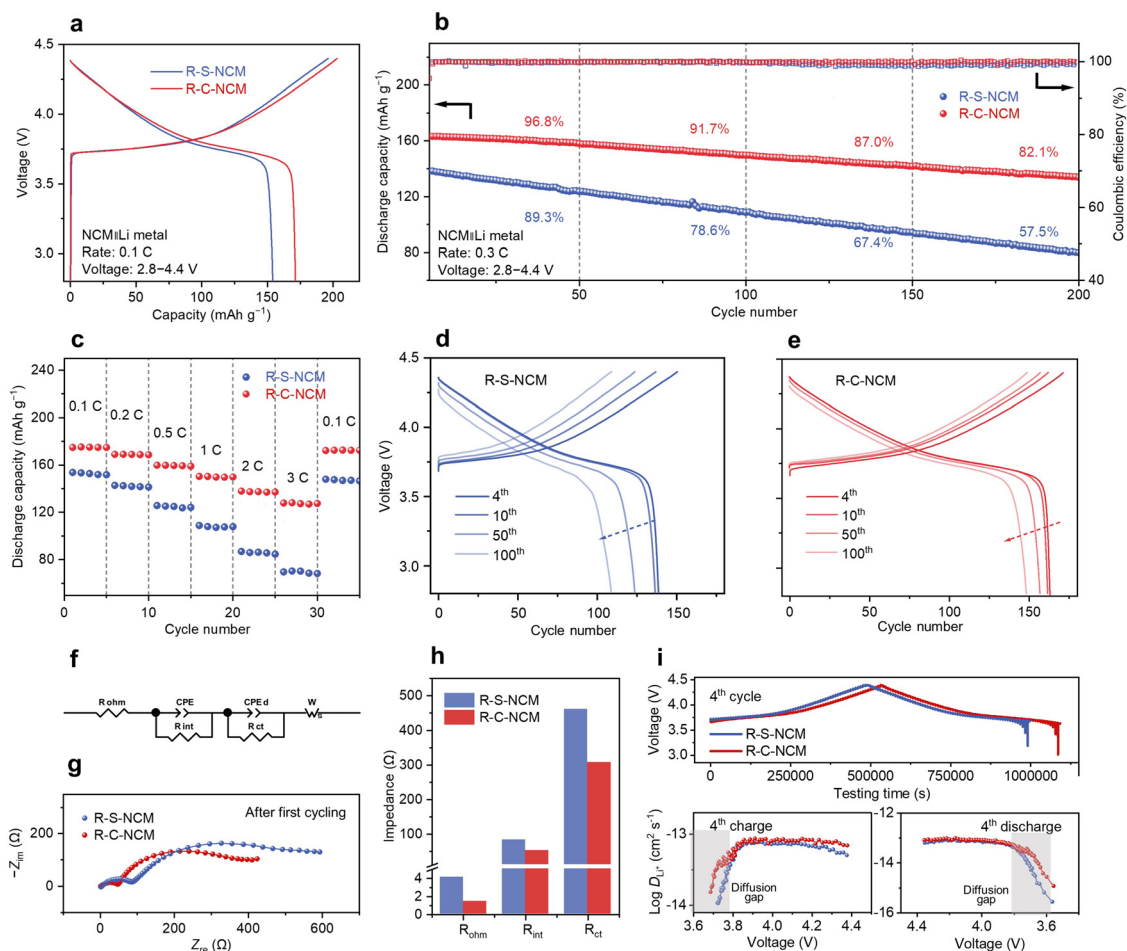
**Fig. 4** Electrochemical deterioration for the regenerated NCM cathodes with impurity residue. (a) Initial galvanostatic charge–discharge curves of R-S-NCM and R-C-NCM at 0.1C (1C = 150 mA h g<sup>-1</sup>) and (b) long cycling test and capacity retention in a half-cell. (c) Rate capabilities of R-S-NCM and R-C-NCM. Charge–discharge curves of (d) R-S-NCM, (e) R-C-NCM in the voltage range of 2.8–4.4 V (vs. Li/Li<sup>+</sup>) at different cycles. (f) Equivalent circuit applied in the EIS measurements. Nyquist plots of (g) R-S-NCM and R-C-NCM and (h) fitting results showing the Ohmic resistance ( $R_{ohm}$ ), interface resistance ( $R_{int}$ ), and charge-transfer resistance ( $R_{ct}$ ). (i) GITT curves and the calculated Li<sup>+</sup>-diffusion rate of R-S-NCM and R-C-NCM for the 4th cycle number after activation in the same charge–discharge period. The shadow area indicates low Li<sup>+</sup> diffusion in a certain voltage range.

As shown in Fig. 4a and Fig. S30 (ESI<sup>†</sup>), the initial discharge capacity increased from 154.1  $\text{mA h g}^{-1}$  for R-S-NCM to 171.4  $\text{mA h g}^{-1}$  for R-C-NCM after the purifying treatment, although this was slightly lower than for P-NCM. In Fig. 4b and Fig. S31 (ESI<sup>†</sup>), the R-C-NCM cathode exhibit 91.7% and 82.1% capacity retention after 100 cycles and 200 cycles, respectively, compared with 91.6% and 78.3% for P-NCM, and 78.6% and

57.5% for R-S-NCM, indicating the R-C-NCM cathode had better cycling stability, even compared to the pristine one. As for the rate performance, the R-C-NCM cathode demonstrated a better high-rate capability (Fig. 4c and Fig. S30, ESI†) at 3C ( $127.8 \text{ mA h g}^{-1}$ ) compared to R-S-NCM ( $69.8 \text{ mA h g}^{-1}$ ) and P-NCM ( $108.9 \text{ mA h g}^{-1}$ ), which was commonly observed on the regenerated NCM cathodes and may be attributed to appropriate F element doping.<sup>12,47</sup> The plateau at  $\sim 3.6 \text{ V}$  in the voltage profiles (Fig. 4d and e and Fig. S30, ESI†) for R-S-NCM nearly disappears after 100 cycles, suggesting that R-S-NCM had a rising polarization after long-term cycling. Based on the cyclic voltammetry curves at different scan rates and calculations (Fig. S31 and Table S12, ESI†), the fitting line slope for R-S-NCM was found to be the lowest among all the samples. According to the equivalent circuit (Fig. 4f), the calculated impedance values ( $R_{\text{ohm}}$ ,  $R_{\text{int}}$ , and  $R_{\text{ct}}$ ) of R-C-NCM (Fig. 4g and h) were 1.4, 51.1, and  $307.1 \Omega$ , respectively, and were smaller than that of R-S-NCM. These results indicate the deteriorated kinetics of  $\text{Li}^+$  transportation due to the residual impurities, especially on the surfaces of the regenerated cathodes. According to the chemical state of the electrode surface (Fig. S32, ESI†), R-C-NCM exposed less inorganic fluoride and more lattice oxide, leading to the suppressed interfacial resistance growing during the long-term cycling. Furthermore, the galvanostatic intermittent titration technique (GITT) test also revealed the kinetic characteristics of the solid phase. The current pulse profile and calculated Li-ion diffusion coefficient ( $D_{\text{Li}^+}$ ) after activation are shown in Fig. 4i. The average  $D_{\text{Li}^+}$  values of R-C-NCM and R-S-NCM were calculated to be  $5.78 \times 10^{-14}$  and  $2.99 \times 10^{-14}$  for the charge process (and  $4.56 \times 10^{-14}$  and  $4.29 \times 10^{-14}$  for the discharge process), suggesting that residual impurities penetrating the interior bulk after regeneration hamper  $\text{Li}^+$  hopping within the lattice of the NCM cathode, as supported by the observed F element (Fig. 3c and Fig. S27, ESI†).

According to the above results (Fig. 1d, Fig. S6, S16 (ESI†), and Fig. 4h, i), the migration rate of lithium ions was significantly influenced by the residual impurities; therefore it was crucial to theoretically investigate their influence on capacity delivery in the reuse case and during direct regeneration. Considering the impurities were mostly concentrated at the surface before and after regeneration, and that F-rich residuals could be observed, as shown in Fig. S9 and S10 (ESI†) and Fig. 3c, we chose three representative inorganic components ( $\text{LiF}$ ,  $\text{Li}_2\text{CO}_3$ , and  $\text{LiOH}$ ) in the CEI layer<sup>48</sup> or residual alkali<sup>49</sup> to calculate the  $\text{Li}^+$  diffusion from a thermodynamic perspective, and their structures are shown in Fig. 5a. By maintaining a similar distance and concentration of mobile Li-ions, the diffusion energy barrier of lithium ions ( $\Delta E_{\text{Li}^+}$ ) during the cycling of spent cathodes within the different crystal structures (Fig. 5b) allowed valid comparisons. We found that the  $\Delta E_{\text{Li}^+}$  of the  $\text{LiF}$  phase, as a common inorganic component from CEI, was about 2 and 3 times higher than that of the  $\text{LiOH}$  and  $\text{Li}_2\text{CO}_3$  phases from
