Cite this: *Nanoscale*, 2018, **10**, 7058

## Non-destructive characterization of extended crystalline defects in confined semiconductor device structures†

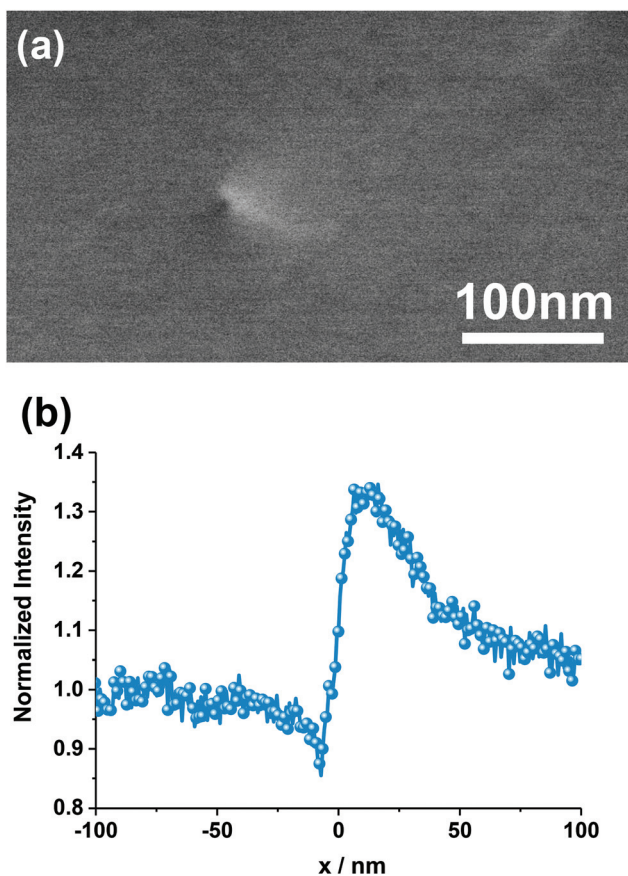
**Fig. 1** (a) ECCI micrograph obtained on a lowly defective SiGe buffer layer showing a single threading dislocation emerging at the layer surface. The typical contrast inversion across the defect is clearly visible. (b) Horizontal line section through the defect illustrating the contrast inversion quantitatively (*i.e.* transition from reduced backscatter signal to an increased backscatter signal when crossing the defect from left to right).

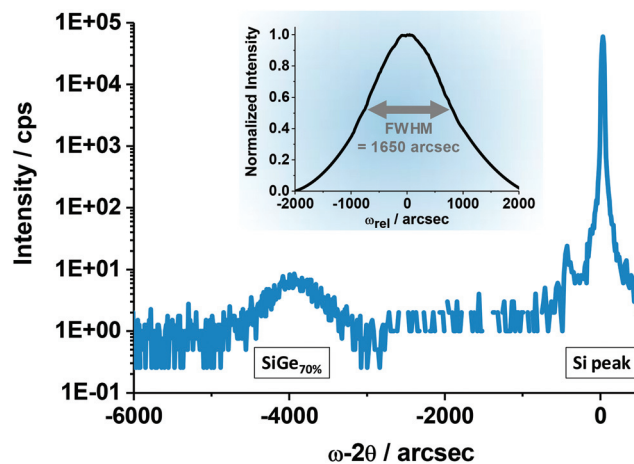
**Fig. 4** HRXRD (004)  $\omega$ - $2\theta$  scan acquired on the large  $\text{Si}_{0.3}\text{Ge}_{0.7}$  pad. The peak around  $-3900$  arcsec corresponds to fully relaxed  $\text{Si}_{0.3}\text{Ge}_{0.7}$ . The inset shows an  $\omega$  rocking curve obtained around the SiGe layer peak. The pronounced peak broadening with a FWHM value of  $1650$  arcsec is due to the high defect density and the associated mosaicity of the material.

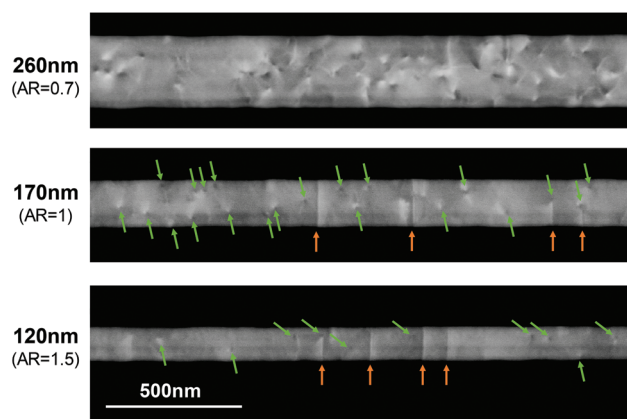
**Fig. 7** Top-view ECCI micrographs obtained on selectively grown SiGe fins of different widths. The density of threading dislocations reduces with decreasing fin width resulting in an effective threading dislocation density of  $4 \times 10^9 \text{ cm}^{-2}$  for the 120 nm wide fins. At the same time, however, the number of planar defects (stacking faults) emerging at the fin surface increases. The fins' aspect ratios AR (height : width) are indicated as well.

The picture changed upon decreasing the width of the selectively grown fins. While we could still observe a threading dislocation density of  $\sim 10^{10} \text{ cm}^{-2}$  on the surface of 260 nm wide fins, fewer threading dislocations (labeled with green arrows) reach the fin surface once the fin width is reduced to 170 nm and below (Fig. 7). In fact, for the 170 nm wide fins, we determined a reduction of the threading dislocation density to  $6 \times 10^9 \text{ cm}^{-2}$  and for the 120 nm wide fins to  $4 \times 10^9 \text{ cm}^{-2}$ . At the same time, however, we detected an increasing number of line-like features on the fin surface when decreasing the fin width. These lines (highlighted by orange arrows in Fig. 7, 8 and 10) are oriented perpendicular to the fin length and they correspond to planar defects emerging at the fin surface as will be discussed further below.

lying fin can either cross the entire fin from one sidewall to the other or they extend only partially across the fin width (see e.g. the different line features highlighted by the orange arrows on top of the 170 nm wide fin in Fig. 7). In the latter case, the stacking fault is boarded by a partial dislocation.

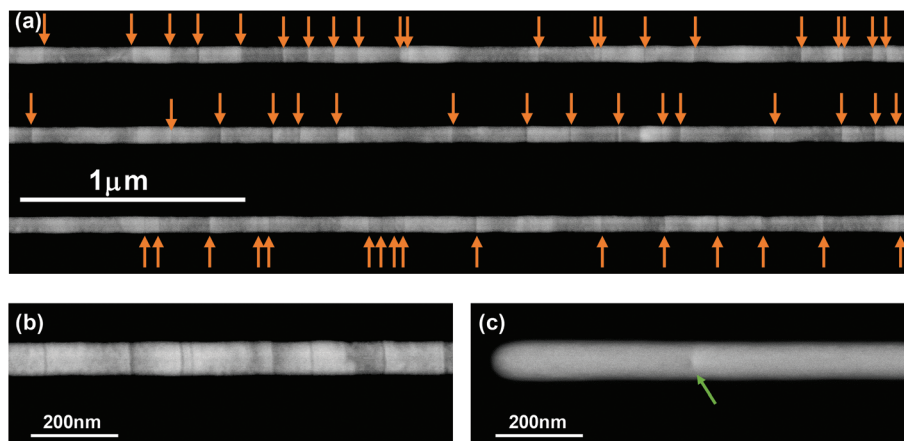
**Fig. 8** (a) Overview ECCI micrograph obtained on 75 nm wide ( $AR = 2.3$ ) selectively grown SiGe fins at lower magnification, which allows for the non-destructive and fast determination of statistically relevant numbers on the density of planar defects (stacking faults, highlighted by orange arrows). In the presented case, a linear density of 44 planar defects per 10  $\mu\text{m}$  fin length could be extracted. (b) ECCI micrograph of the same fin at higher magnification. Threading dislocations as observed for wider fins could not be detected. (c) ECCI micrograph acquired on a fin of similar dimensions which has been etched from a plastically relaxed blanket Ge layer. A single threading dislocation (highlighted by a green arrow) on the fin surface can be easily resolved.

In the case of 75 nm wide fins ( $AR = 2.3$ ), we could not observe any threading dislocation reaching the fin surface (Fig. 8a/b) whereby we inspected a fin surface area equal to 3.4  $\mu\text{m}^2$  in total, out of which a representative part is shown in Fig. 8a. Hence, the threading dislocation density for fins of this dimension must be below  $3 \times 10^7 \text{ cm}^{-2}$  if one assumes a uniform defect distribution. In this regard one must realize that in order to ascertain a defect density as low as *e.g.*  $10^5 \text{ cm}^{-2}$  (*i.e.* one threading dislocation per 1000  $\mu\text{m}^2$  on average) one needs to inspect a fin surface area of several thousand  $\mu\text{m}^2$  in order to obtain statistically relevant information. We are currently extending our setup to enable automated measurements to facilitate the inspection of such large areas thereby achieving better statistics and hence a lower overall detection limit.
